2011 ANNUAL EROSION RECONNAISSANCE ENGINEERING REPORT

February 2012

SACRAMENTO RIVER BANK PROTECTION PROJECT SACRAMENTO RIVER AND TRIBUTARIES

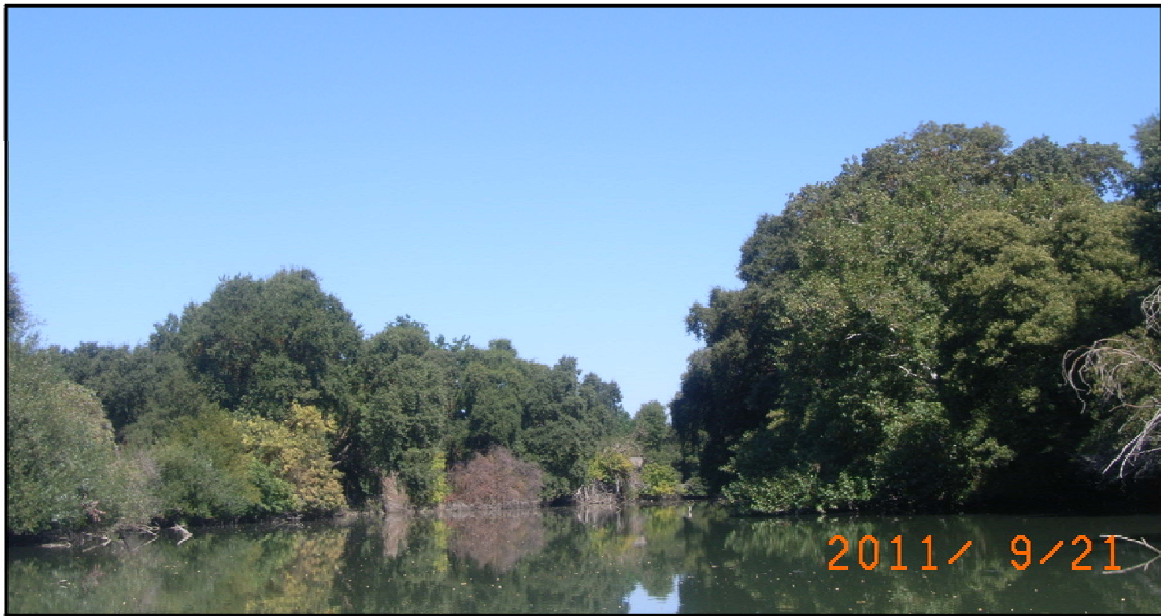
Figure 12. Typical View of Elk Slough.

Elk Slough – Elk Slough was cut off from the Sacramento River on the upstream end by the Sacramento River levee and therefore has no inflow, it is purely a backwater channel with some tidal influence. The channel is shallow, and the banks are full of vegetation and lined with docks. The levees are over-steepened and built out of non-cohesive dredge material. The entire levee reach is in poor condition, with slumping, holes, and stability problems. **Figure 12** shows a typical view of Elk Slough. With the levees being in such poor shape the entire leveed reach (right bank and left bank) is classified as an erosion site. This reach would benefit from a reach wide repair.

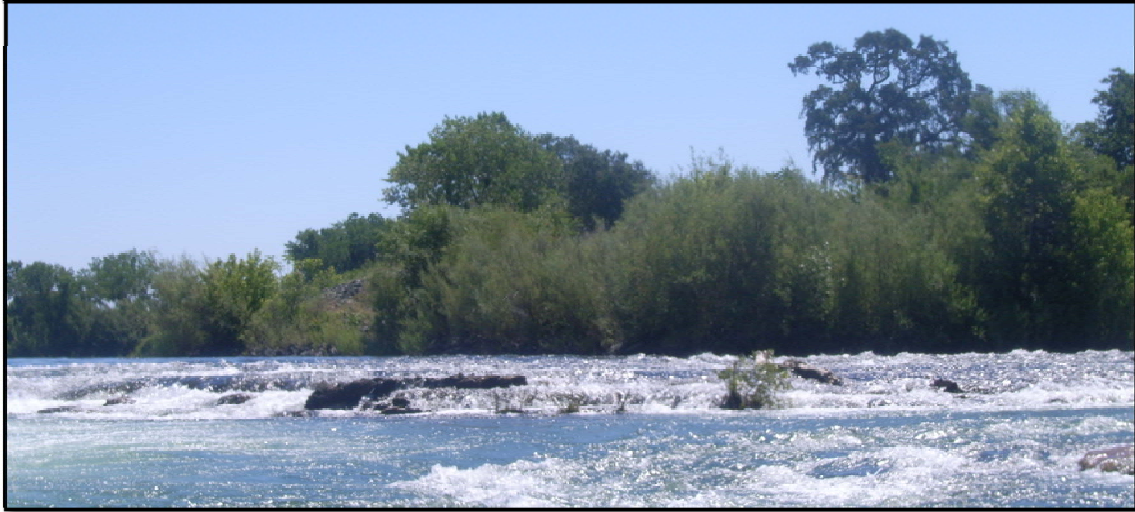
Figure 14. View of Clay Plug on the Feather River at RM 24.8 before Breaching.

Middle Reach of the Feather River, South of Yuba River (RM 28 to RM 7) – The middle reach of the Feather River is wide and shallow and has a large amount of sand bedload coming from the Yuba River. There was a large head-cut (clay plug) at RM 24.8 that had been slowly moving through the system. This feature acted as a grade control feature in the river and as of early February 2012, this clay plug has been breached. The impacts of this breach are not yet known, but there will most likely be further erosion to the system and potentially new erosion sites in the future. **Figures 14** and **15** show the falls over the clay plug before and after the breach. The levees are setback in this reach and a new setback levee was recently constructed on the left bank from RM 25 to RM 18. The primary causes of erosion in this reach are fluvial and mass failure of eroded banks. There is currently one erosion sites in this reach of the Feather River.

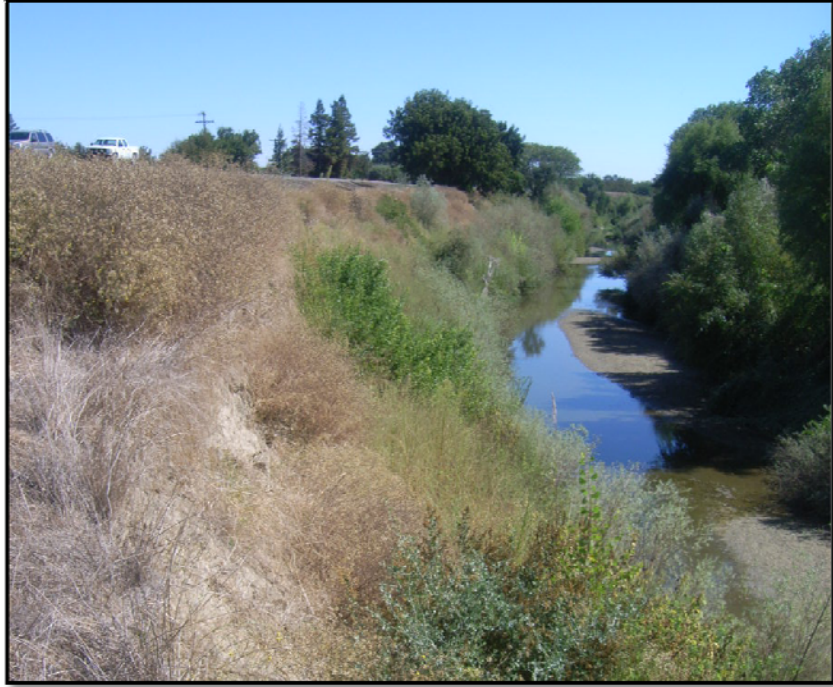
Figure 18. Typical View of Cache Creek.

Cache Creek – Cache Creek is a deeply incised channel with near vertical banks (of over 20 ft in height) for the entire leveed reach. The channel is sediment starved from excessive in-stream gravel mining. Some sand and gravel are present in the channel bed, indicating that the channel may be starting to recover and become more stable. **Figure 18** shows a typical view of Cache Creek. The erosional mechanisms in this reach are toe erosion, fluvial and mass failure. The banks are too steep and the channel is too narrow for a traditional bank protection repair; setback levees have been the selected option for repair. This creek may benefit from a reach-wide repair. There are currently seven (7) erosion sites on Cache Creek, three of which are considered critical. DWR currently has plans to repair four (4) of these erosion sites with setback levees, two of which are critical.

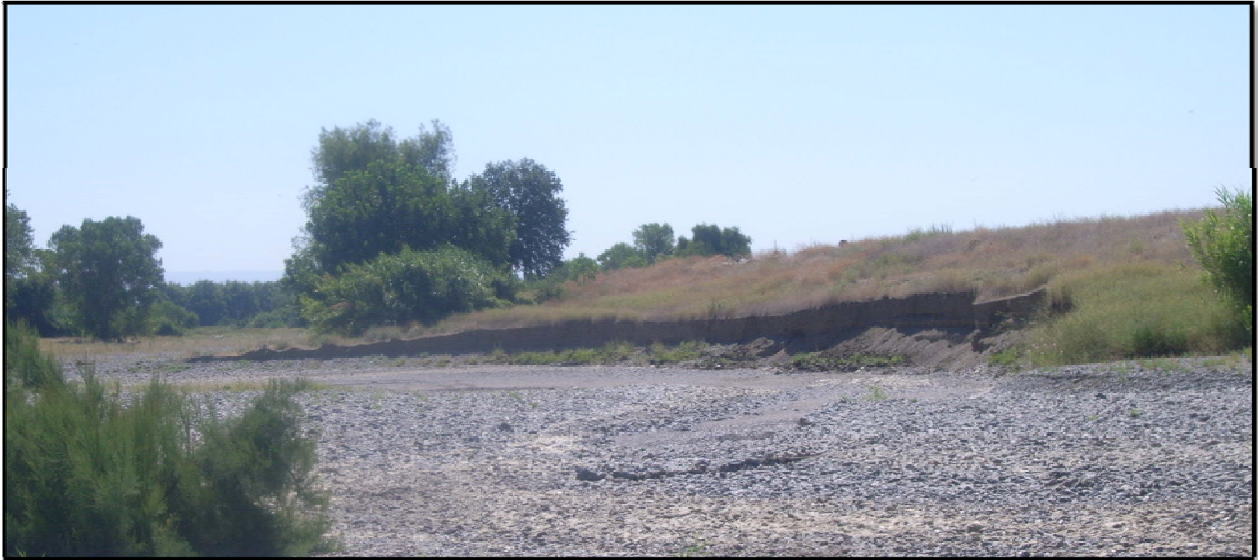
Figure 19. Typical View of the Channel and Eroding Bank of Elder Creek.

Elder Creek – Elder Creek is located in the upper Sacramento Valley, it flows from the east side of the Coastal Mountain range and ends at the Sacramento River near RM 230. Only portions of the creek, near the lower end, are leveed to protect the towns of Gerber and Tehama. Elder Creek is an incised channel with short levees. The channel meanders through a gravel bed and has multiple point bars. The primary mechanisms of erosion are fluvial and whole bank failure. **Figure 19** shows a typical view of Elder Creek channel and eroding bank. There are currently two (2) erosion sites on this creek.

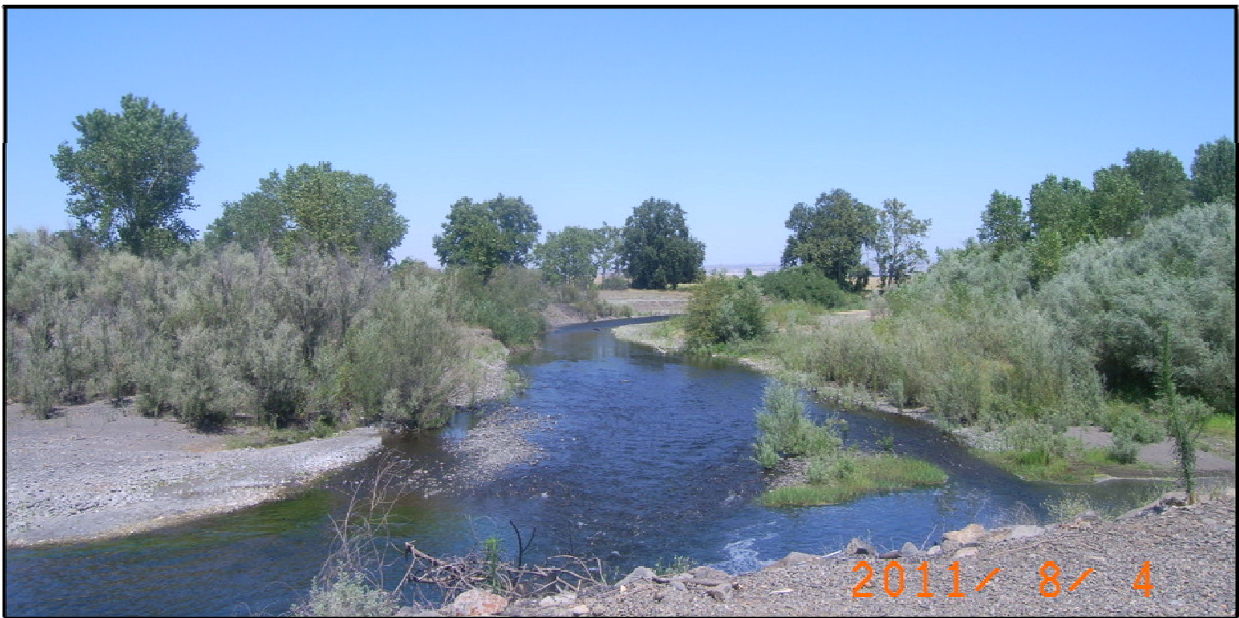
Figure 20. Typical View of Deer Creek.

Deer Creek – Deer Creek is located in the upper Sacramento Valley, it drains water from Lassen Mountain/Cascade Range and ends at the Sacramento River near RM 220. Only portions of the lower end are leveed and most of the places where the creek is close to the levee, it is already rockied. Deer Creek is a natural stream with a boulder/cobble bottom and a riparian habitat. **Figure 20** shows a typical view of Deer Creek. The primary mechanisms of erosion are fluvial, whole bank failure, and tree pop-

outs. There are currently two (2) erosion sites on this creek. The Deer Creek Watershed Conservancy is planning a reach wide repair and restoration to the lower portion of Deer Creek.
