THE STATUS OF BANK SWALLOW POPULATIONS
ON THE SACRAMENTO RIVER, 1986.

Joan M. Humphrey and Barrett A. Garrison

^{1/} Wildlife Management Division Contract Final Report.

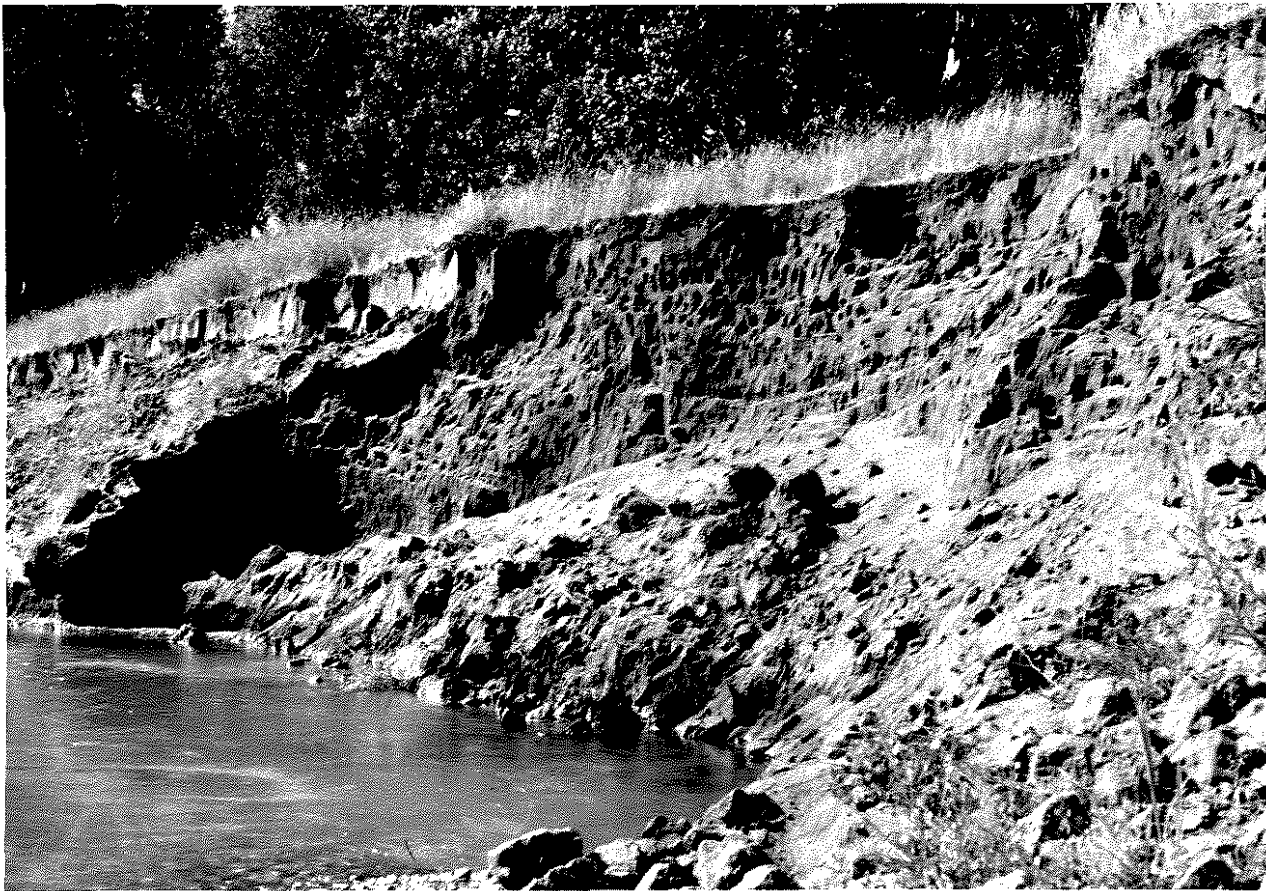
Figure 7. Example of a typical medium sized (131-375 burrows) Bank Swallow colony on an outer bend of the Sacramento River with a forested area immediately above and behind the site.

Except for a sandstone bluff at RM 280, all Sacramento River Bank Swallow colonies were found in recently eroded vertical riverbanks. Bank Swallows showed a preference for the outer curves of the river bank where erosion is heaviest (Hamblin 1975). We found 44 (73.3%) of the 60 colonies on outer bends, 9 (15.0%) were on straight reaches of the river, and 7 (11.6%) were on inner bends. Of the breeding pairs, 14,266 (88.3%) were found on outer bends, 1220 pairs (7.6%) were on inner bends, and 663 pair (4.1%) were on straight reaches of the river. This tendency toward outer bank selection was most obvious within the meandering area between RM 243-143, where 35 (81.8%) of the 44 colonies and 12,695 (92.4%) of the 13,737 breeding pairs nested on outer bends (Figure 7).

Bank Swallow colonies we located on the Sacramento River were relatively similar in appearance (Table 4, Figures 7 & 9). The 3-4 m (10-13 ft) tall, vertically eroded riverbanks were usually devoid of green vegetation and at water's edge. We estimated roots present in 33.7% of the colonies. The typical colony had burrows occupying only 15% of the bank's vertical face, with 20% of the bank above and 65% of the bank below the colony. The average

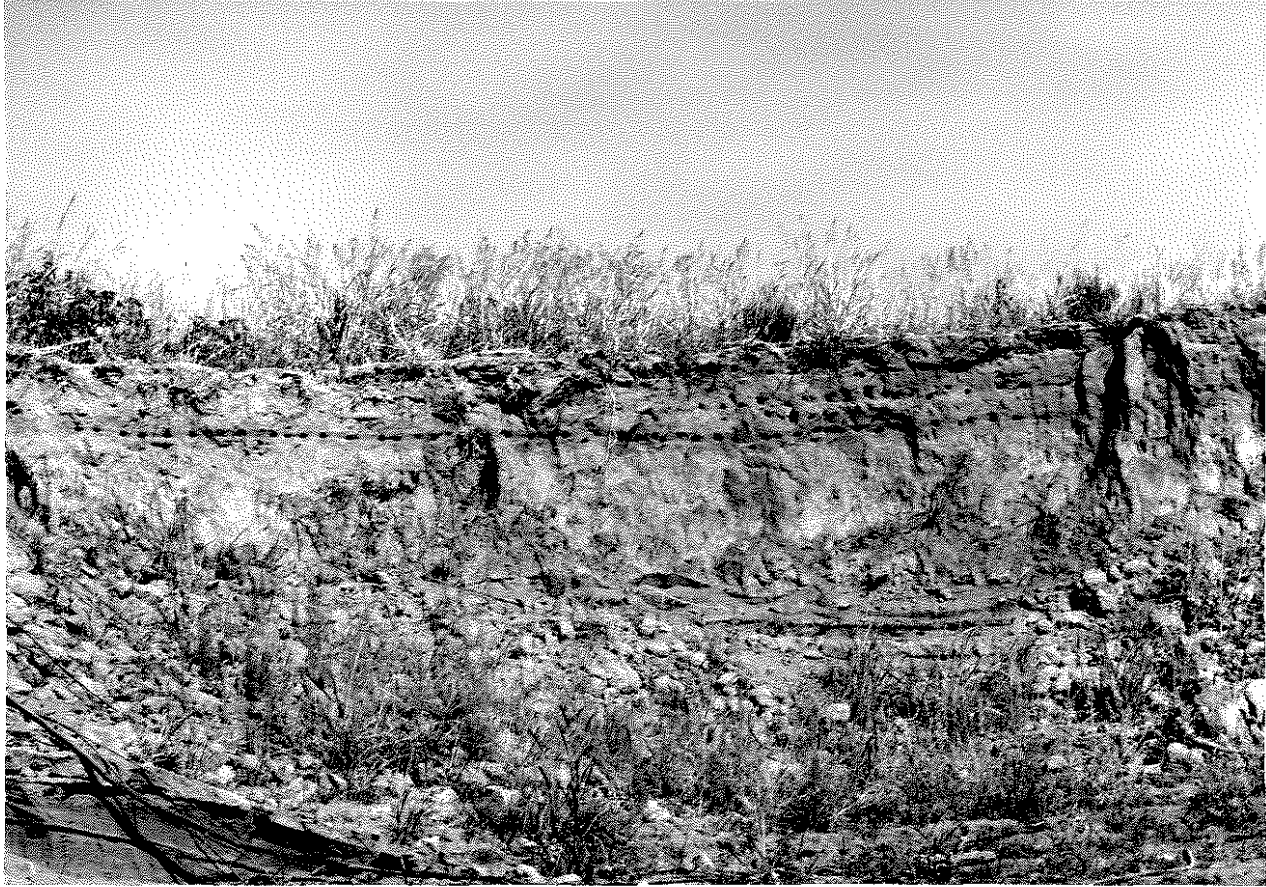
Figure 9. Example of a typical Bank Swallow colony showing marked stratification of burrow locations and open habitat immediately above and behind the site.

Most (73.8%) of the 88 Bank Swallow burrows analyzed were located in evenly textured silty loam to sandy loam soils (Table 6). The mean bulk density of soils samples ($N = 88$) was 1.23 ± 1.2 grams/cc, a loam soil (Hausenbuiller 1978). Bank Swallows were not found burrowing in coarser soils or soils mixed with small rocks or pebbles. The typical colony had burrows in narrow layers of softer silty or sandy soil sandwiched between layers of other soils (Figure 9).

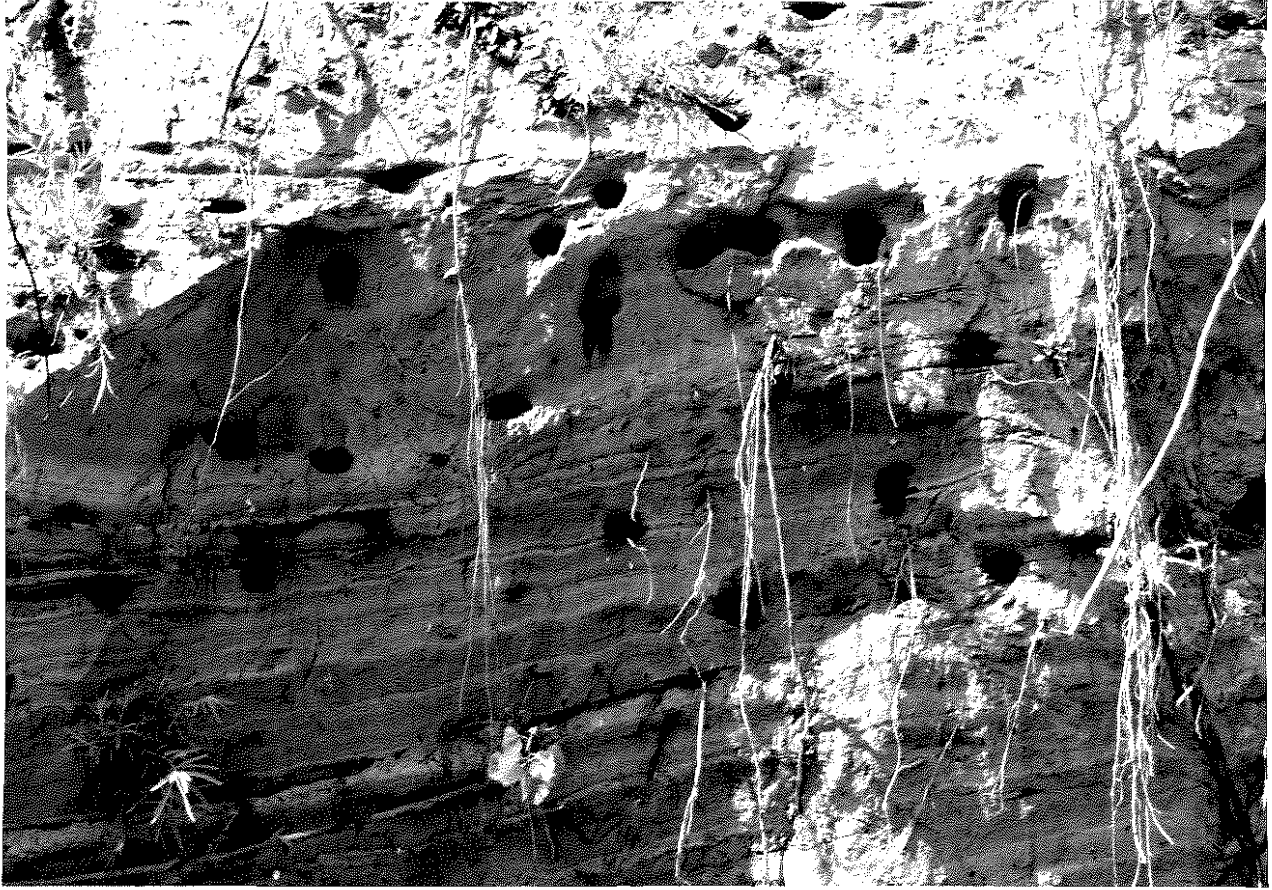
Figure 10. Typical view of a portion of a Bank Swallow nesting colony showing soil stratification and size and distance relationships of individual burrows.

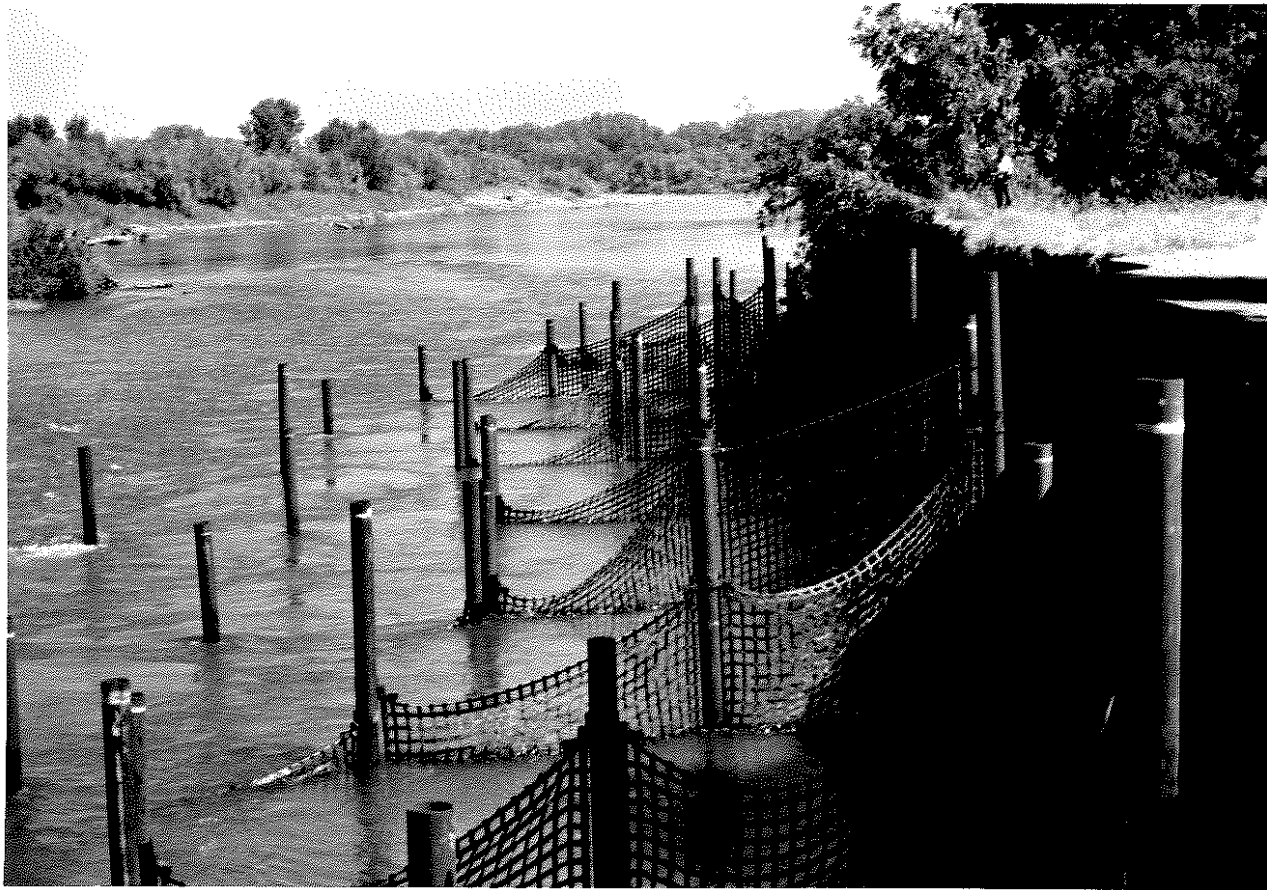
Figure 15. An alternative bank stabilization method called palisading was constructed at Woodson Bridge State Recreation Area in August, 1986 after the Bank Swallow breeding season. The impact of construction on this Bank Swallow nesting colony is currently unknown (note person on bank for scale).

Experimental techniques such as palisading may be effective in controlling erosion, may be more visually pleasing and may provide habitat for some later successional stage riparian species. However, these techniques do not take into account the needs of the flora and fauna, especially bank nesting species and those dependent on early stages of riparian habitat, for a free flowing river.
