THE RIPARIAN FORESTS OF THE SACRAMENTO RIVER ECOSYSTEM

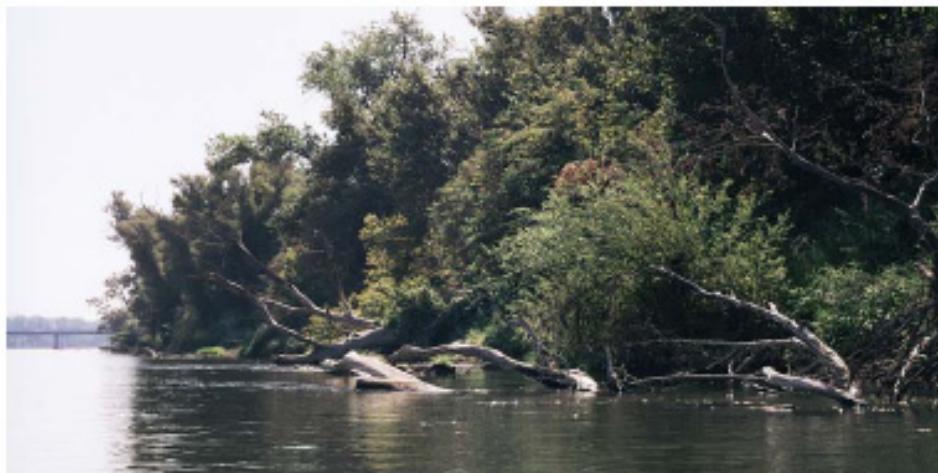
Figure 2-10. Shaded Riverine Aquatic Habitat along the Sacramento River.

Shaded banks are an important component of the Sacramento River ecosystem, created as the river erodes into a bank supporting riparian forests (Figure 2-10). This habitat has an important aquatic component. The U.S. Fish and Wildlife Service has dubbed this

type of area “shaded riverine aquatic cover,” (known as SRA) an area where “the adjacent bank is composed of natural, eroding substrates supporting riparian vegetation that overhangs or protrudes into the water” (USFWS, 1992). It is also characterized by “variable amounts of woody debris, such as leaves, logs, branches and roots, as well as variable depths, velocities and currents.” SRA provides feeding and cover for aquatic species such as salmon, and when less vegetated (see following section on cut banks) provides burrowing substrate for bank swallows.

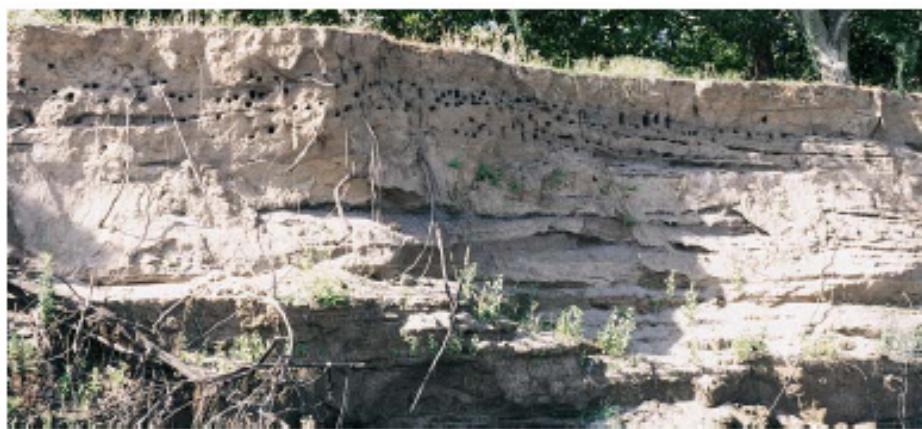
Figure 2-11. Cut bank with bank swallow burrows, Sacramento River, Chico Landing-Red Bluff Reach

Cut banks are another important component of the riparian ecosystem along the Sacramento River. Most often associated with valley oak woodland and high terrace agriculture, cut banks along the Sacramento River also support the majority of California’s bank swallow (*Riparia riparia*) colonies. The migratory bank swallow, which winters in Central and South America, nests in the spring, mostly in steep freshly eroded earth banks (Figure 2-11).
