RED BLUFF – CHICO LANDING REACH

Figure 4-1. Sacramento River Conservation Area, Red Bluff to Chico Landing

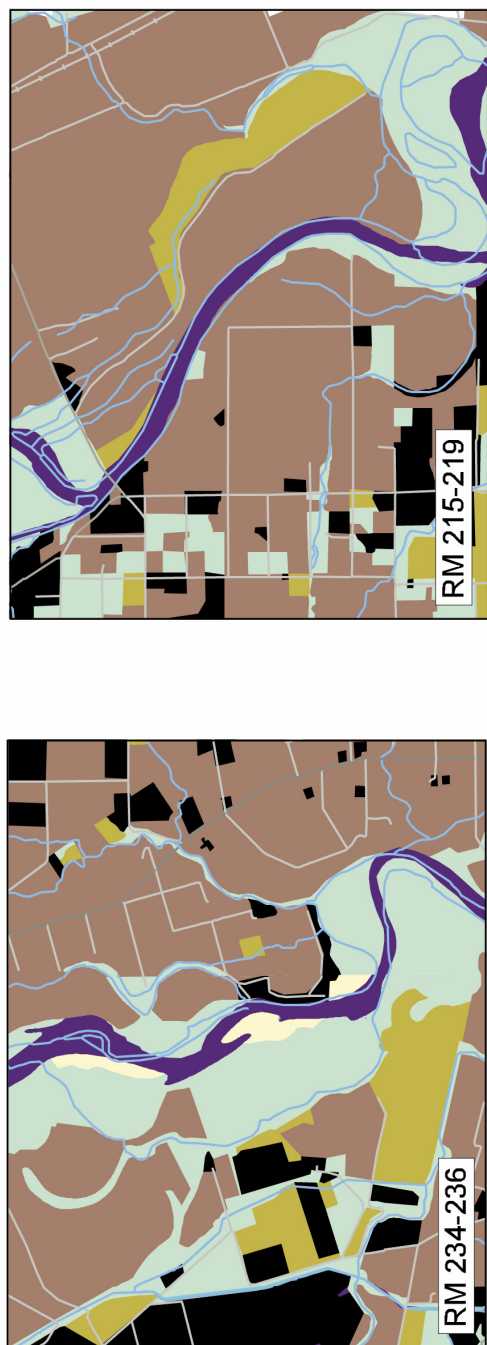
Figure 4-4a. A comparison of land use patterns between an active subreach (left) and a more stable subreach (right). Dark brown areas represent orchards.

Within the inner river zone guideline, about 4,854 acres (30 percent) of the land is in agricultural crops, mostly walnuts, almonds, and prunes. A comparison of land use with the eight subreaches shows that orchards are planted most closely to the river channel along the more stable subreaches and that riparian habitat is most developed along the more unstable reaches (Figures 4-4a and 4-4b).
