# **Draft Detailed Project Report and Environmental Assessment Section 1135 Ecosystem Restoration Project**

## **Woodson Bridge, California**

**U.S. Army Corps of Engineers  
Sacramento District  
Tehama County  
California State Reclamation Board**

**Sep 2003**

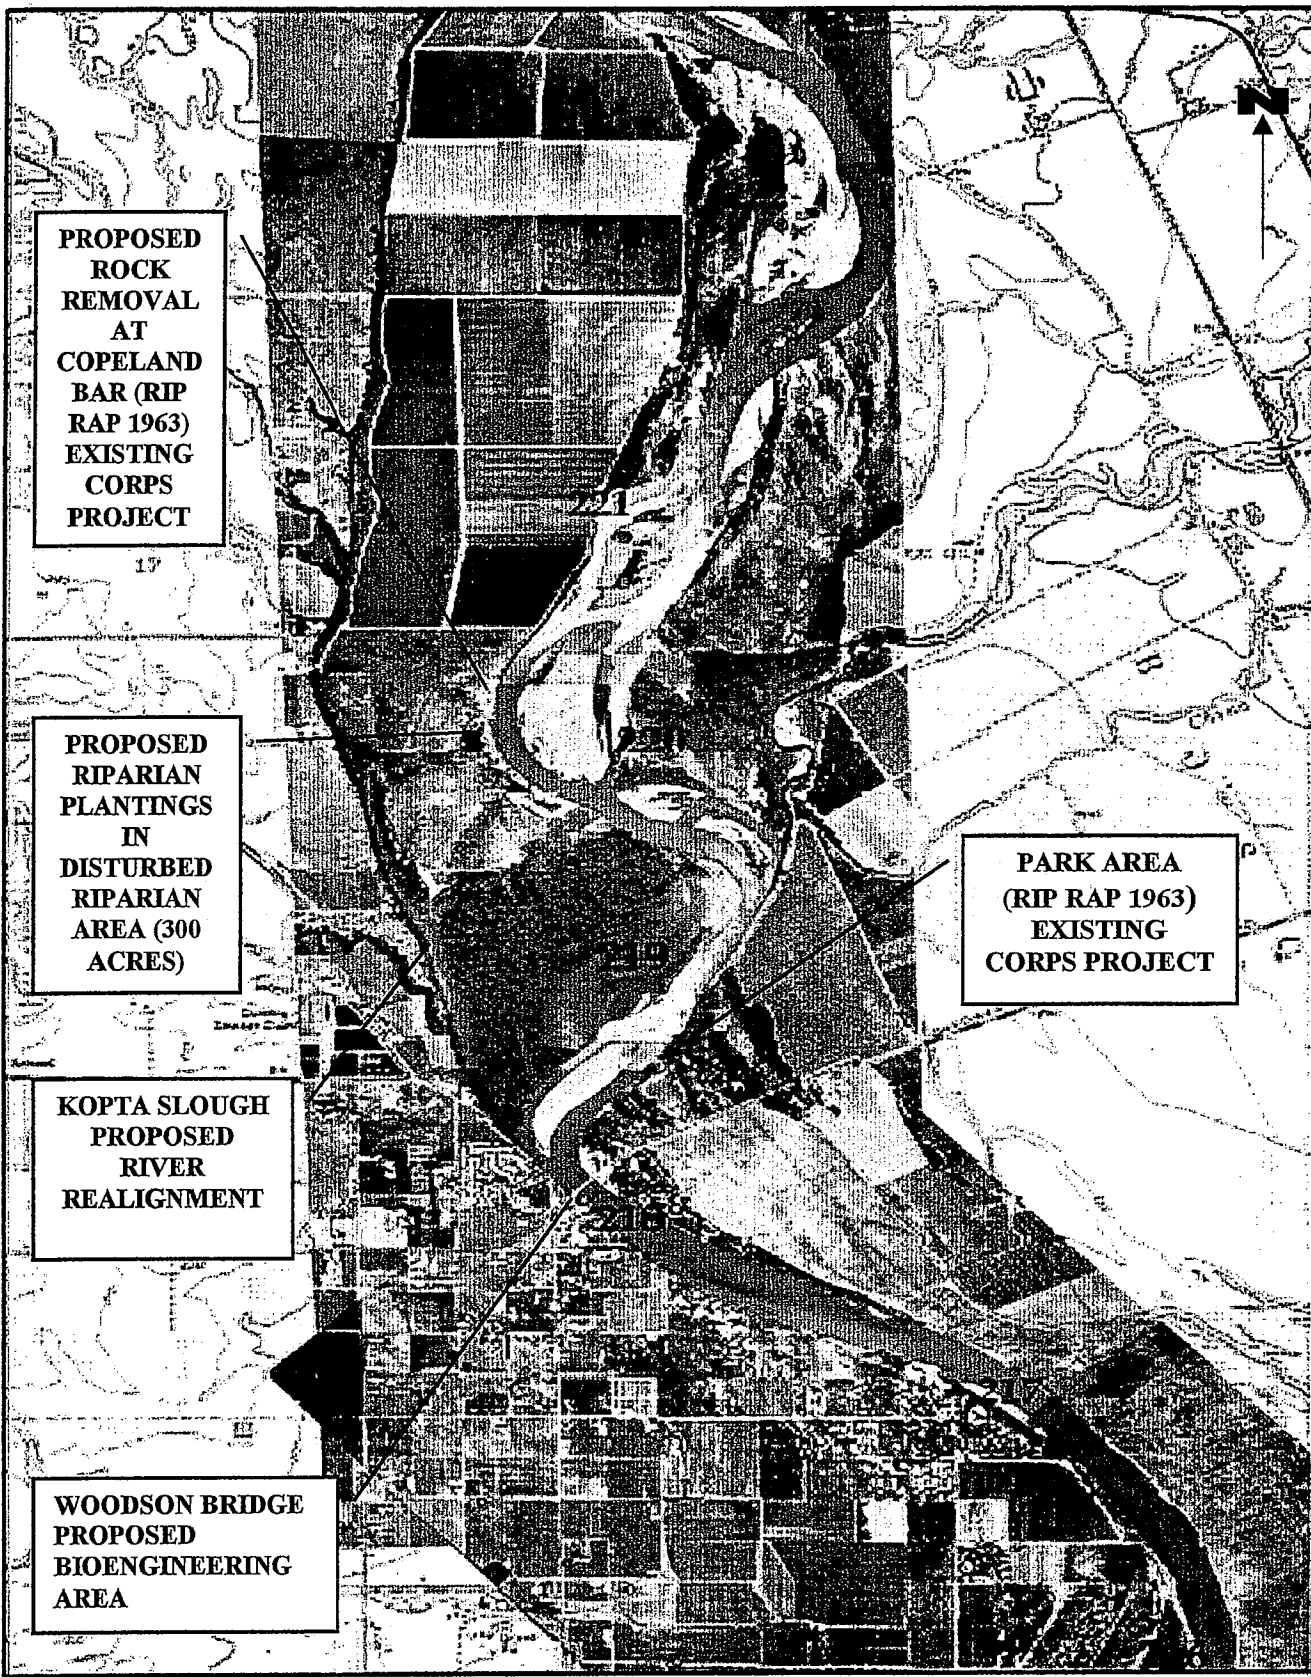
PROPOSED  
ROCK  
REMOVAL  
AT  
COPELAND  
BAR (RIP  
RAP 1963)  
EXISTING  
CORPS  
PROJECT

PROPOSED  
RIPARIAN  
PLANTINGS  
IN  
DISTURBED  
RIPARIAN  
AREA (300  
ACRES)

PARK AREA  
(RIP RAP 1963)  
EXISTING  
CORPS PROJECT

KOPTA SLOUGH  
PROPOSED  
RIVER  
REALIGNMENT

WOODSON BRIDGE  
PROPOSED  
BIOENGINEERING  
AREA

Woodson Bridge State Recreation Area is east of Corning in the northern part of the Sacramento Valley and about 15 miles south of Red Bluff. The study area includes a 3-mile river reach and associated riparian corridor from River-Mile 218 near Vina Woodson Bridge State Recreation Area through River Mile 221 upstream of Vina Woodson Bridge. The area also includes Kopta Slough and the mouth of Deer Creek, both of which include high quality shaded riverine aquatic habitat. This river reach also includes 2.2 miles of rock revetment (previous Corp bank stabilization project), and 6.3 miles of shaded riverine aquatic habitat, and 0.4 miles of eroded banks. The location of the proposed restoration project is shown in Figure 1. The proposed project modifications are shown in Figure 2.

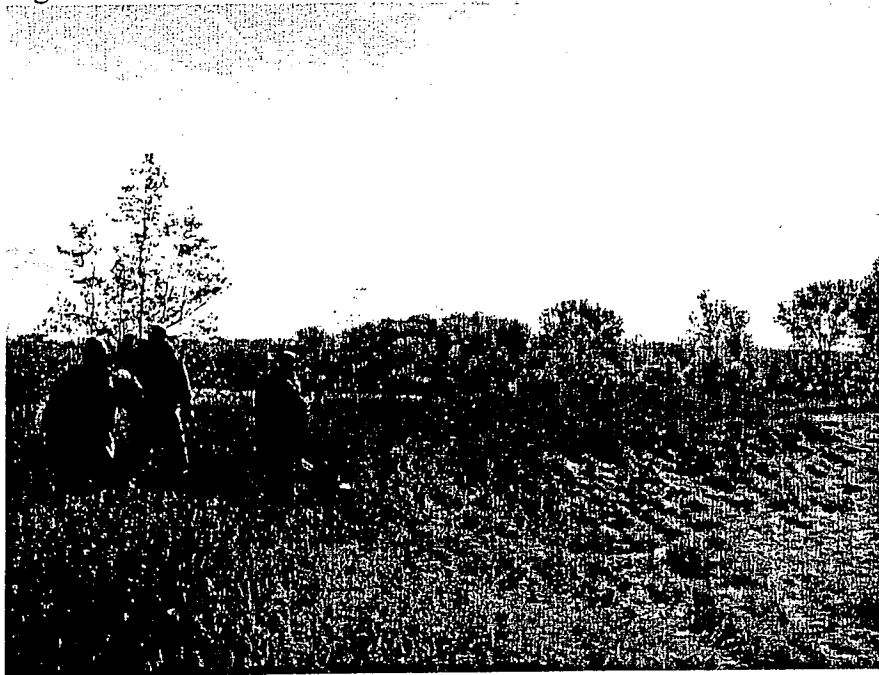
Figure 4.

Loss of aquatic, riparian, and adjacent terrestrial habitats between Kopta Slough and the river for use by migratory and neo-tropical birds that migrate along the Sacramento River corridor, listed species and other wildlife species are shown below from site visit in November 2002.

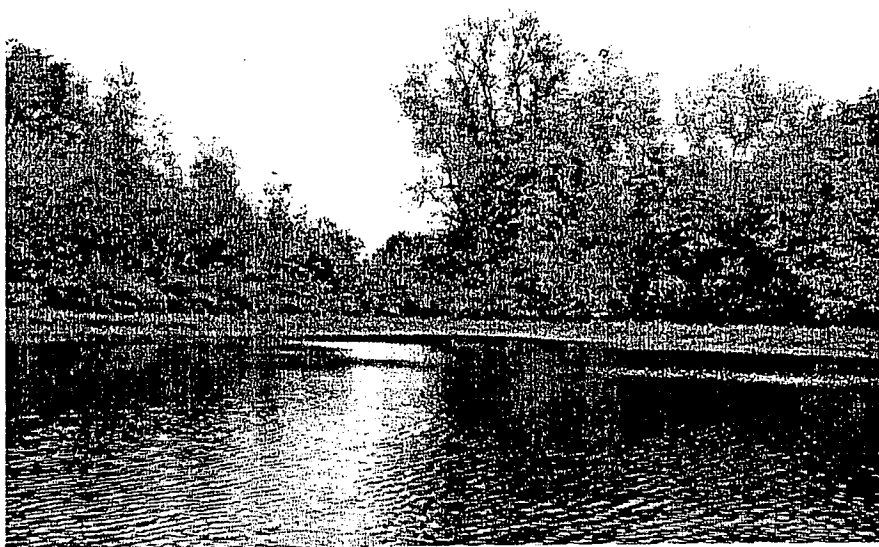
Figure 5.

The below figure is the north side of Kopta Slough where it has been cut off due to rock revetment from the Sacramento River where it historically flowed for 42 years.

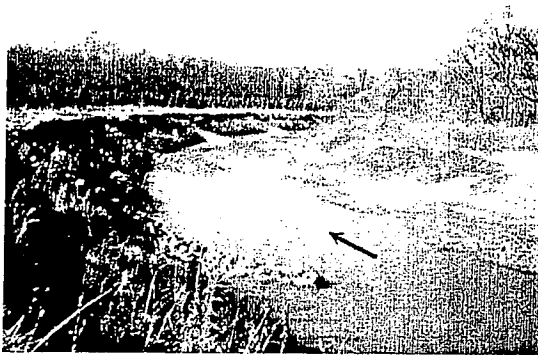
Example of bendway weir immediately  
After construction

Reach 11 - Immediately after construction

- **Bendway weirs at Woodson Bridge** – involves the installation of a series of low rock structures at the bend of an eroding stream channel. These structures redirect high-velocity flow and dissipate water energy – taking pressure off a stream bank.

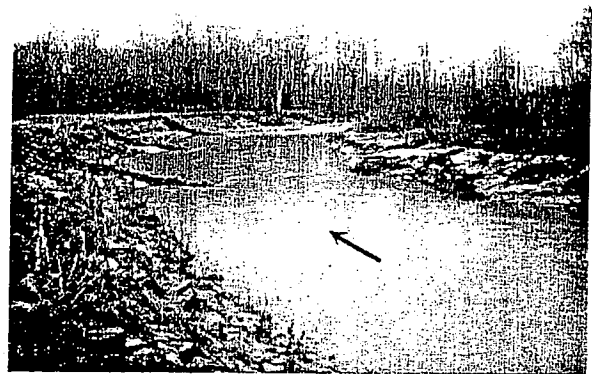
Current redirection at mid-bank flow

Reach 11 - Current redirection at mid-bank flow
