Bank Swallow (*Riparia riparia*) Colony Population Status and Trends on the Middle Sacramento River—1999 to 2012

Joe Silveira, Greg Golet, Dawn Garcia, Jennifer Isola, Mike Carpenter, Mike Wolder, Adam Henderson, Danika Tsao, Ron Schlorff

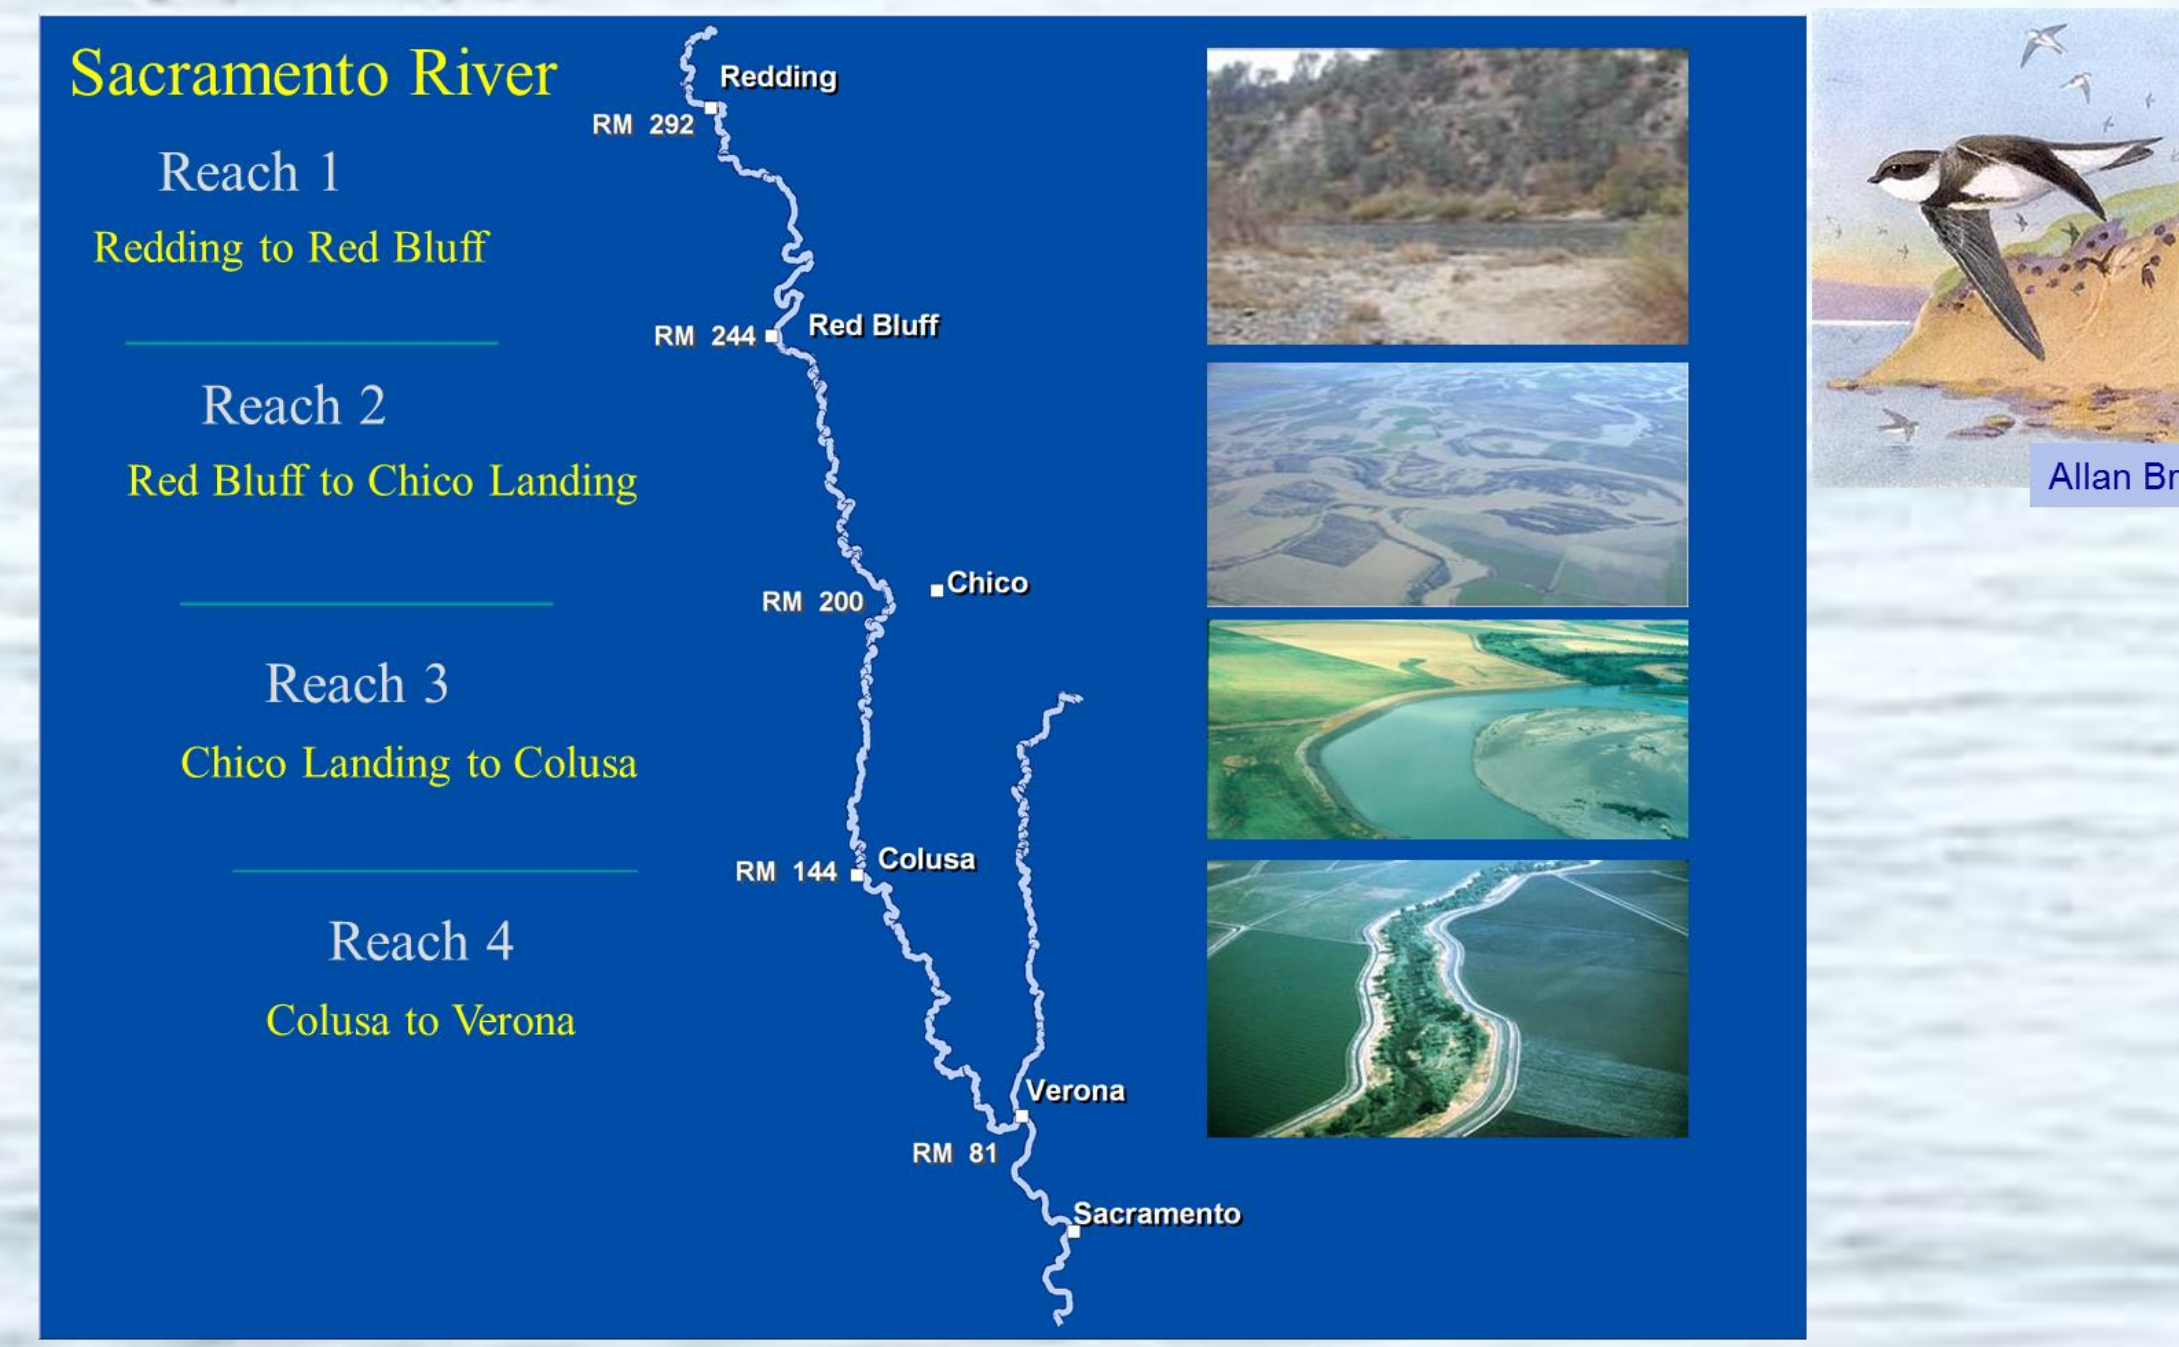
Figure 1. Sacramento River, showing reach segments, and Feather River.

- About 90% of these occur on middle Sacramento River Reach 2 and Reach 3 (Figure 1)
- Middle Sacramento River characterized by over-bank flooding, erosion & deposition, lateral channel migration, floodplain re-working, on-channel meander loops, off-channel oxbow lakes & floodplain sloughs

- About 85% of the California Bank Swallow population breeds on the Sacramento & Feather rivers, excavating nesting burrows in eroding river banks forming various-sized colonies (Figures 1 & 5)

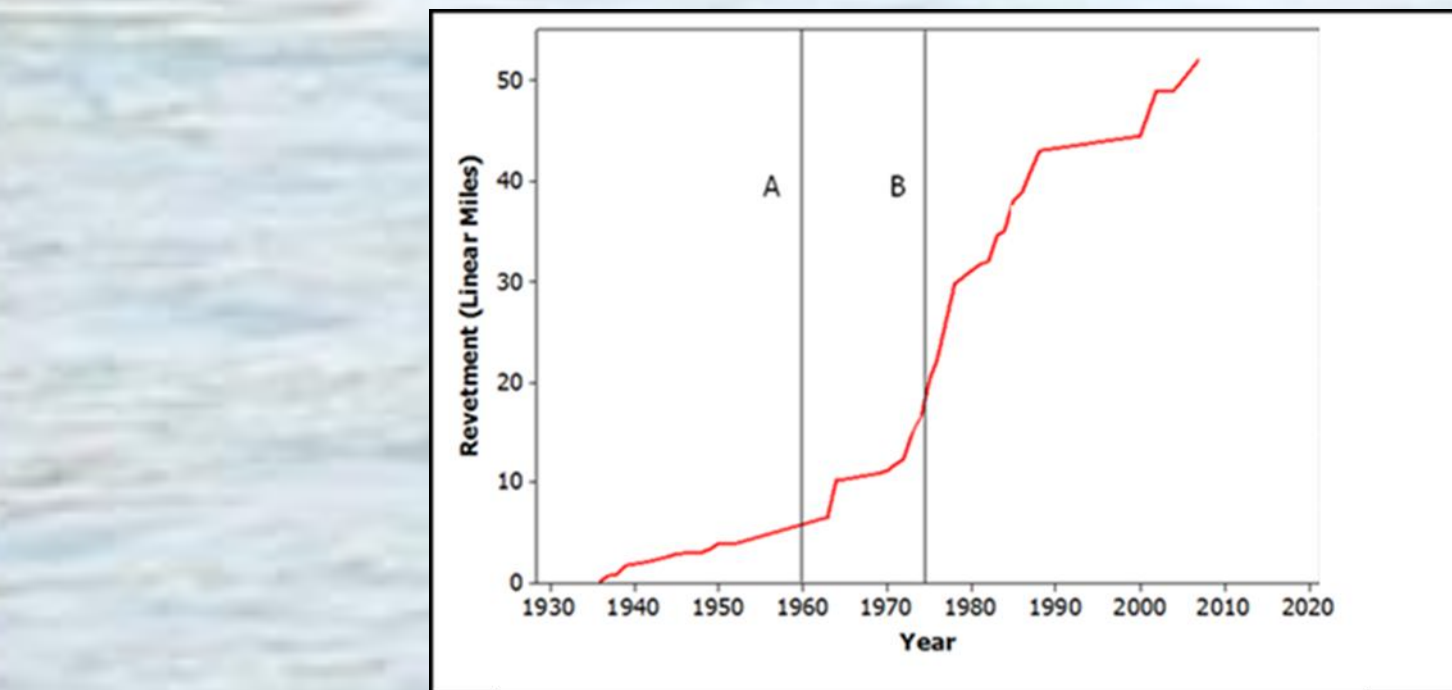
- California Department of Water Resources has documented over 50 miles of bank revetment from Red Bluff to Colusa, a 100-mile stretch of the river (Figure 3)

Figure 3. Cumulative length of rock revetment placed on the middle Sacramento River between Red Bluff and Colusa (approximately 100 miles of river) from 1935–present. Vertical line A – Initial authorization of SRBPP, Phase 1, 1960, Vertical line B – Authorization of SRBPP, Phase 2, 1974. Data from Bank Swallow Technical Advisory Committee (2013).

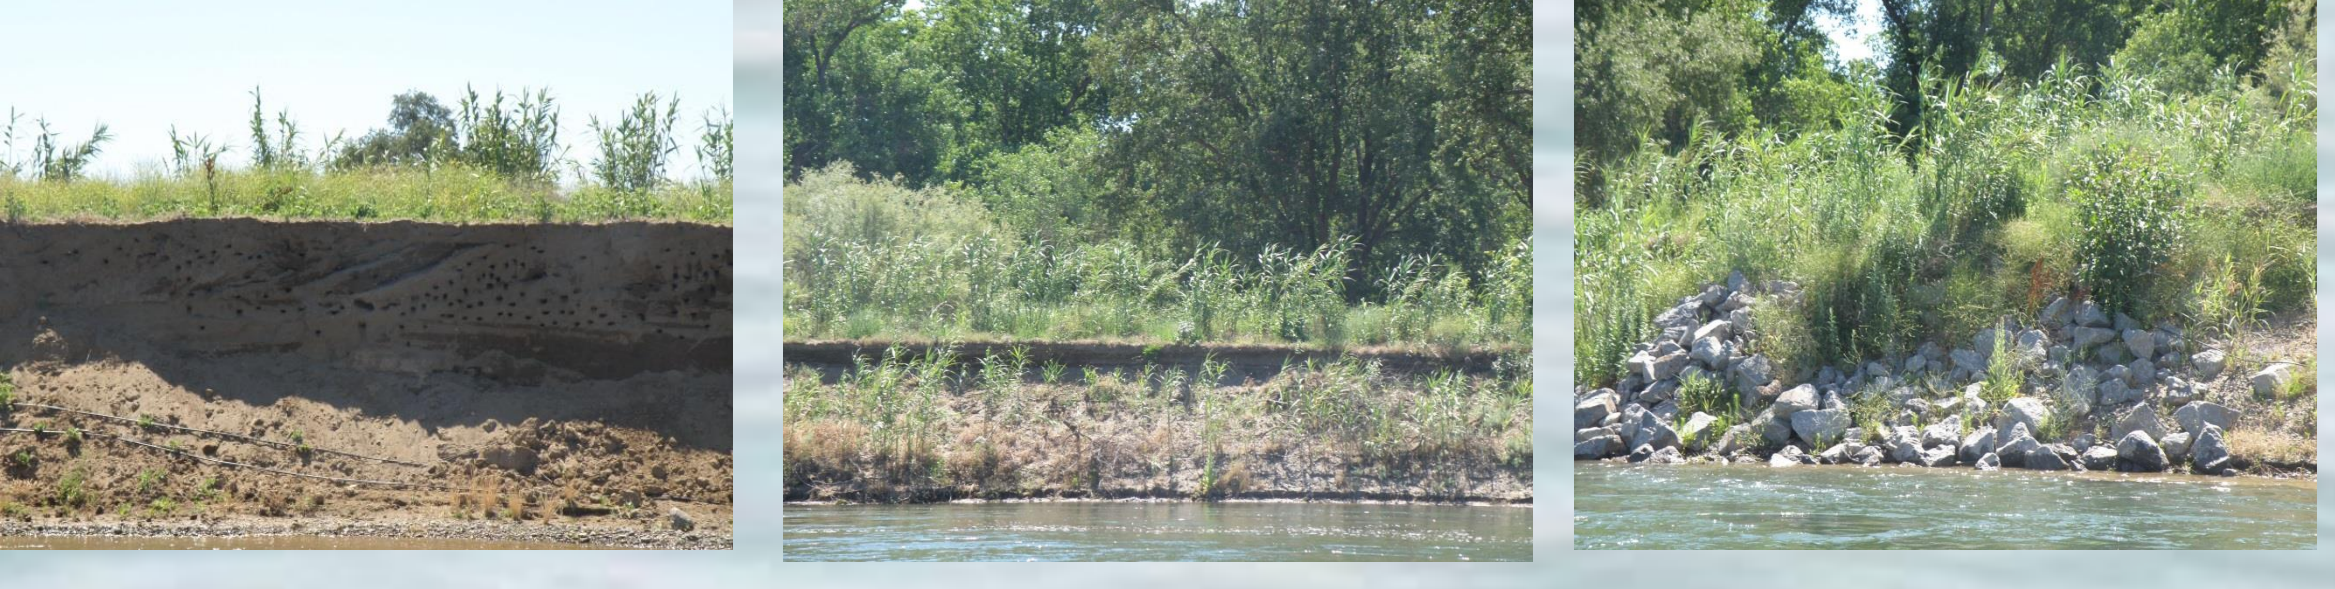
Figure 4. Examples of recent agency and private rock revetment at significant Bank Swallow Colony locations.

Fall 2006: Bank with sloped rock
 Winter 2006: Bank with "emergency rock"

River Mile 233.5 Left— Private Bank Revetment 2012
 • Irrigated *Arundo donax* &
 • Trenched rip-rap

- The Bank Swallow Technical Advisory Committee formed in December 2006 after River Mile 182 (Sacramento River Wildlife Area Jacinto Unit) was rip-rapped under suspect circumstances (Figure 4)

Bank Armoring (Rip-rap) Identified as a Major Cause of Habitat Loss
