Successes, Failures and Suggested Future Directions for Ecosystem Restoration of the Middle Sacramento River, California

Outline

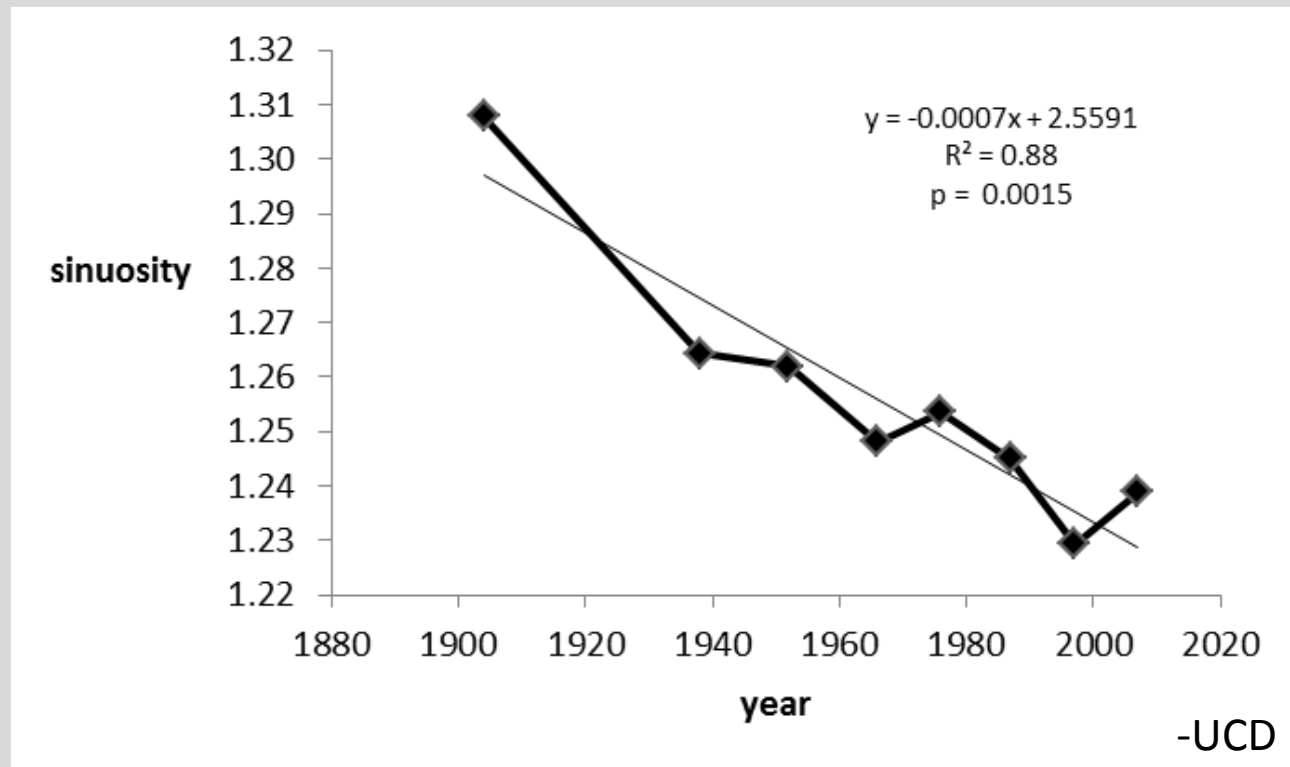
Whole River Sinuosity

- Definition
- Rationale
- Methods
- Results
- Interpretation

Average Bend Entrance Angle	Main river channel between Red Bluff and Colusa	1906 - 2007	Declined since 1987; at lowest value ever in 2007 Decreased significantly (by 13%, from 46 degrees) over the period of record	Larsen (unpublished)	- (-)
Total Channel Length	Main river channel between Red Bluff and Colusa	1906 - 2007	Declined in recent decades; Decreased significantly (by 4%, from 160,529 meters) over the period of record	Larsen (unpublished)	- (-)
Overall					- - (- -)

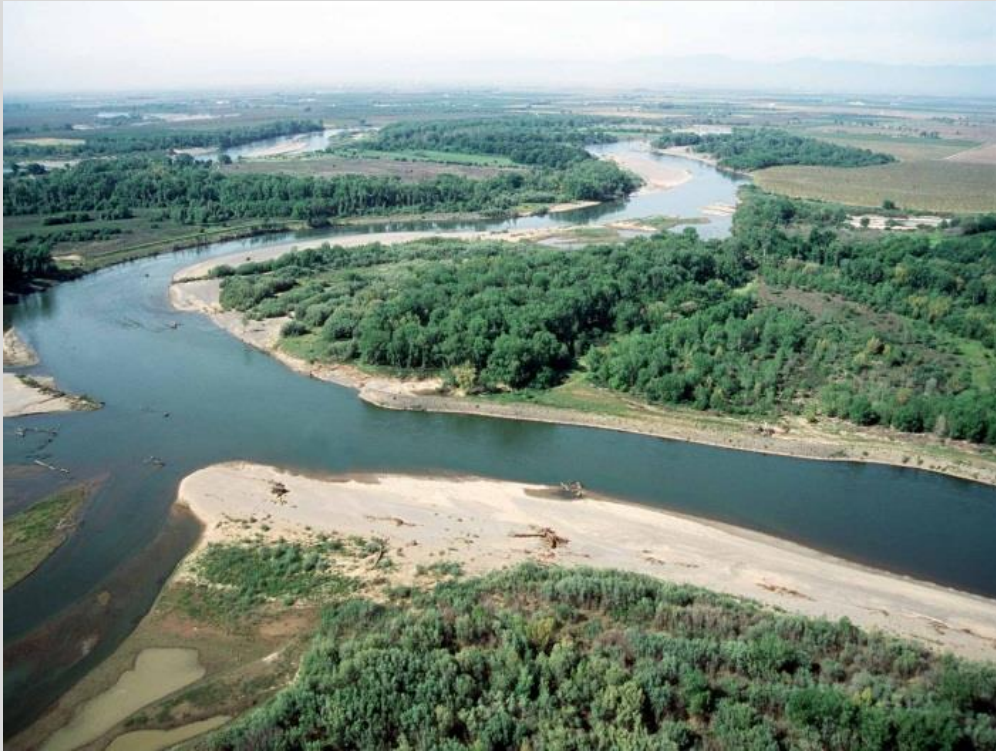
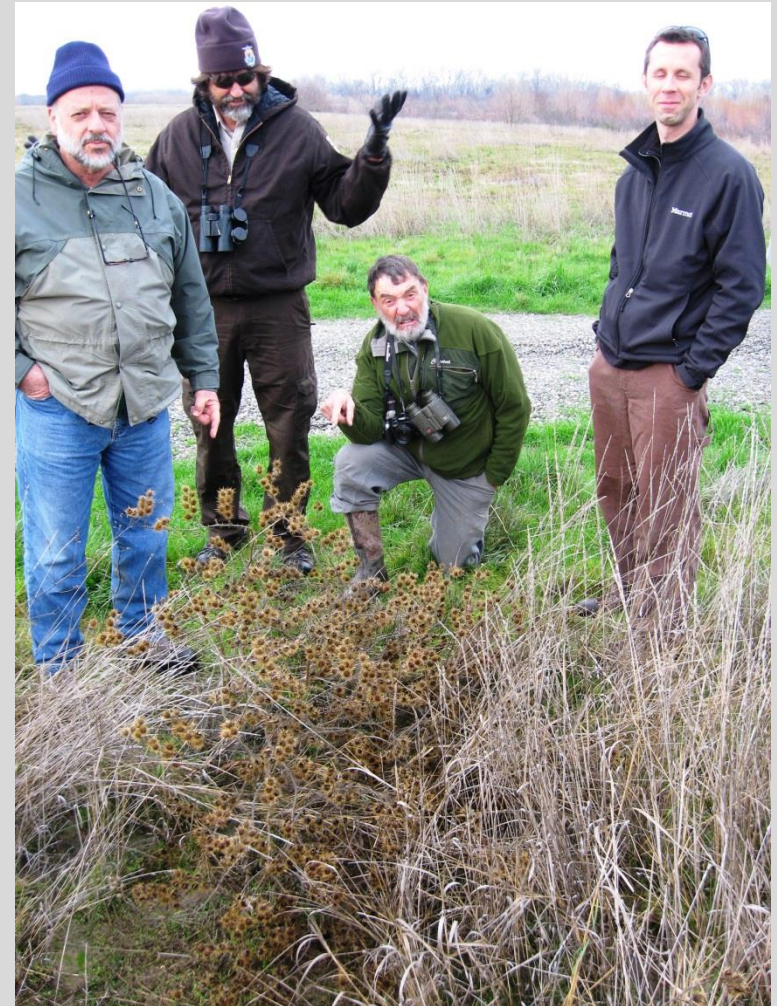
Results *Good progress in the restoration of riparian habitats*

From 1999-2007:

- >600% increase in forest patch core size
- 43% increase in the percent of the river bordered by natural habitat >500 m wide

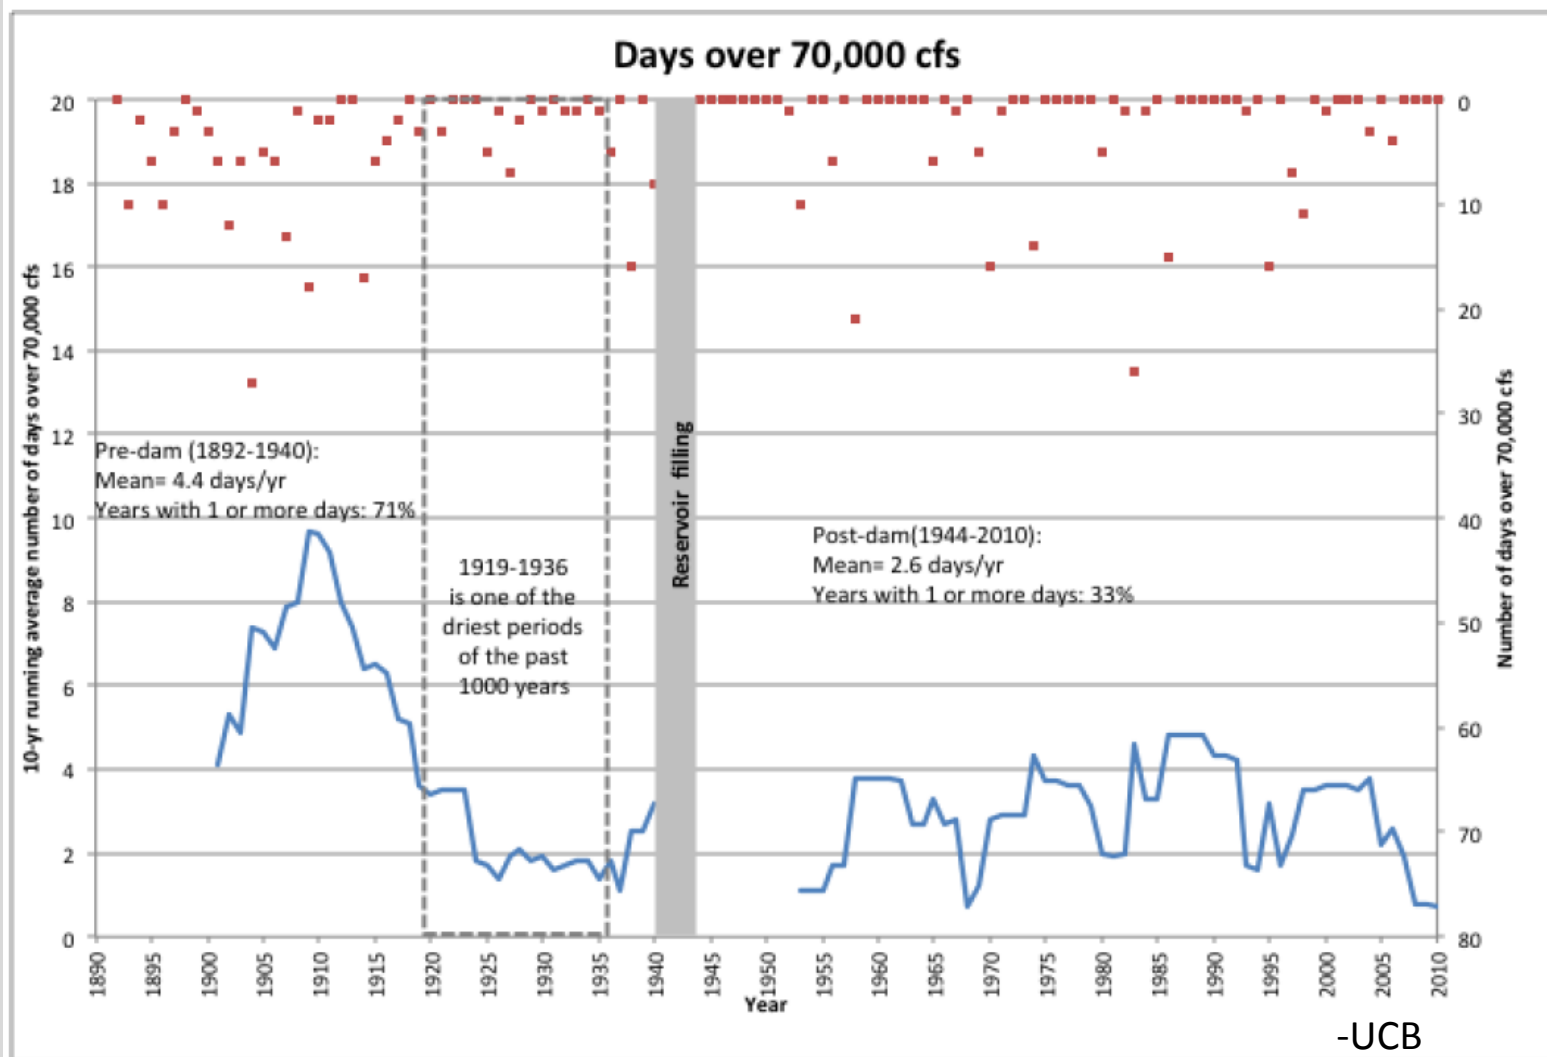
Results *Degraded post-Shasta Dam streamflow conditions have continued*

Relative to pre-dam conditions:

- # of years between bed mobilization
 - # of years between floodplain inundation
- Increased by > 100%

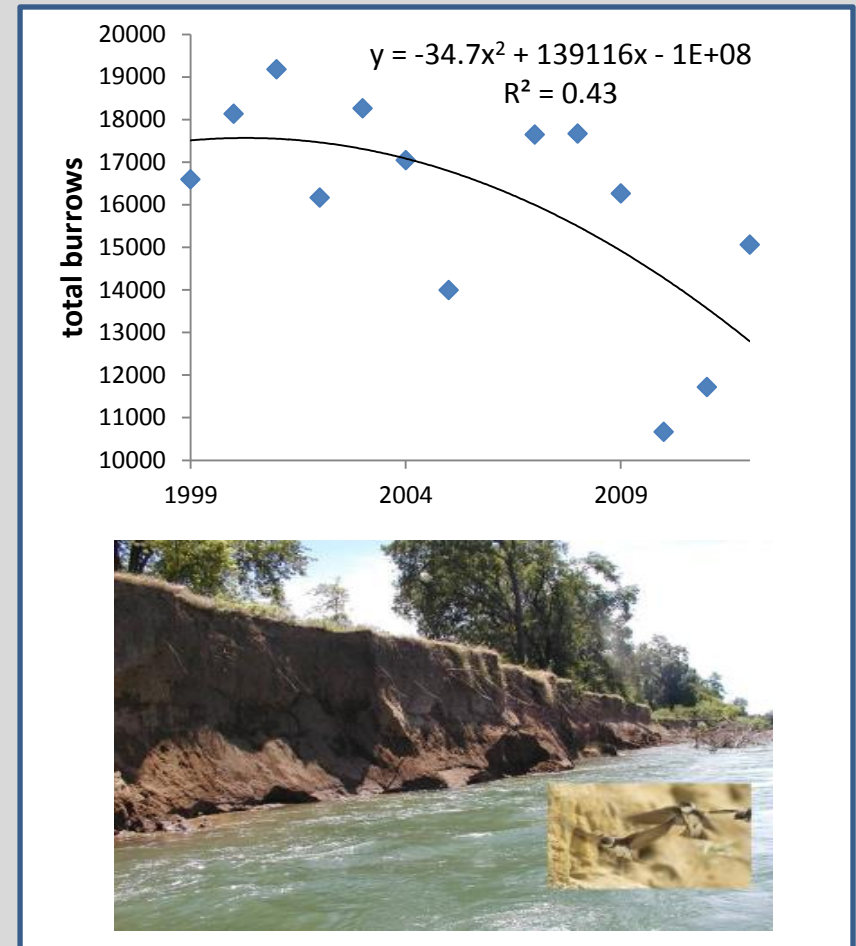
Results *Trends in geomorphic processes were strongly negative*

- channel simplified, becoming less sinuous with reduced overall channel length with increases in the amount of bank hardened with riprap, and decreases in the area of floodplain reworked
- Biological consequences include decline of bank swallows
