# ***Riparian Restoration and Flood Management:***

## ***An Exercise in Communication***

Dr. F. Thomas Griggs, River Partners

Sacramento River Science Conference  
4 June 2013

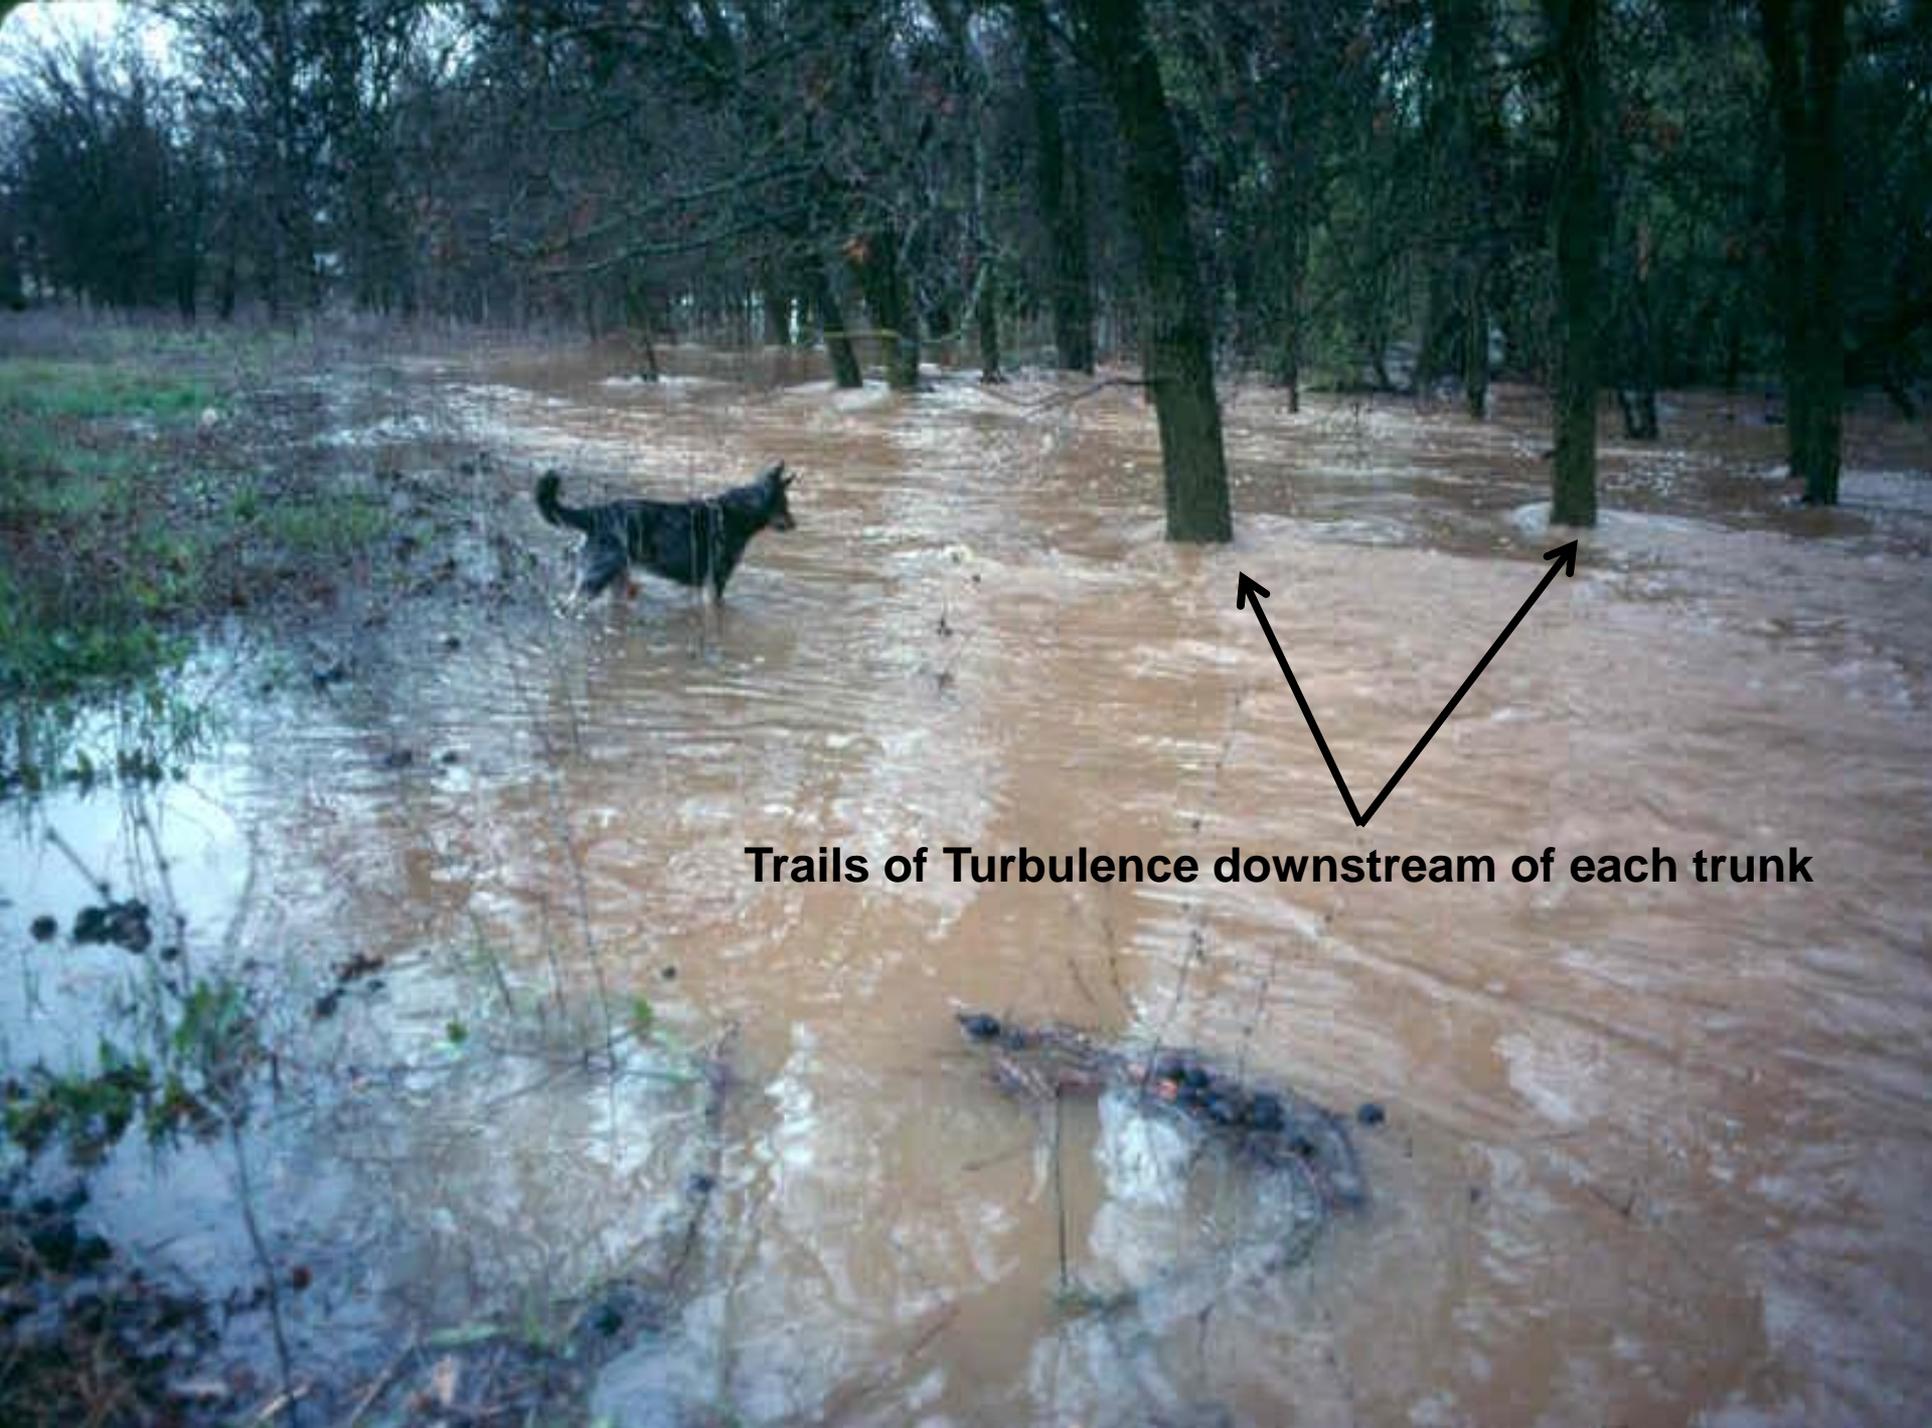
**Trails of Turbulence downstream of each trunk**

Low  
Elevation  
Surface

Turbulence

Water "Stacking-Up" Upstream

← Flow

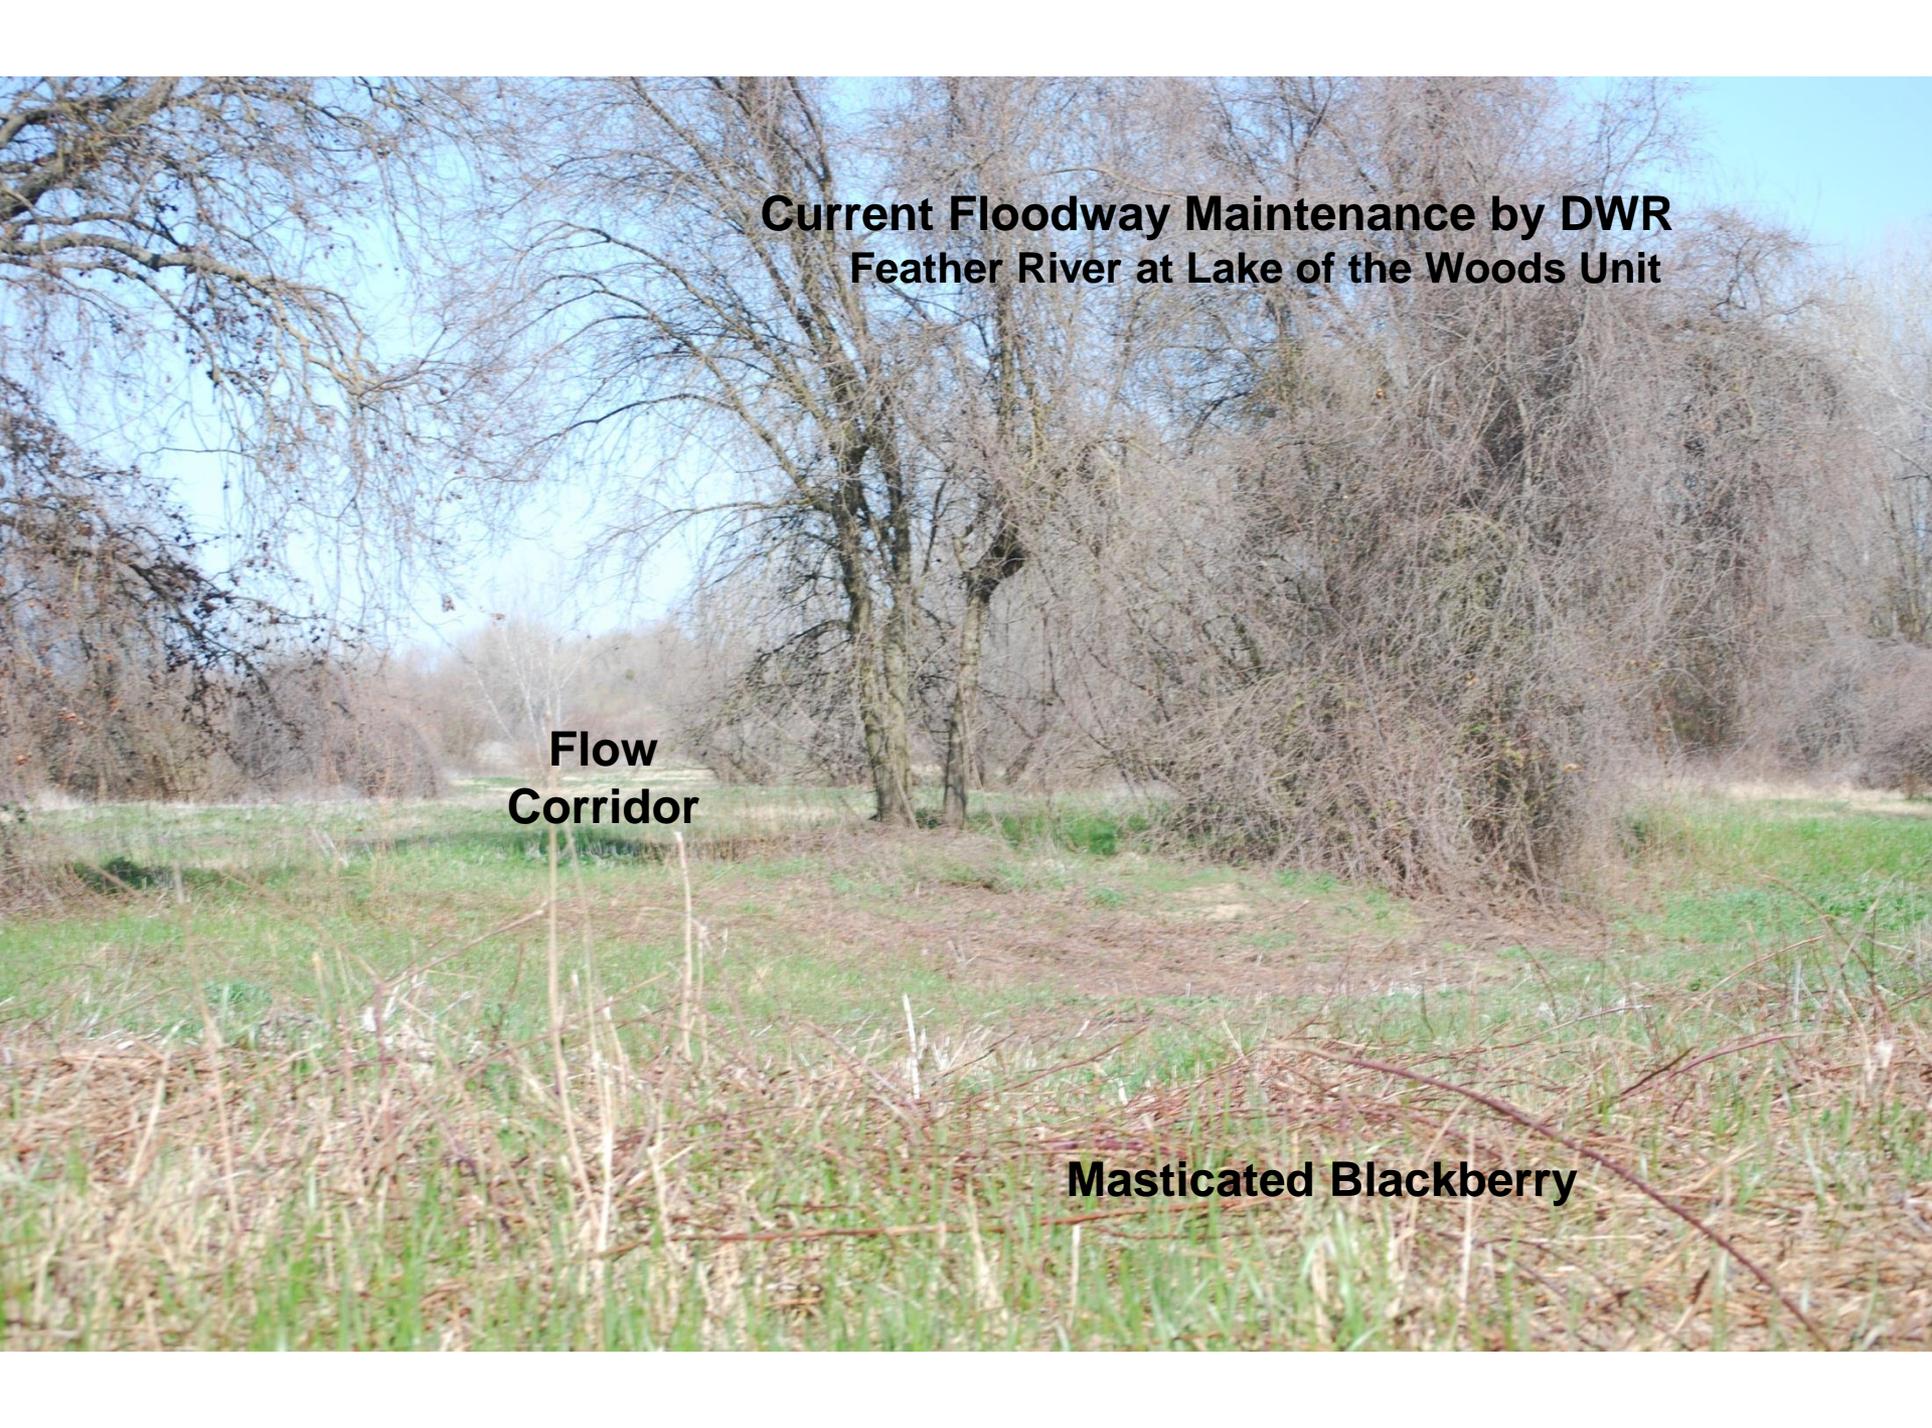
A photograph showing a riverbank with a flow corridor and masticated blackberry branches. The foreground is filled with a dense thicket of brown, masticated blackberry branches. In the middle ground, a narrow flow corridor is visible, bordered by green grass and a line of bare trees. The background shows a dense forest of bare trees under a clear blue sky.

**Current Floodway Maintenance by DWR  
Feather River at Lake of the Woods Unit**

**Flow  
Corridor**

**Masticated Blackberry**
