Bank Swallow Response to Rock Revetment Removal on the Sacramento River, California

California Department of Water Resources
Floodway Ecosystem Sustainability Branch

Bank Swallow — Response to Revetment Removal

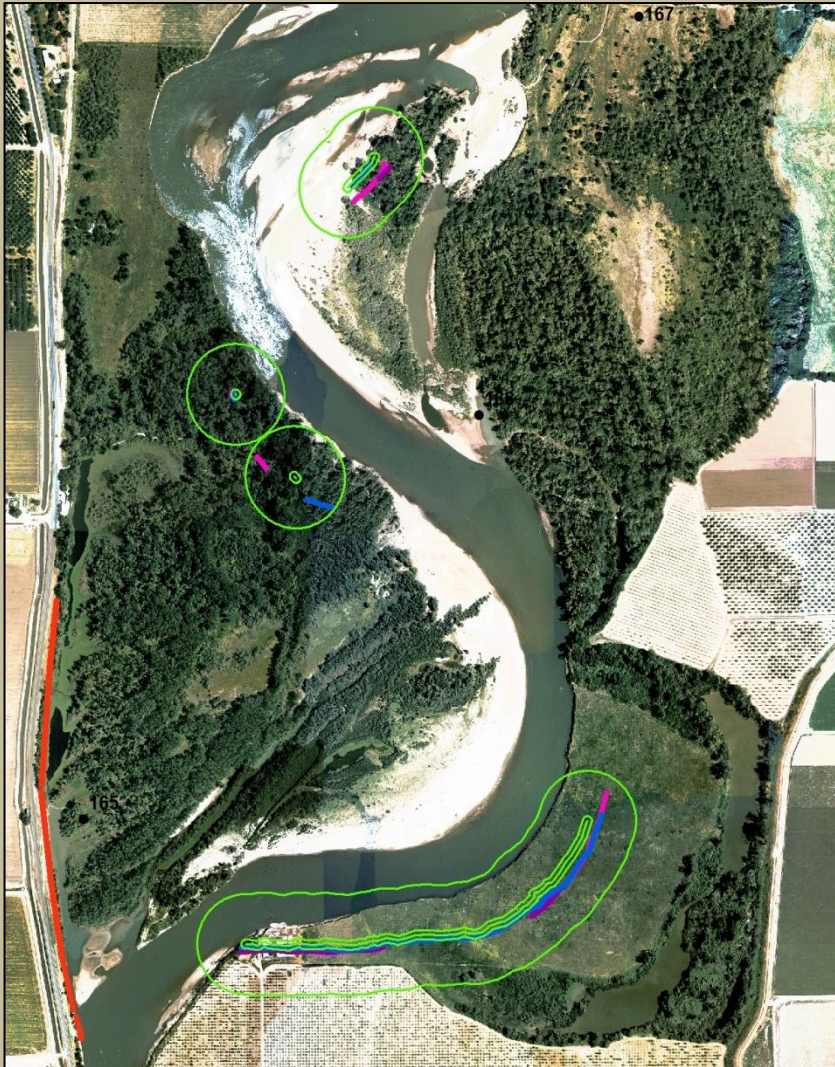
RM 166 - 1999

Bank Swallow – Linked to River Process

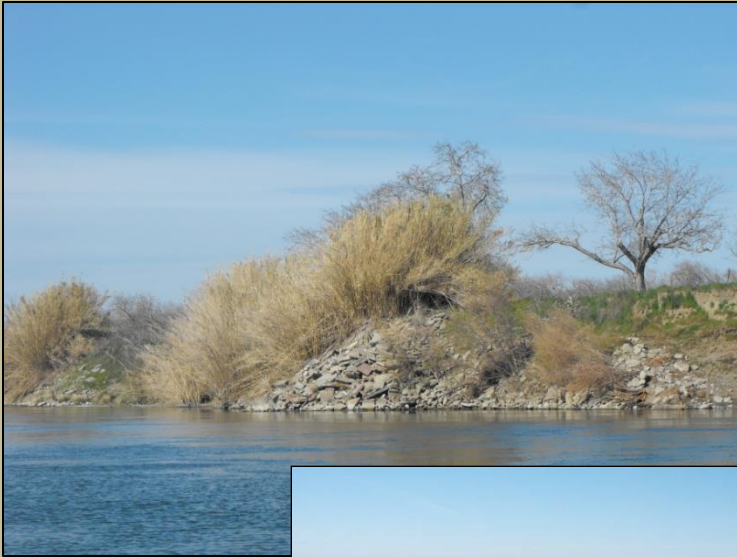
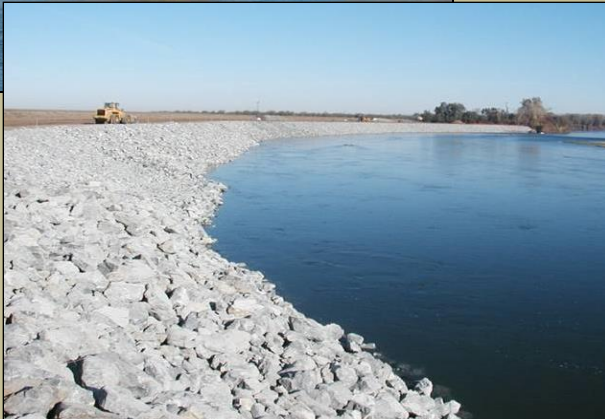
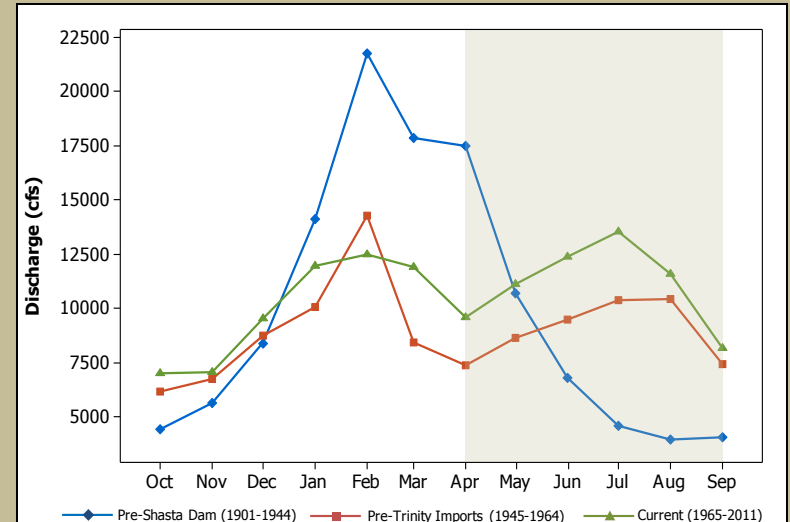
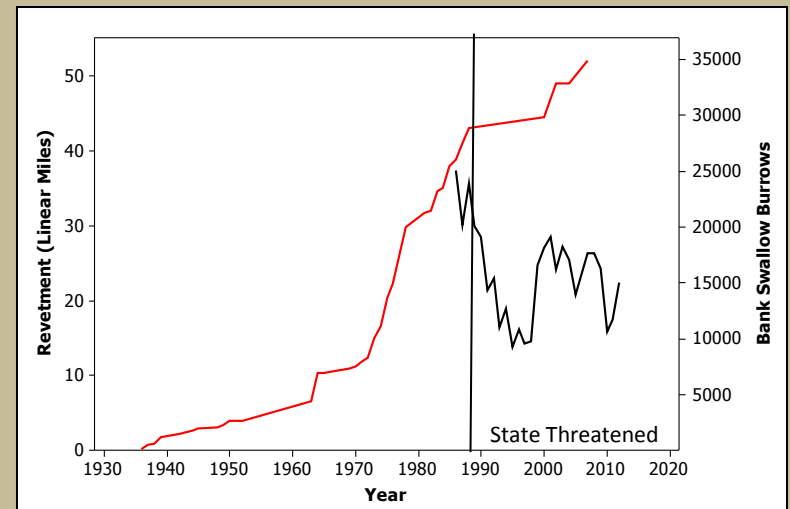
- Changes in flow regimes
- River bank stabilization
- Loss of foraging habitat

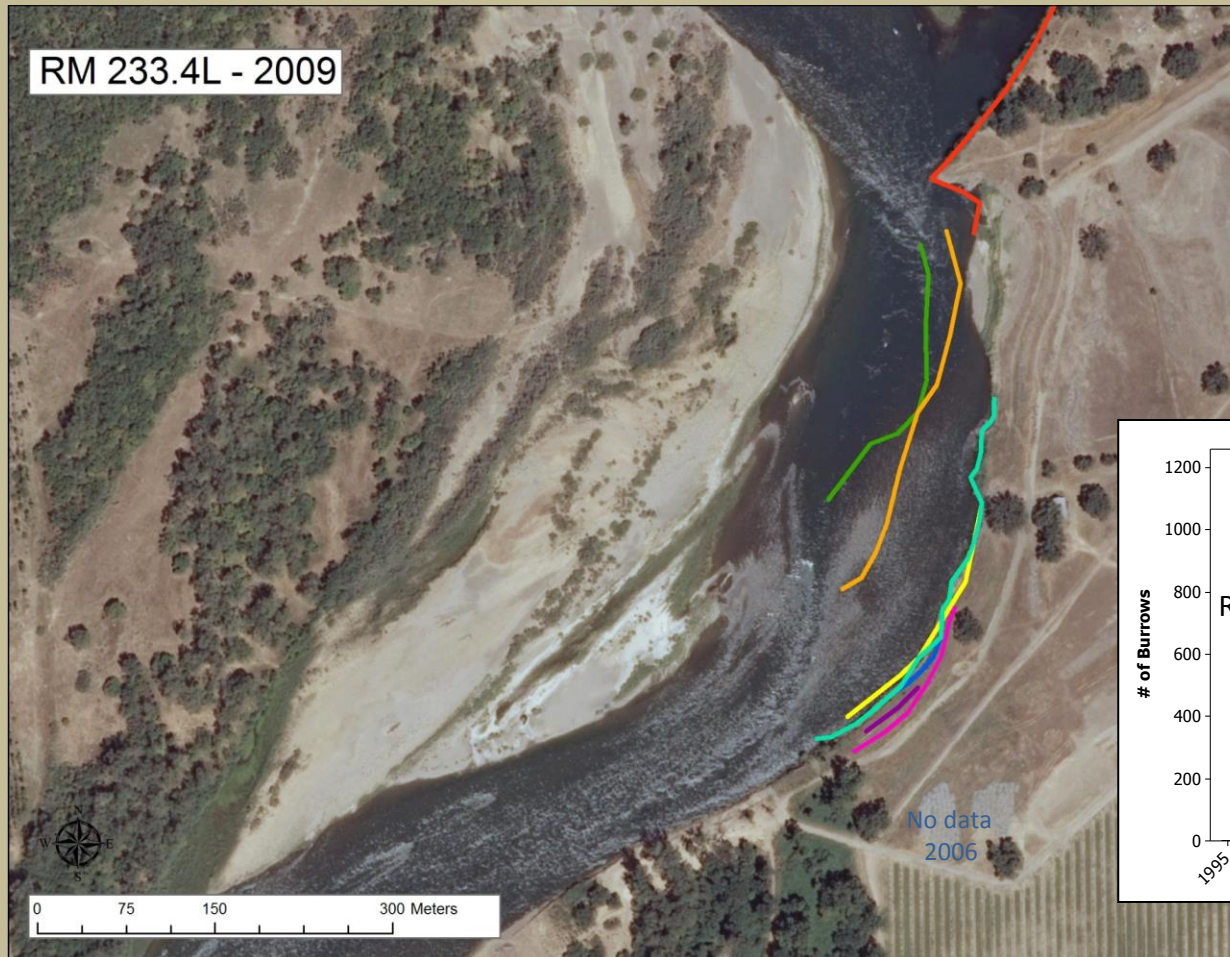
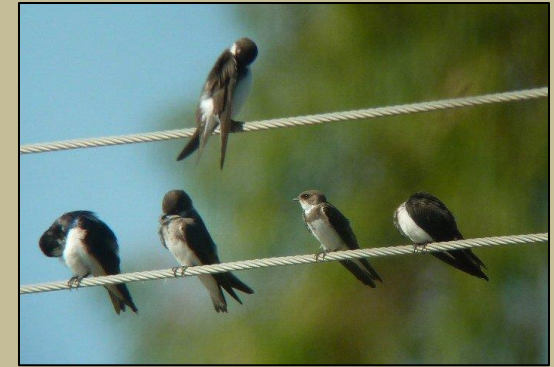
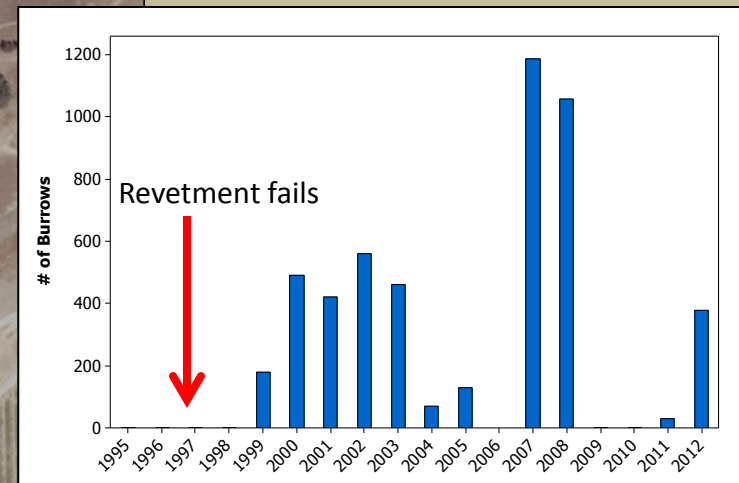
BANS return within 2 years to the site; in 2007-2008, > 1000 burrows at site

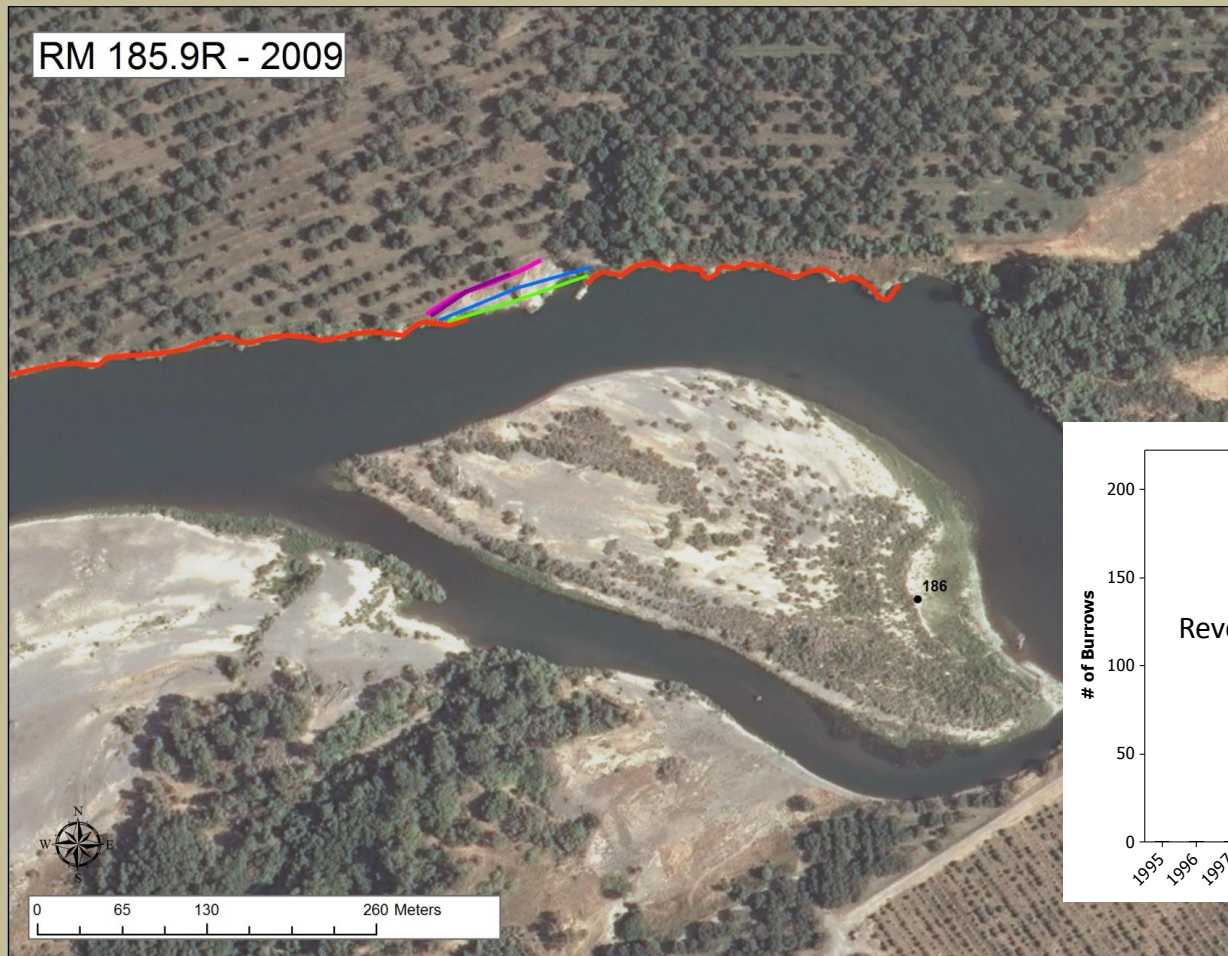
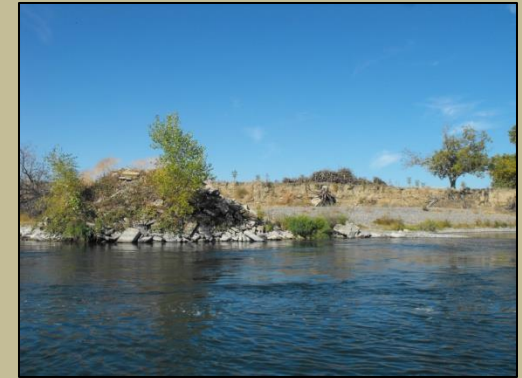
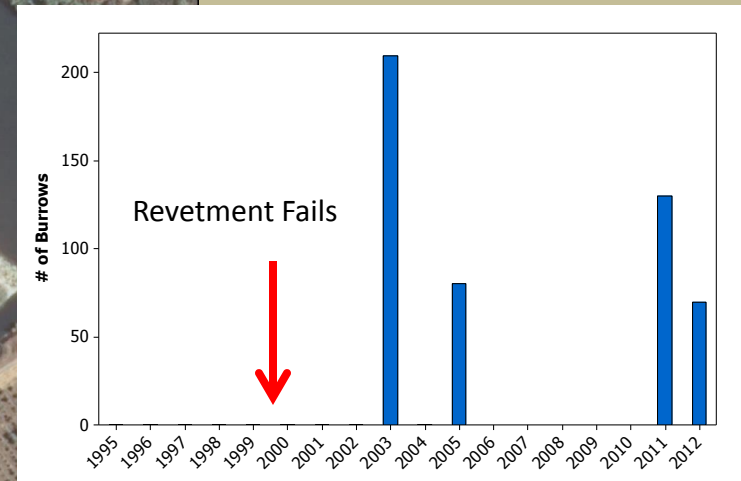
BANS return within 3 years to the site; in 2003, > 200 burrows at site

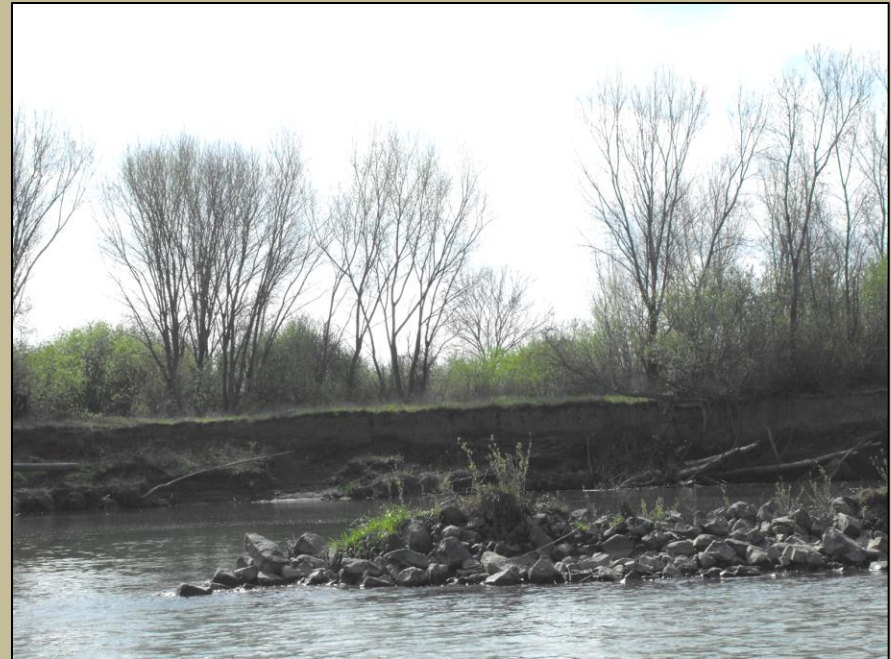
- 11 sites located where revetment removed, failed, or no longer serving design purpose.
- Approximately 3339 meters (11,018 ft) in total.
- Average length 371 meters (240 m median length), or 800-1200 feet.
- Most sites were probably the result of 1997 high water event
- All but 1 site on alluvium; historic meander deposits.

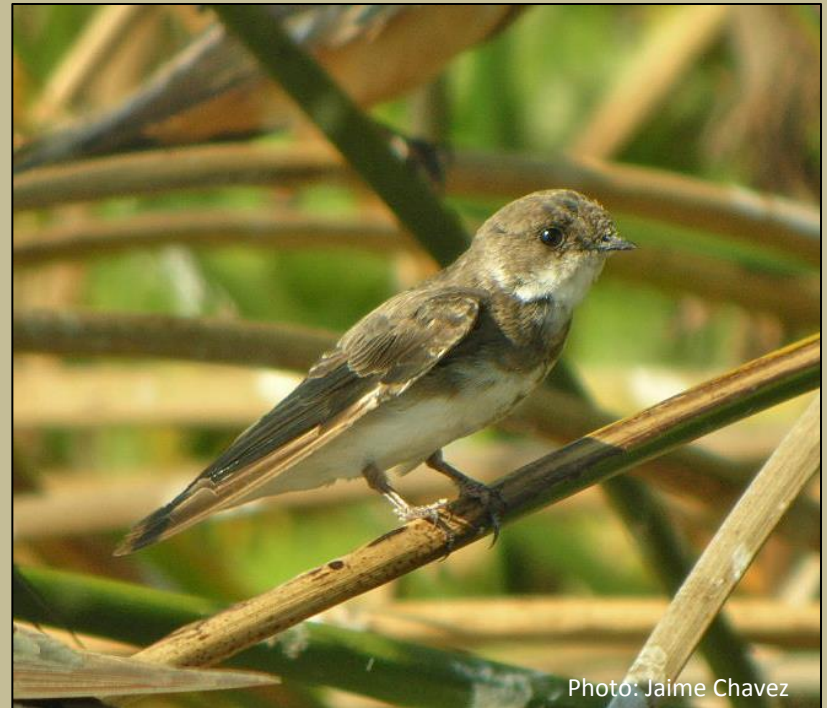
- 10 of 11 sites were re-colonized by BANS
- On average, sites were re-colonized in 2.5 years; (min = same year; max = 6 years)
- Soil types at sites were mapped as Columbia, Gianella, moonbend, silty or sandy loam
- Site that was not colonized did not form cut bank
