TWO-DIMENSIONAL HYDRAULIC MODELING OF RIPARIAN HABITAT
RESTORATION FROM COLUSA TO PRINCETON

SACRAMENTO RIVER, RM 142.5 TO RM 164.5
GLENN AND COLUSA COUNTIES, CA

March 28, 2008

Ayres Associates Project No. 33.0551.00

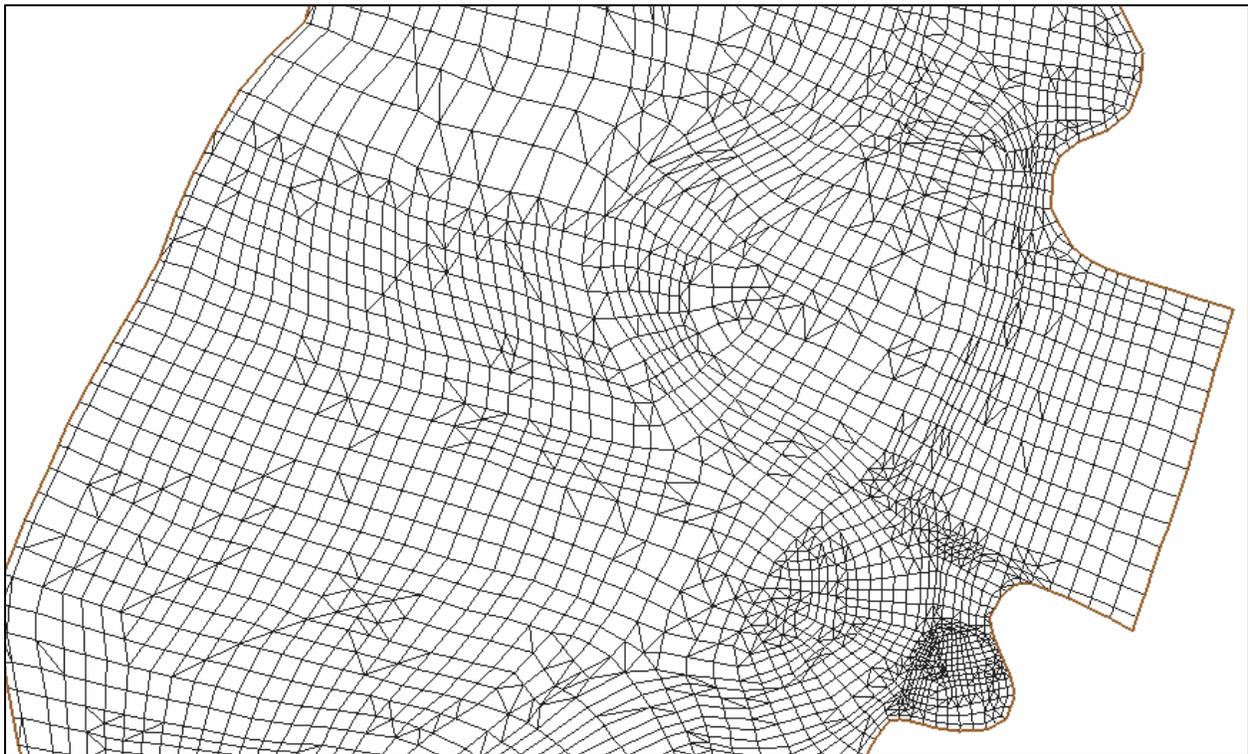
Figure 6. Finite Element Mesh

The geometric definition of the project reach is given in the form of a finite element network of triangular and quadrilateral elements, known as a mesh, a section of the mesh is shown in **Figure 6**. The elements were sized and oriented to represent hydraulic features, breaklines, structures, and topographic changes. Each element contains corner and mid-side nodes, which represent points in space (X, Y, Z) and define the topography of the project reach.

The topography used to develop the mesh came from a combination of two mapping projects. The initial mesh was developed using the 1997 bathymetric survey completed by Ayres Associates for the USACE. The mesh and channel alignment were updated with the 2006 LIDAR topography provided by TNC. The model mesh coordinates are in NGVD-29, NAD-83, US feet.

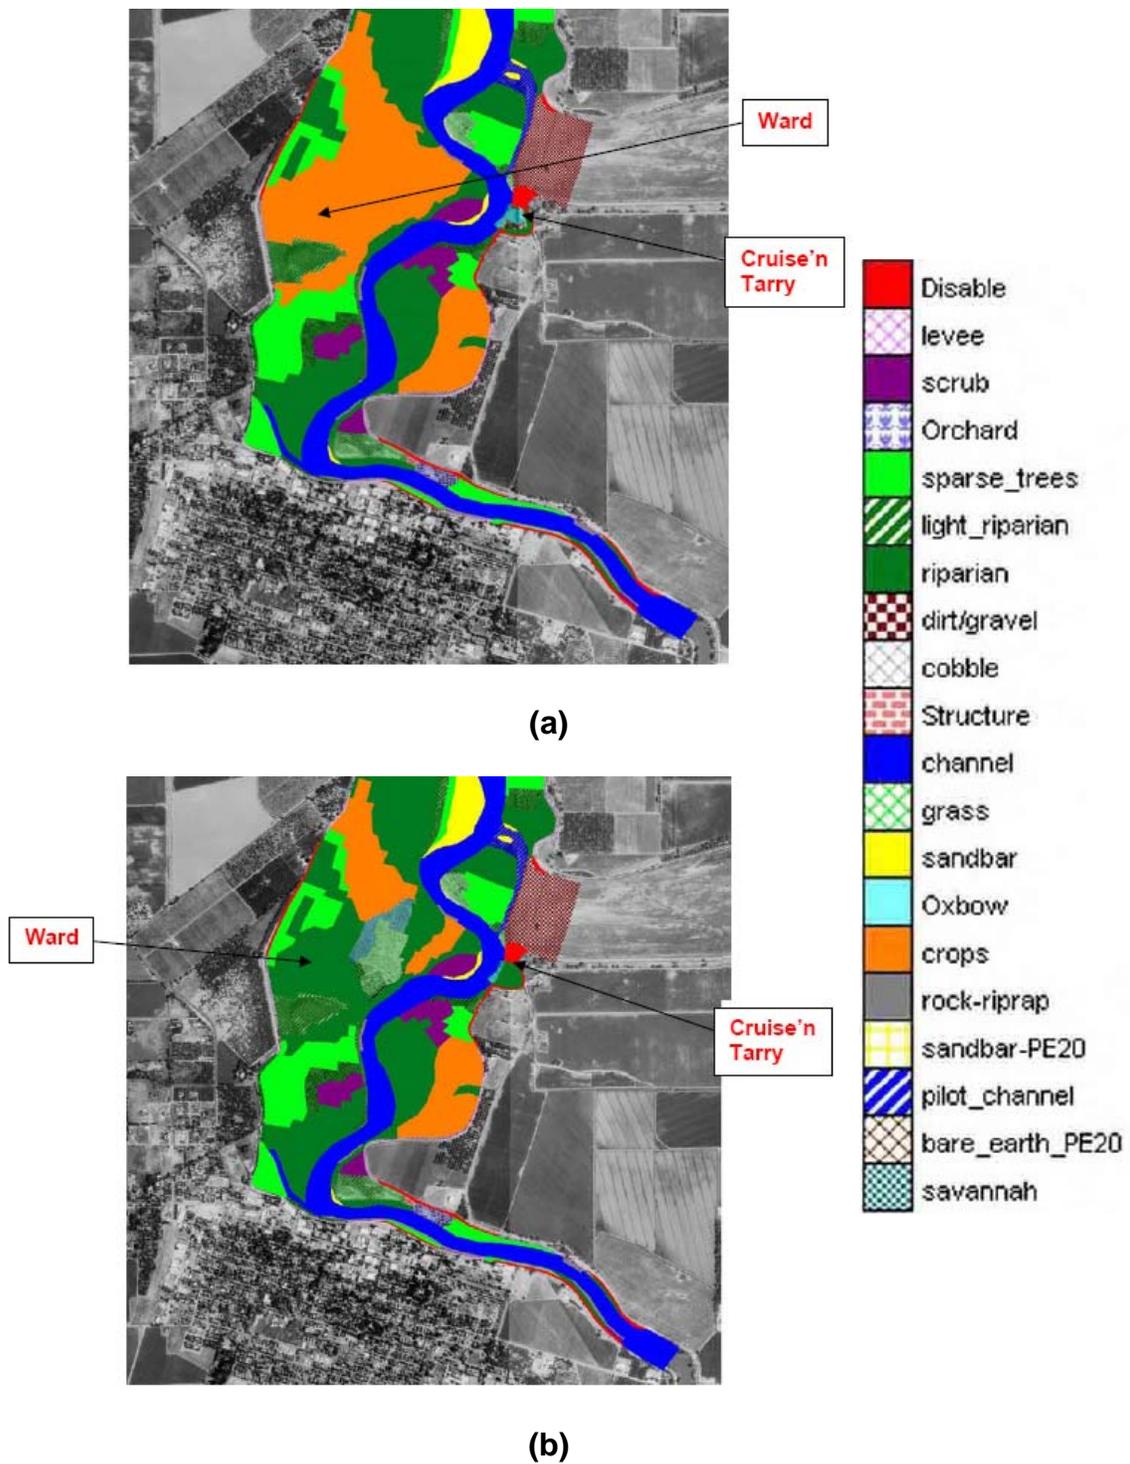
Figure 1: (a) Existing Conditions (Without Project) and (b) Restored Conditions (With Project) Land Use in the vicinity of Ward Tract, as represented in the model. (adapted from Ayres Associates)

- The model is calibrated to the January 10, 1995 high flow (143,000 cfs), for which high water marks are available.
- In the existing conditions (without project) run, the Ward Tract restoration area was represented as being in crops ($n = 0.035$). (See **Figure 1 a**).

- In the restored conditions (with project) run, the Ward Tract restoration area was represented as being in a mix of vegetation types: grassland ($n = 0.032$), savannah ($n = 0.045$), and riparian forest ($n = 0.090$). (See **Figure 1 b and Figure 2**).

- It is conservative to reflect the existing conditions, crops ($n = 0.035$), rather than the conditions of Ward Tract when it was purchased for restoration, orchard ($n = 0.075$), in the existing conditions (without project) model run. (See **Figure 1**). Setting material roughness to the lower value in the existing conditions run will predict greater change when comparing restored condition results with existing condition results.
- The distribution of vegetation types in the restored condition (with project) run creates an overbank flow corridor where the low hydraulic roughness of the grassland ($n = 0.032$) and savannah ($n = 0.045$) are placed. (See **Figure 2**). This will encourage some of the water that would otherwise have flown around Cobb's Bend to short-cut across Ward Tract. This will tend to keep stage low.

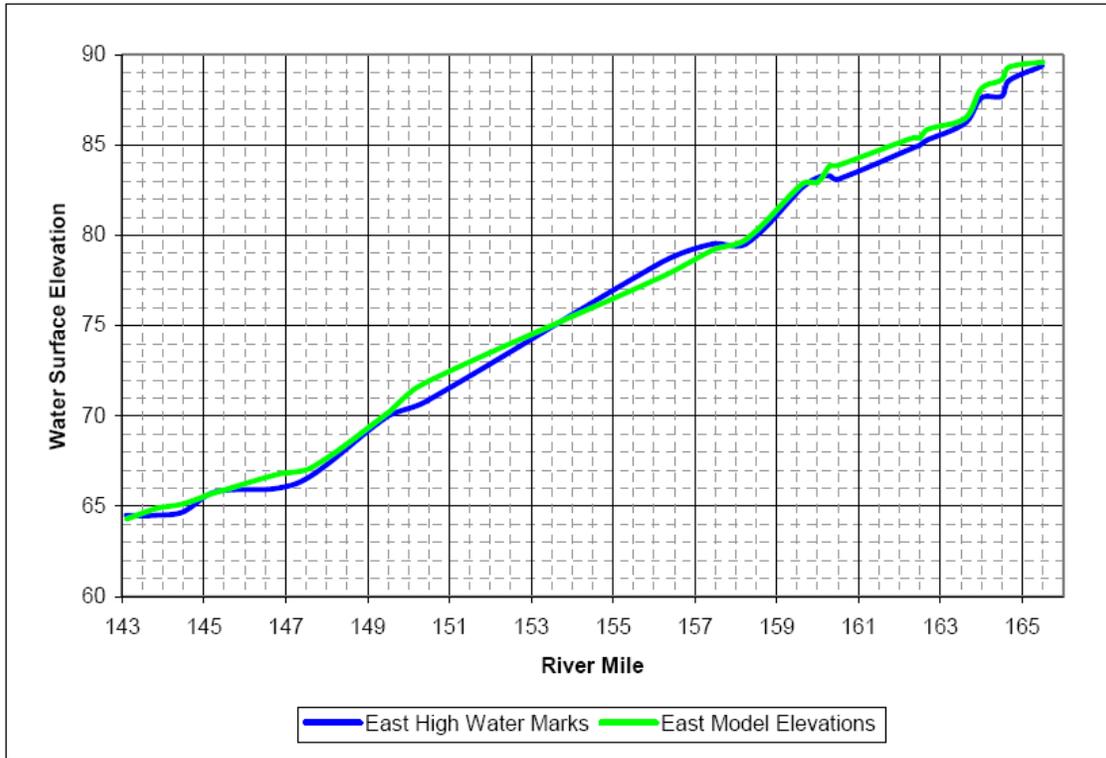
Figure 3: Comparison of Modeled Water Surface Profile with High Water Marks on the East Bank. (Ayres Associates) Note that model calibration trends at or slightly above the measured high water marks at most locations, including the vicinity of Ward Tract (RM 145 to RM 146)

- The model calibration trends at or slightly above the measured high water marks, at most locations, especially along the downstream half of the model, where the Ward Tract is located. (See **Figure 3**) Ward Tract is located between River Miles 145 and 146. The calibration of the model trending at or slightly above the measured high water marks is both conservative, and an indication that raising hydraulic roughness values would reduce the closeness of fit of the model calibration.

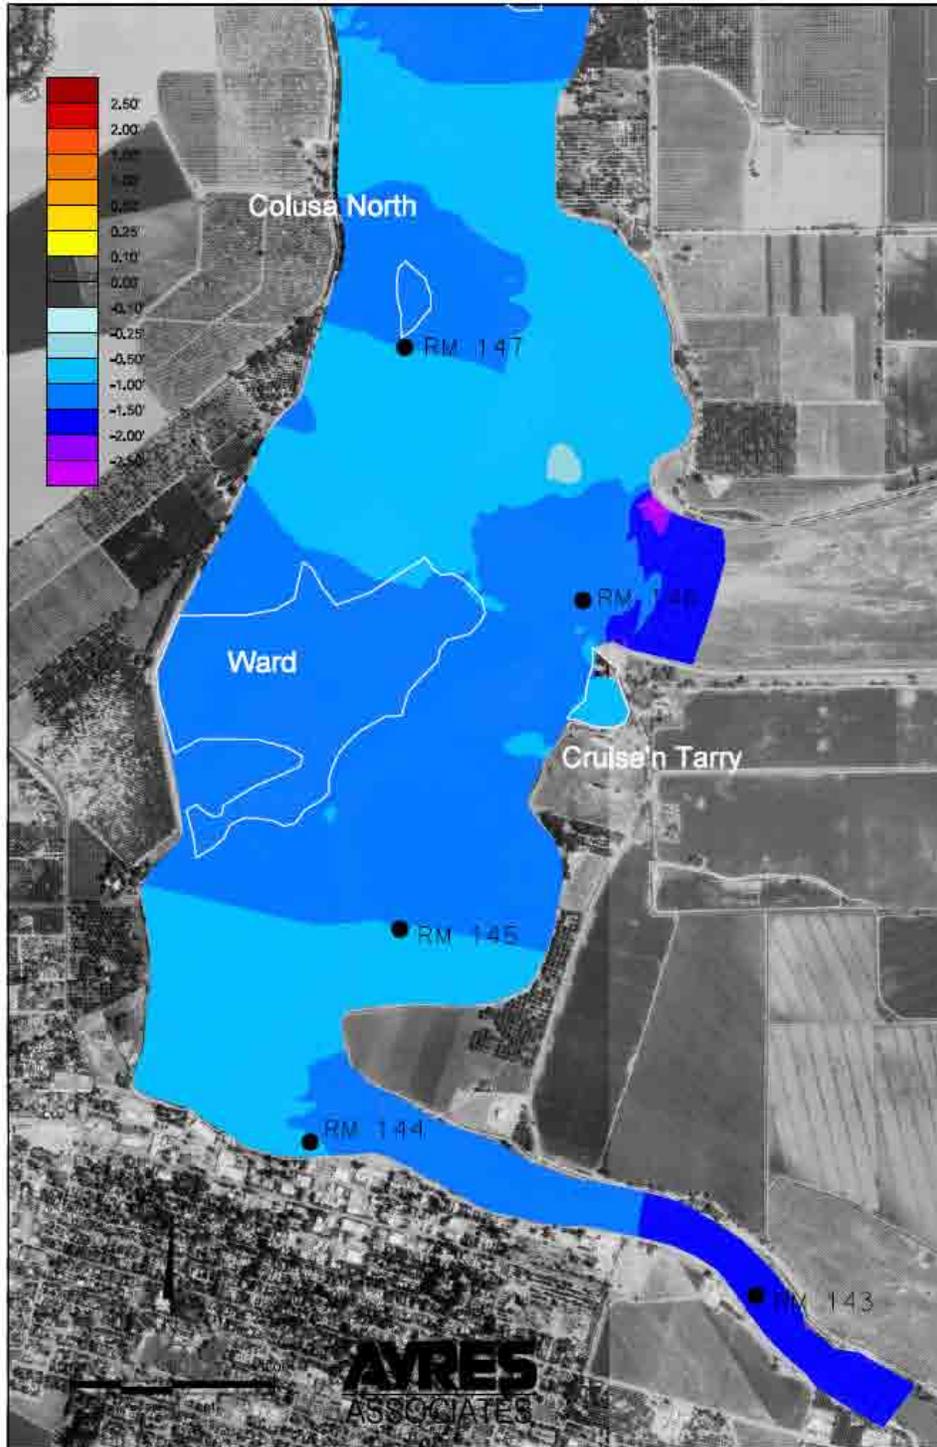
Figure 7: Difference between Design Profile and Existing Conditions (Without Project) modeled water surface elevations (Ayres Associates)

- Model results indicate that for eight river miles upstream of the Ward Tract property, and three river miles downstream of it, under existing vegetation conditions, when 160,000 cfs enters the Colusa Subreach, the water surface ranges from 0.25 to 3 feet below the design profile. (See **Figure 7** to view River Miles 144 through 147, and Ayres' report for graphics of more distant sites). In the immediate vicinity of Ward Tract, the water surface ranges from -0.5 to -1.5 feet below the design profile. Note that the design profile itself is at least 3 ft below the levee crest.

- With the project's proposed restored vegetation conditions, the water surface remains 0.25 to 3 feet below the design profile (See **Figure 8**). There are some slight localized water surface differences (both positive and negative) compared to modeled existing conditions (Compare **Figure 7** and **Figure 8**)

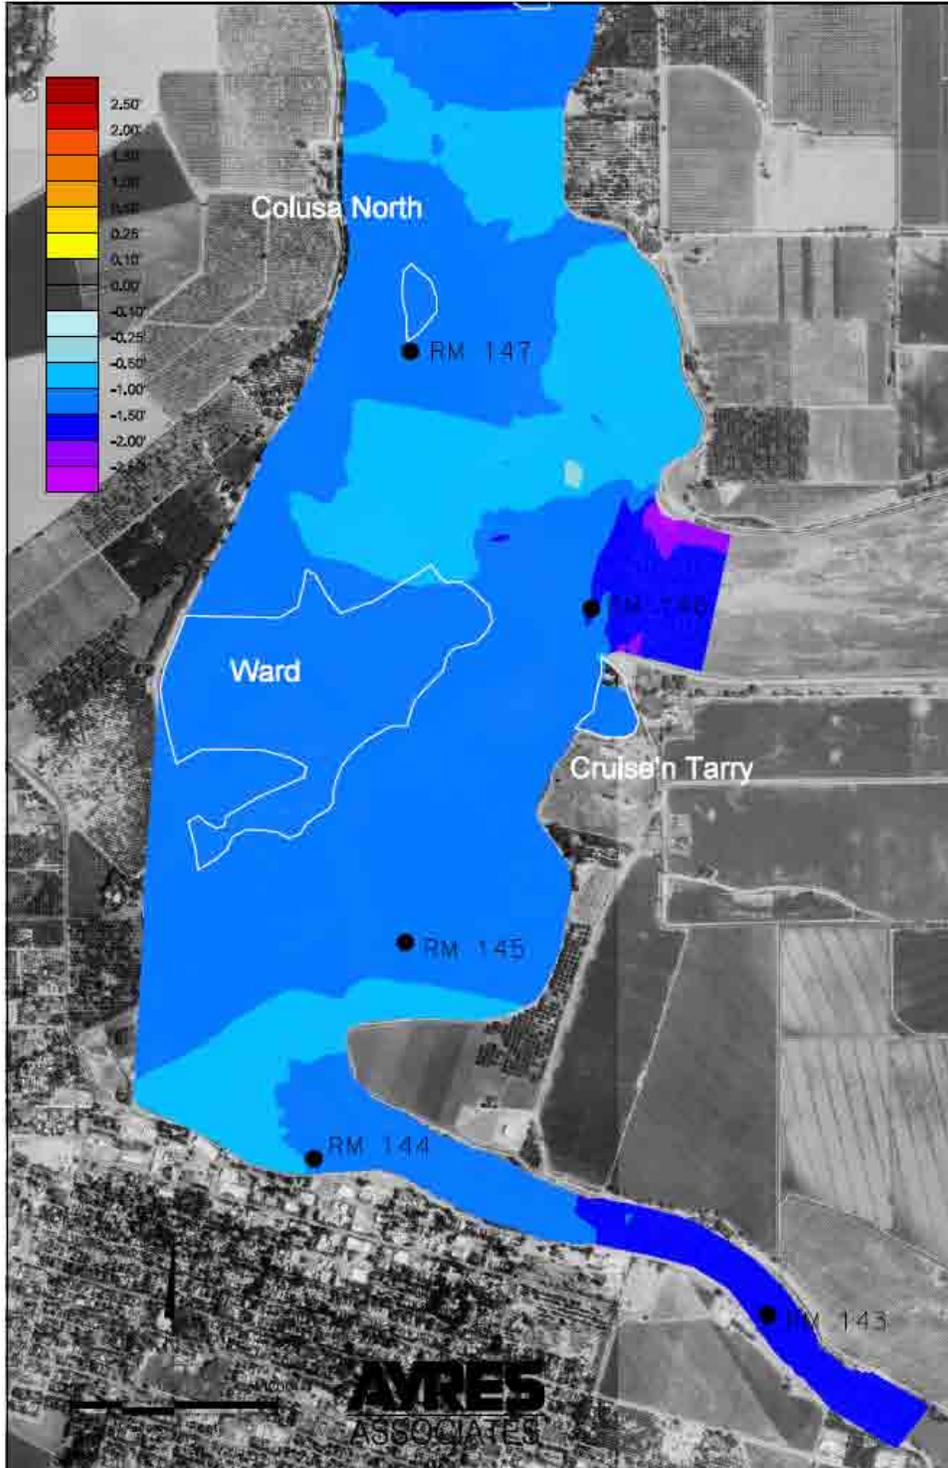
Figure 8: Difference between Design Profile and Restored (With Project) modeled water surface elevations (Ayres Associates)

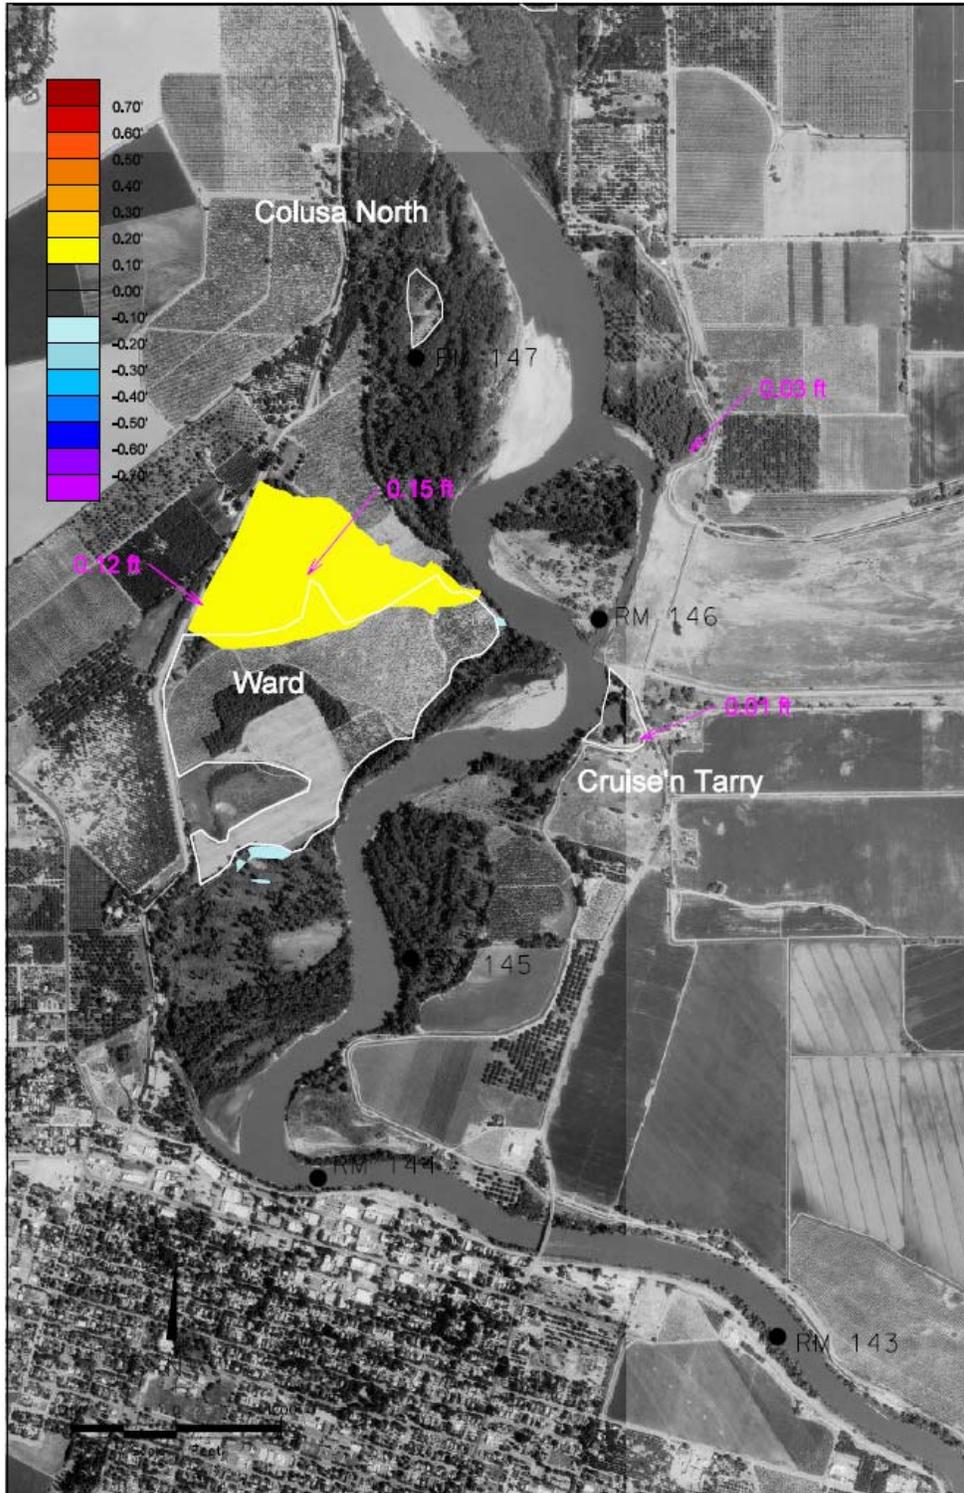
Figure 9: Net change in Water Surface Elevation; Difference between modeled Existing Conditions (Without Project) and Restored (With Project) water surface elevations (Ayres Associates)

- **Figure 9** isolates the difference between existing conditions and restored vegetation conditions. The yellow triangle indicates the area upstream of Ward Tract where there would be an approximately 0.1 ft rise in water surface elevation. The maximum rise in water surface elevation along the west levee is 0.12 ft. The maximum rise in water surface elevation within the yellow triangle shown is 0.15 ft. The maximum rise in water surface elevation along the eastern levee, north and south of the Colusa Bypass is 0.03 and 0.01 ft respectively.

- The cross section shown in **Figure 10** compares the differences among the design profile, existing conditions (without project) water surface elevations, and restored condition (with project) water surface elevations. This cross-sectional location along the upstream portion of Ward Tract was selected for illustration because it cuts through the area that is modeled to undergo 0.1 to 0.2 ft of water surface elevation rise, as shown by the yellow triangle in **Figure 9**.
