**HYDRAULIC ANALYSIS, CONCEPTUAL DESIGN, AND
PRELIMINARY COST ESTIMATE FOR THE KOPTA SLOUGH
FLOOD DAMAGE REDUCTION AND HABITAT RESTORATION
STUDY ON THE SACRAMENTO RIVER, RM 216 TO RM 224
TEHAMA COUNTY, CALIFORNIA**

December 28, 2009

AYRES
ASSOCIATES

DWR Contract Number 4600008120

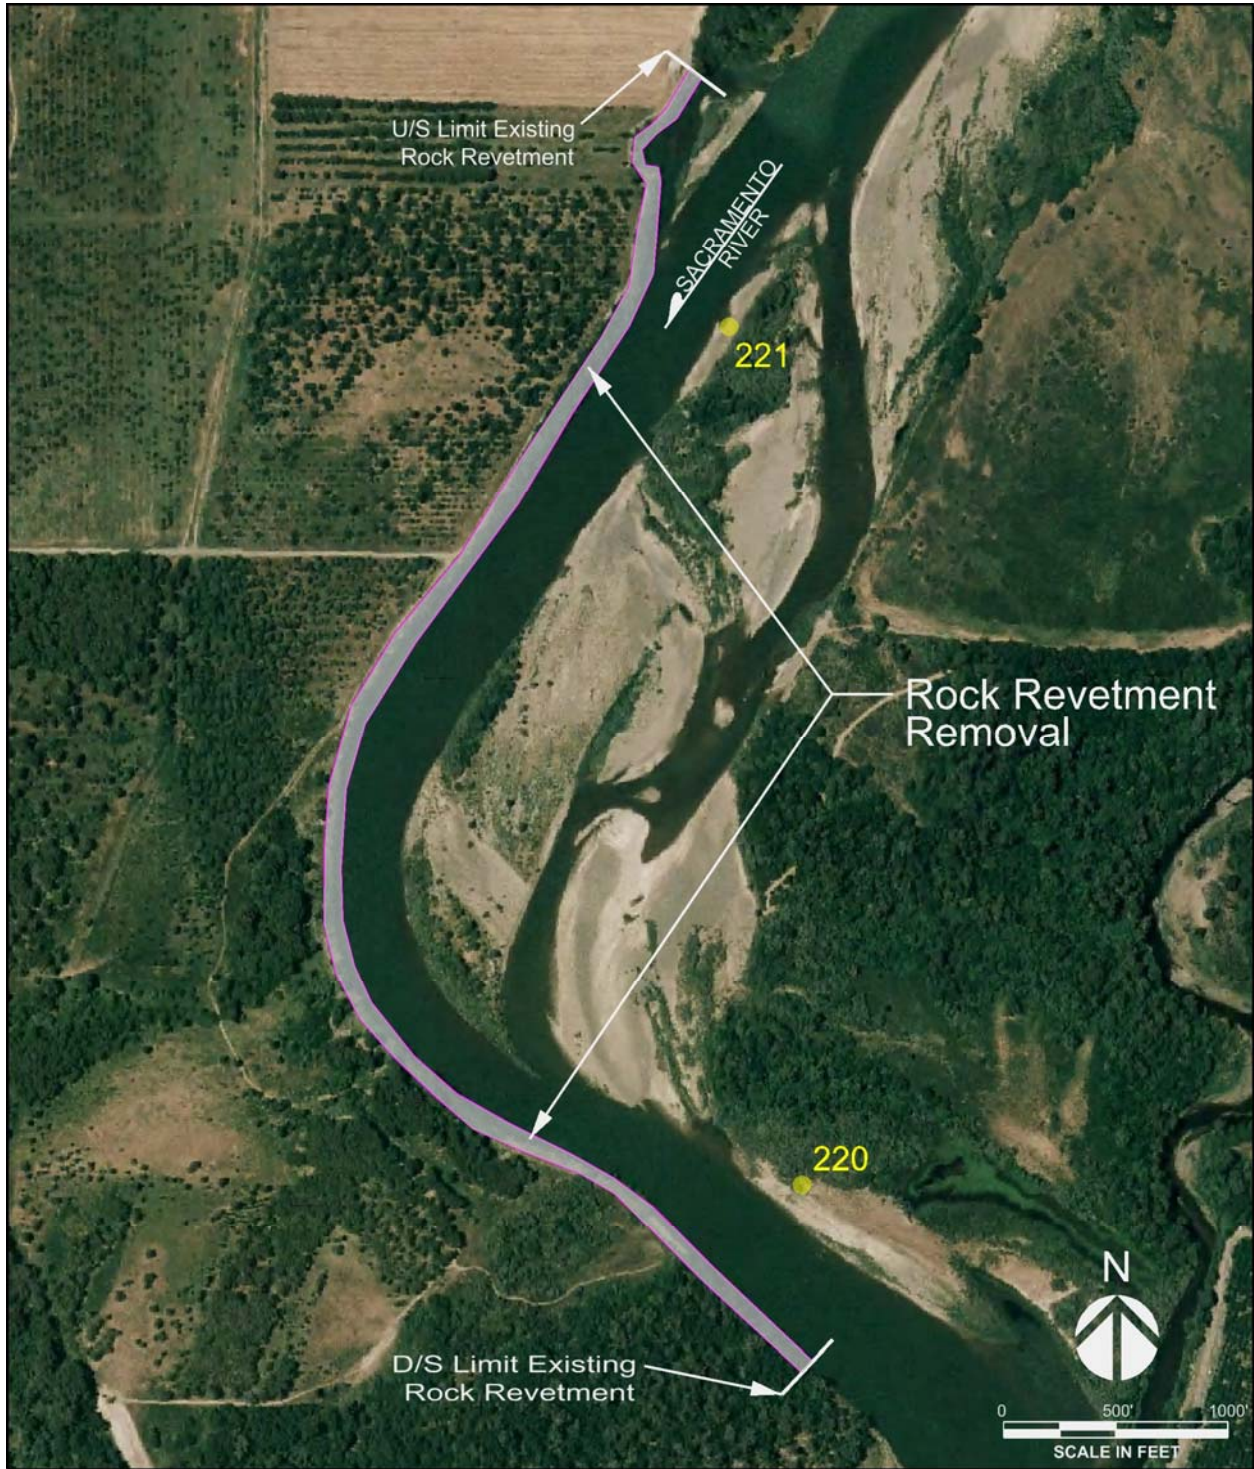
Figure 4. Full Length Rock Revetment Removal

For the rock revetment removal, the element was split into two options, removal of the full length of rock (about 7,300 ft) or removal of the downstream half of the rock (4,000 ft), as shown in **Figures 4 and 5**, respectively. Within these 2 options there were additional options; for the lateral removal of the rock, the options were to either remove as one large section or remove it in a notching pattern. The notching pattern would remove sections of rock and leave other sections, as shown in **Figures 6 and 7** for the full length (2,800 ft) and half length (1,400 ft), respectively. For the vertical bank, either rock would be removed for the entire bank height (26 ft) or only removed from the top portion of the bank (12 ft), as shown in **Figures 8 and 9**, respectively. The existing berm behind the rock would also be excavated to match the existing floodplain elevation.

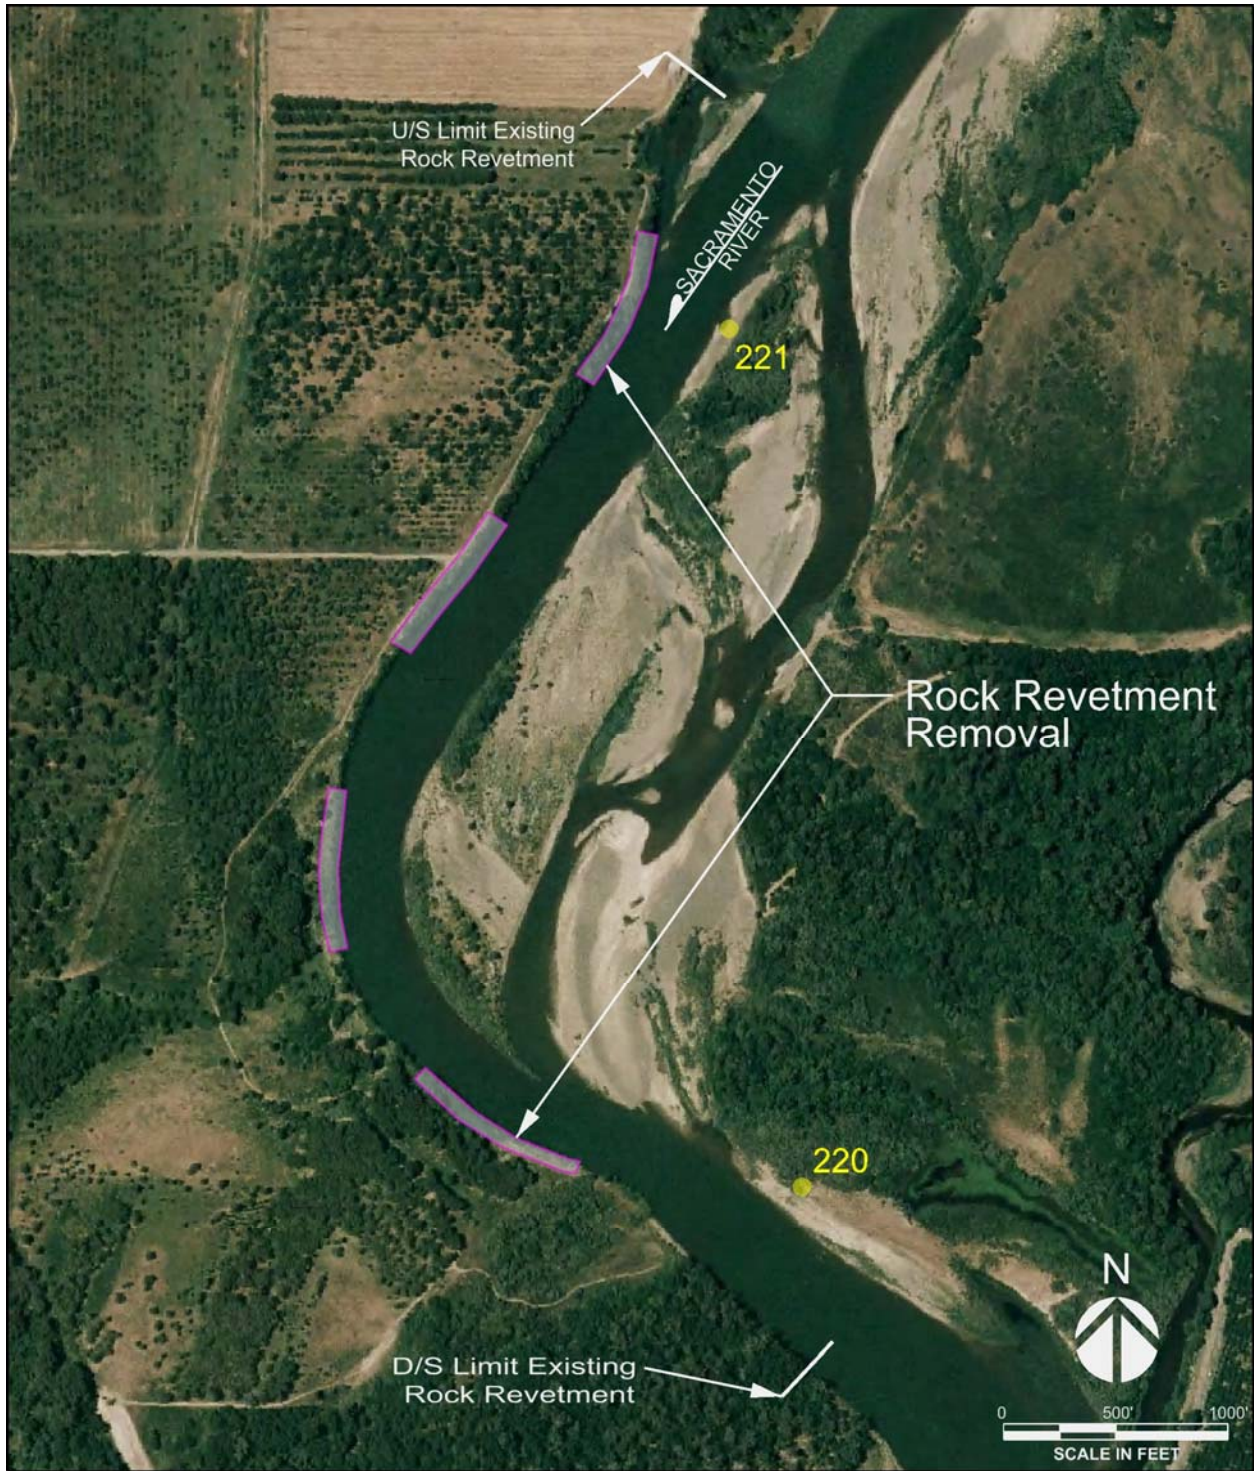
Figure 6. Full Length Notching Rock Revetment Removal

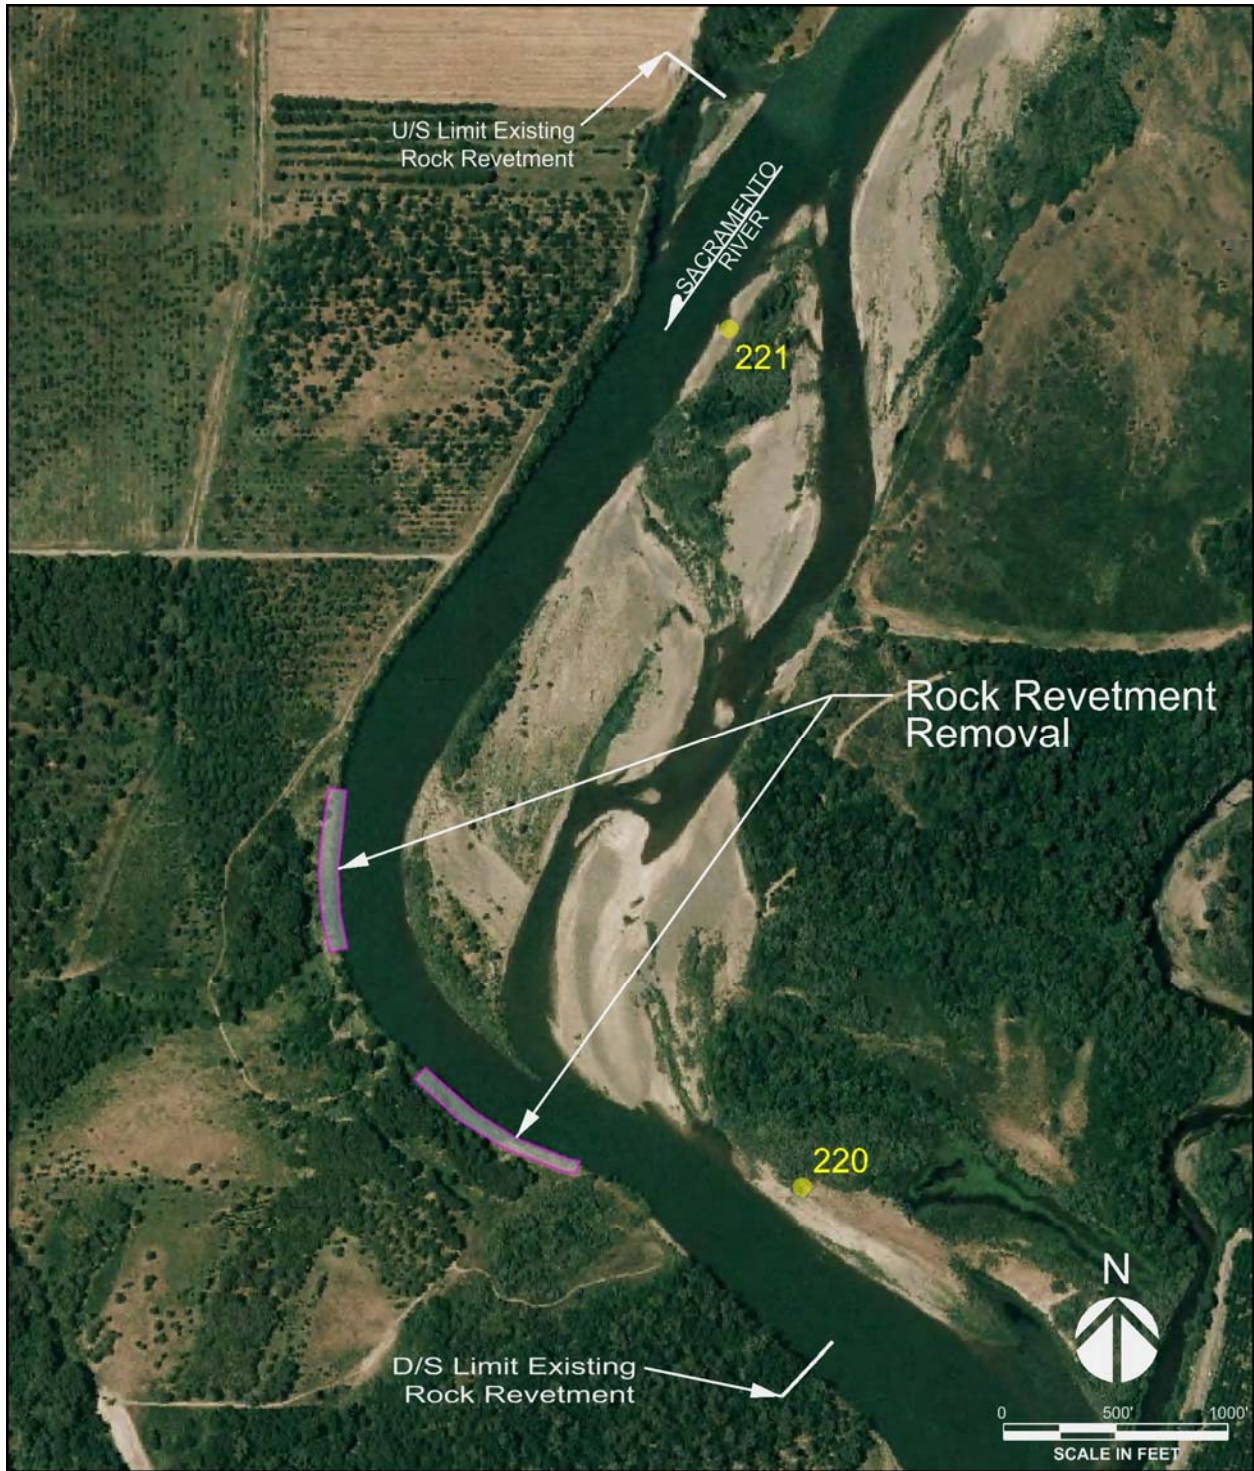
Figure 7. Half Length Notching Rock Revetment Removal

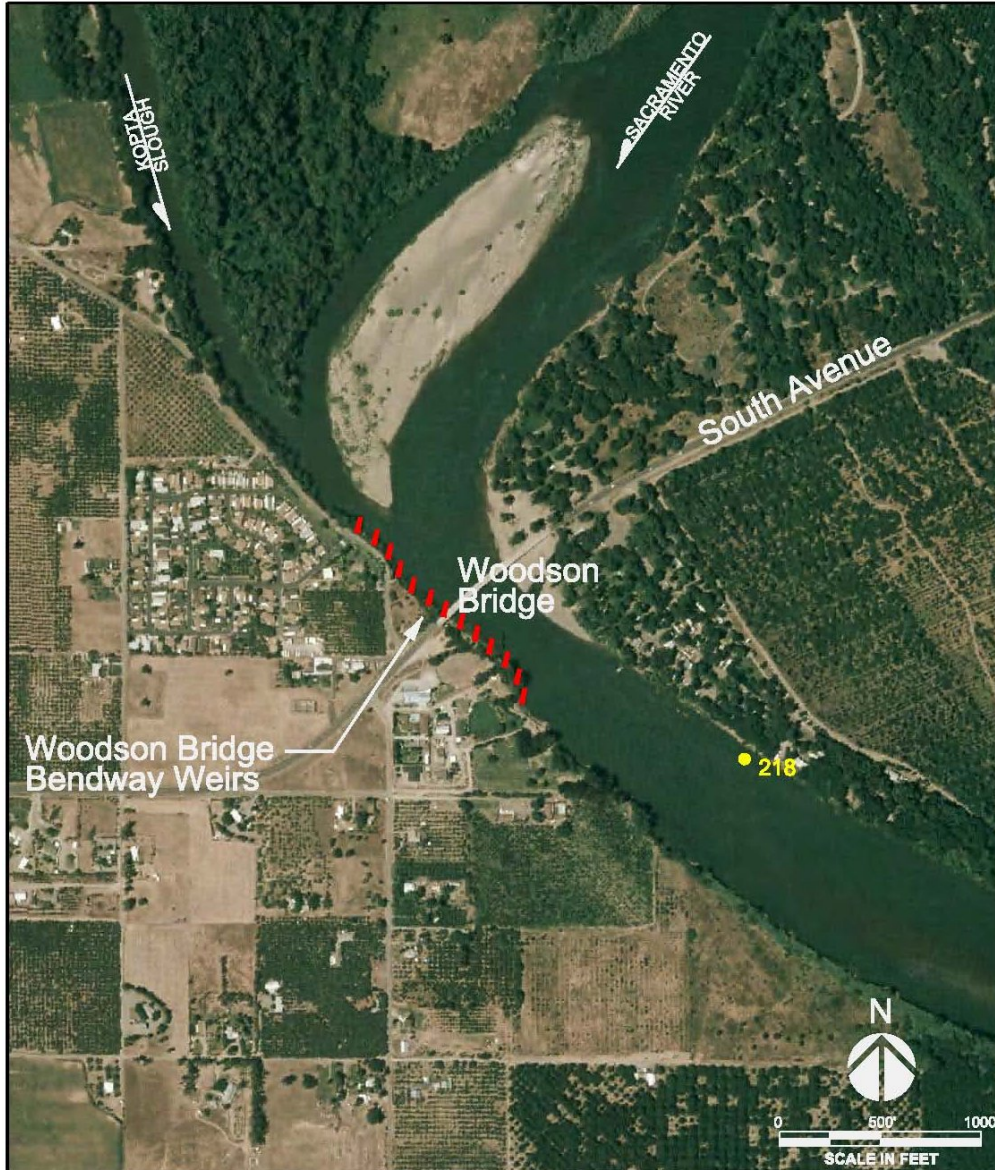
Figure 11. Plan View of Bendway Weirs at Woodson Bridge

Bendway weirs act to redirect the flow away from the bank and into the channel. The weirs would extend into the channel and be placed at an angle to ensure the redirection of flow. The design for this study includes 13 weirs, spaced 100 ft apart, protecting 1,200 ft of bank, as shown in **Figure 11**. The weirs would be approximately 6 ft high, with 1.5:1 side slopes, and a crest width of 2 ft. The top of the weir would be at about the summer low flow water level and may require the use of buoys to prevent them from becoming a navigational hazard. The configuration of these weirs is shown in **Figure 12**. Vegetation would be placed on the existing bank where the velocities are lower than 5 ft/s to protect the bank from erosion. In addition, the vegetation would have environmental benefits and be aesthetically pleasing.

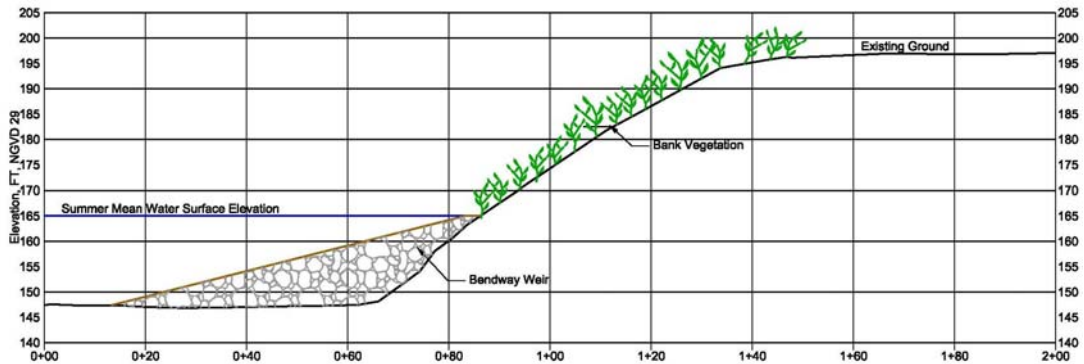
Figure 12. Cross Section showing a typical Bendway Weir at Woodson Bridge

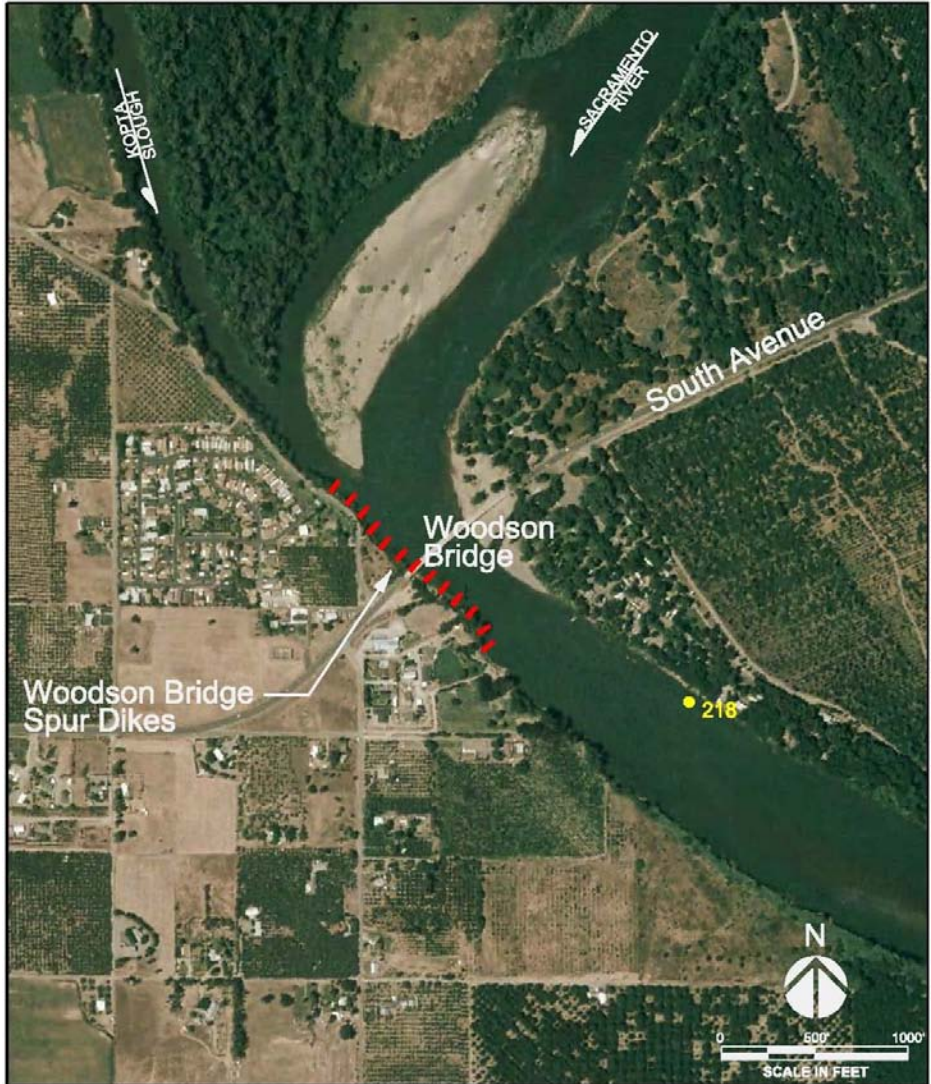
Figure 13. Plan View of Spur Dikes at Woodson Bridge

Another erosion protection option for Woodson Bridge was the use of spur dikes with bank vegetation. Spur dikes are similar to bendway weirs; however, they are designed differently and their goal is to produce deposition on the banks rather than redirect flow. For this design 13 dikes would extend perpendicular to the banks into the channel, spaced approximately 100 ft apart for 1,200 ft, as shown in **Figure 13**. The configuration of the dikes is shown in **Figure 14**.

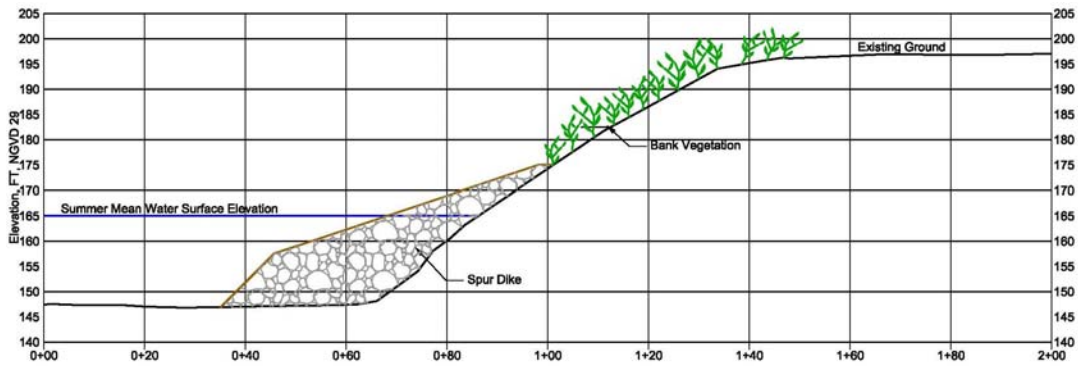
Figure 14. Cross Section of a typical Spur Dike at Woodson Bridge

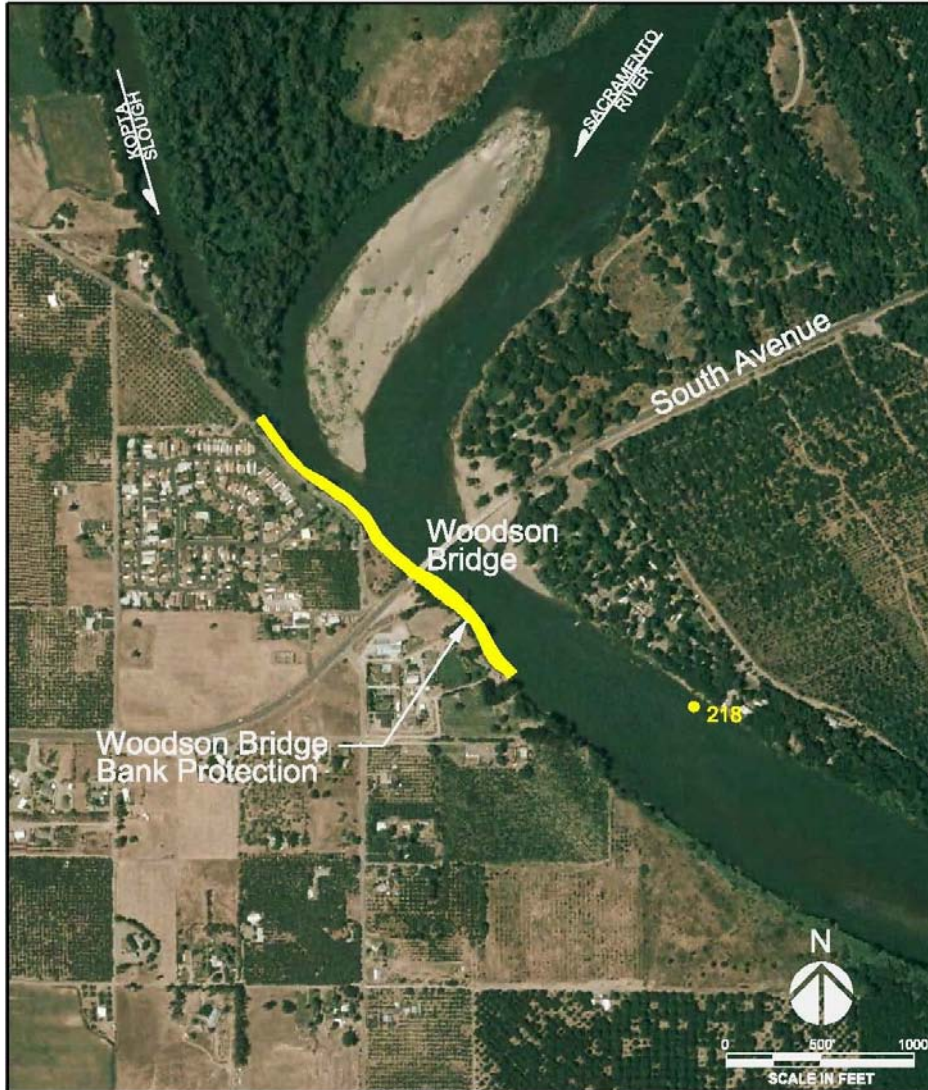
Figure 15. Plan View of Bank Armor/Low Berm Location at Woodson Bridge

Another option for protecting Woodson Bridge is building a low berm. The low berm would extend approximately 1,900 ft, in the vicinity of high velocities, as shown in **Figure 15**. The berm would extend approximately 20 ft into the main channel at the summer low flow water surface elevation with a 2:1 slope to the bottom of the channel. Some rock will need to be placed up the slope where the velocities exceed 5 ft/s. The remaining upper slope will be protected with bank vegetation. The configuration of this design is shown in **Figure 16**.

For the bank armor option, the rock would be placed in the same location as the low berm (Figure 15). The rock would extend past the mean summer water level until the velocity is below 5 ft/s, as shown in **Figure 17**. The remaining upper slope will be protected with vegetation.

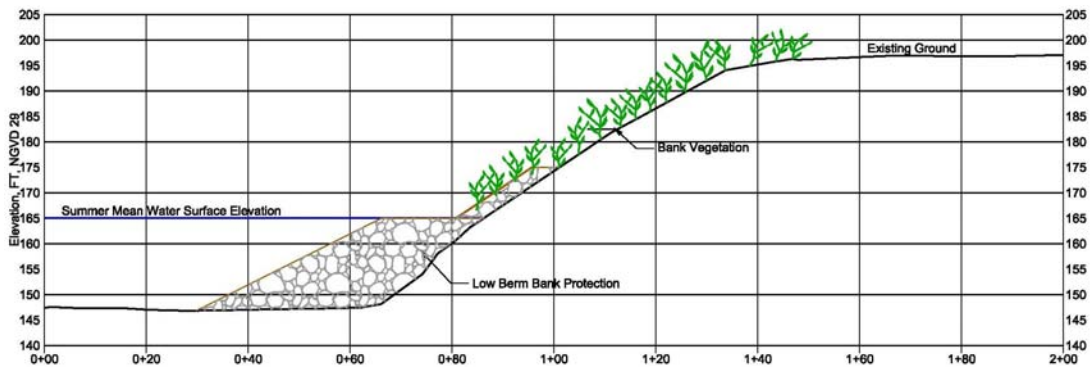
Figure 16. Cross Section for Low Berm Protection at Woodson Bridge

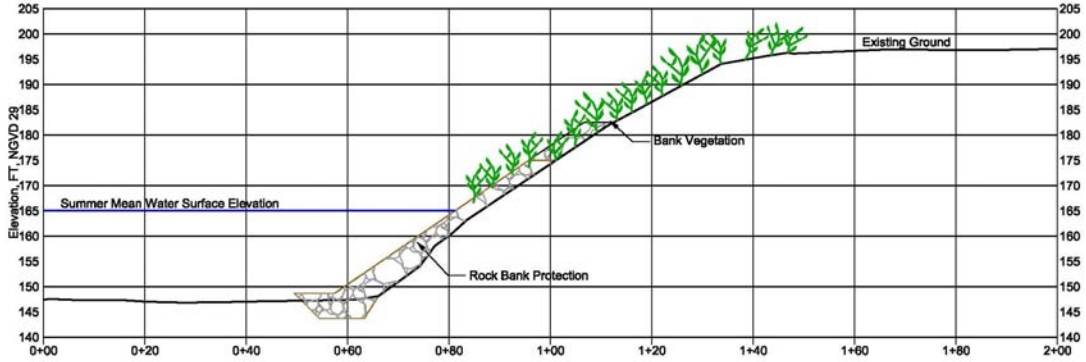
Figure 17. Cross Section for Bank Armor Protection at Woodson Bridge

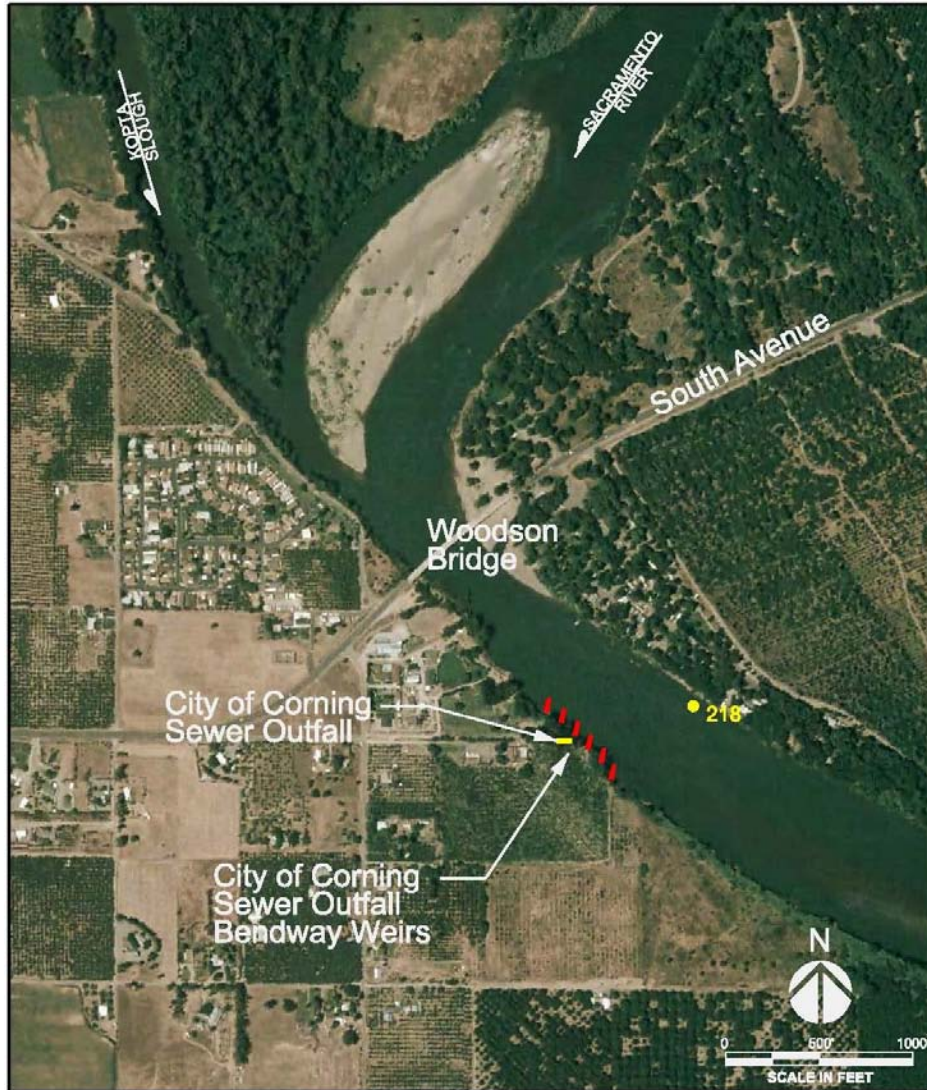
Figure 18. Plan View of Bendway Weirs at the City of Corning Sewer Outfall

The bendway weirs act to redirect the flow away from the bank and back into the middle of the channel. This would redirect the high velocities away from the erodible soils in the vicinity of the City of Corning sewer outfall. The weirs are placed at an angle to ensure the redirection of flow and extend to the middle of the channel. The design for this study includes 6 weirs, spaced 100 ft apart, protecting 500 ft of bank, as shown in **Figure 18**. The top of the weir would be at the summer low flow water level and may require the use of buoys to prevent them from becoming a navigational hazard. The configuration of these weirs is shown in **Figure 19**. Vegetation would be placed along the existing bank to provide additional erosion protection, environmental features, and for aesthetics.

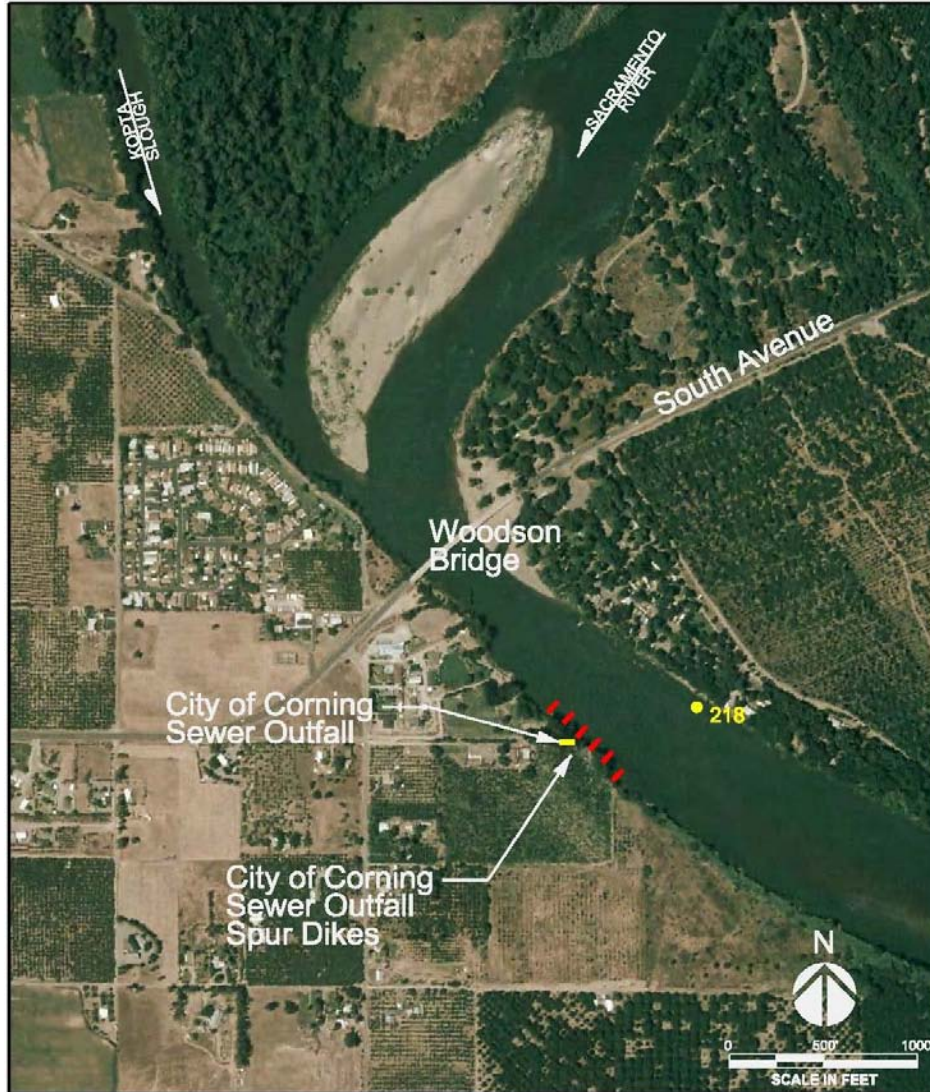
Figure 20. Plan View of the Spur Dikes at the City of Corning Sewer Outfall

The next measure for protecting the City of Corning sewer outfall was the use of spur dikes with bank vegetation. Spur dikes are similar to bendway weirs; however they are designed differently to produce deposition on the banks rather than redirect flow. For this design 6 dikes would extend perpendicular to the banks into the channel, spaced approximately 100 ft apart for 500 ft, as shown in **Figure 20**. The configuration of the dikes is shown in **Figure 21**.

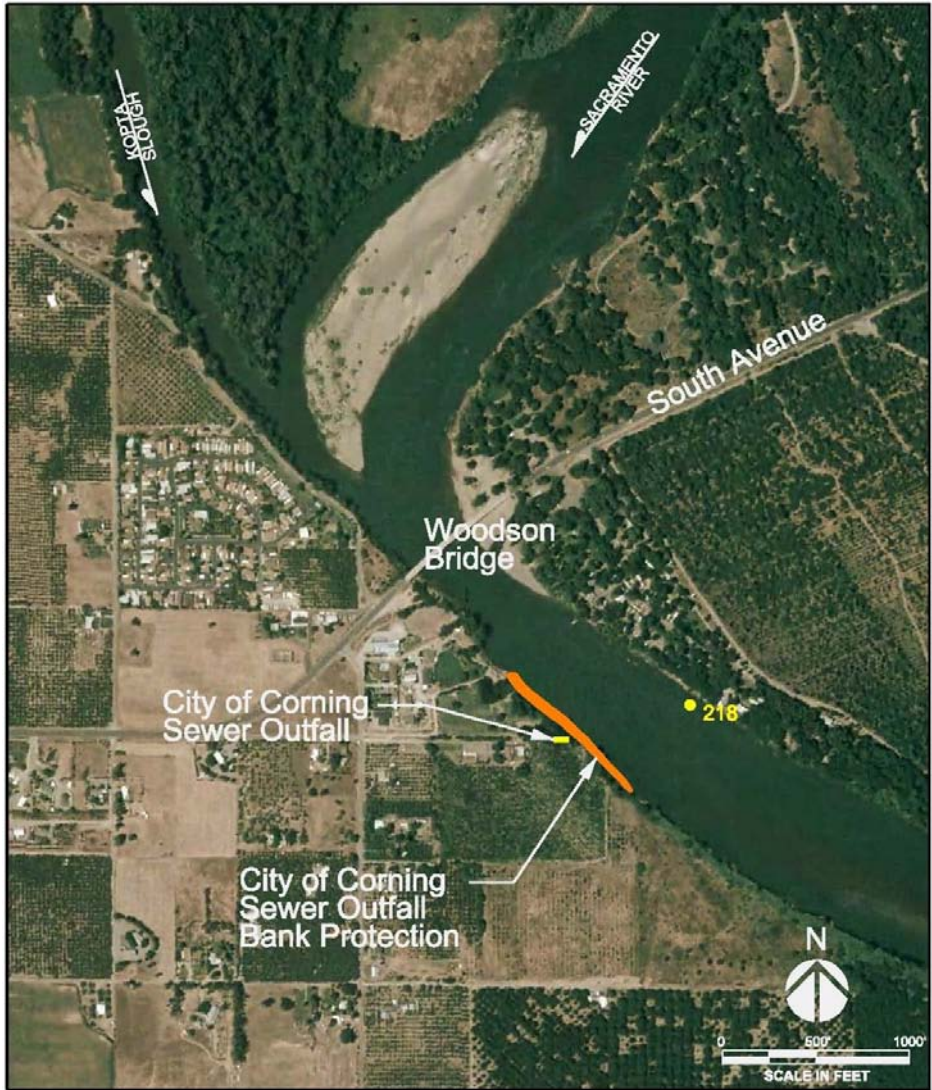
Figure 22. Plan View of Bank Armor/Low Berm at the City of Corning Sewer Outfall

Bank armor was considered for the City of Corning sewer outfall and would extend approximately 900 ft in the location shown in **Figure 22**. The bank armor would consist of toe rock and continue up the bank until the velocities dropped below 5 ft/s. Bank vegetation will be planted on the upper bank to provide additional protection and a more natural aesthetic look. The configuration of this measure is shown in **Figure 23**.

Another option for protecting the City of Corning sewer outfall is building a low berm. The low berm would cover the same area as the bank armor, as shown in Figure 22. The berm would extend out approximately 20 ft at the summer low flow water surface elevation with a 2:1 slope to the bottom of the channel. Rock will need to be placed half way up the bank slope where the velocities are greater than 5 ft/s. The upper slope will also be protected with bank vegetation. The configuration of this design is shown in **Figure 24**.

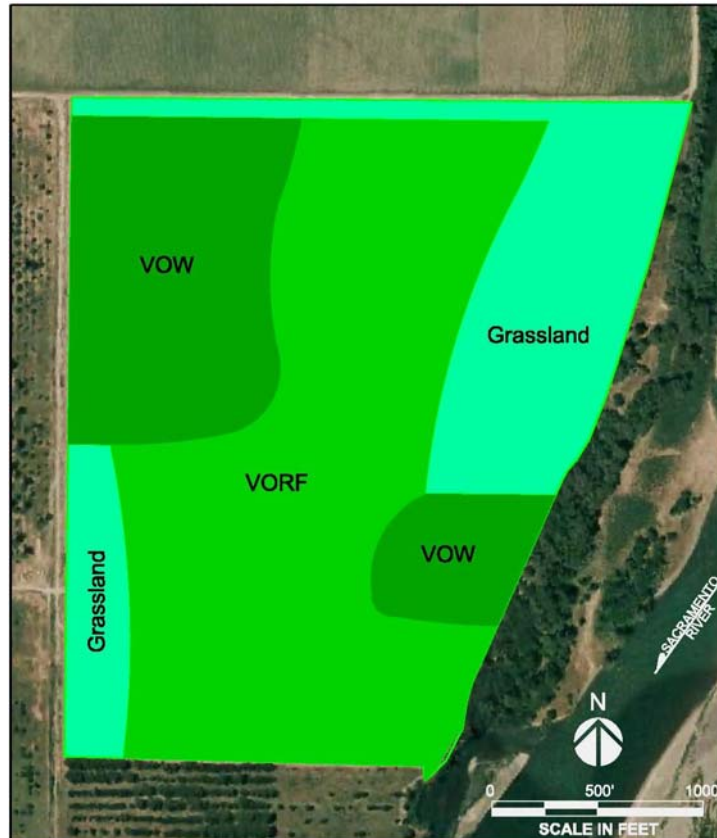
Figure 25. Habitat Restoration Plan for the Kopta Slough Property

The habitat restoration site is on the right overbank floodplain between RM 221 and 222. For this element the choice is to either have a full riparian planting or to base planting on what the soil can support and what will have the least effect to the system. Many habitat restorations have been performed on the upper Sacramento River, and the best results have come from planting a mix of forest, savannah, and grassland. After discussions with The Nature Conservancy, a plan was made for the best layout of the existing soil types and depth to ground water table. The habitat restoration includes 85 acres of Valley Oak Riparian Forest (VORF) through the center of the restoration site, 45 acres of Valley Oak Woodland (VOW), and 47 acres of grassland. The upstream end of the restoration site includes a grassland buffer. The layout of the proposed restoration is shown in **Figure 25**.

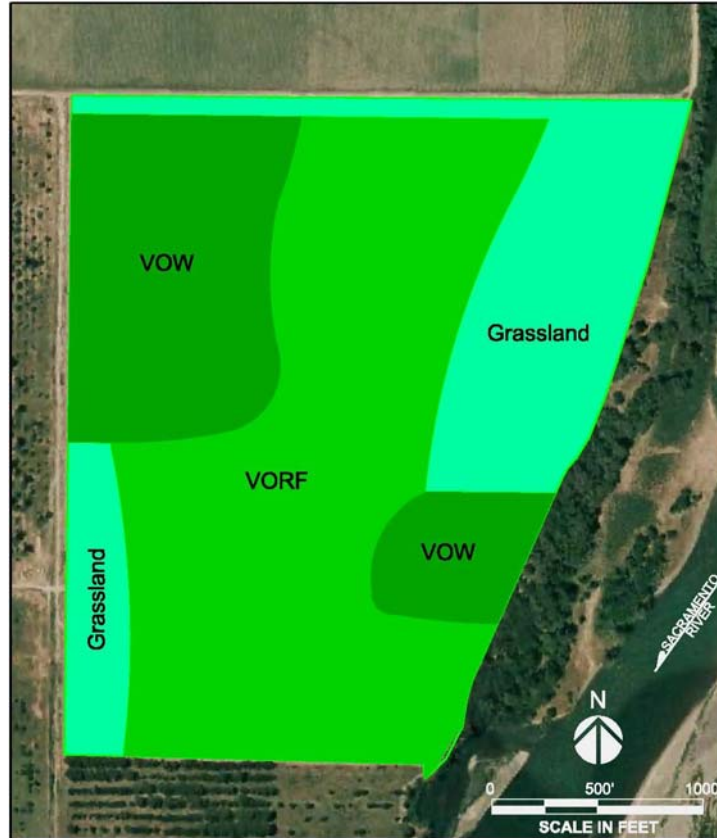
Figure 27. Habitat Restoration Plan for the Kopta Slough Property

Scenario 1 simulates the 100-year flow in combination with the restoration condition for the Kopta Slough Property. The model represents a restoration condition to the Kopta Slough property. The area of proposed restoration is used for crops, which is alfalfa in the existing condition. The restoration habitat consists of a mixture of Valley Oak Riparian Forest (VORF), Valley Oak Woodland (VOW) and Grassland, as shown in **Figure 27**.

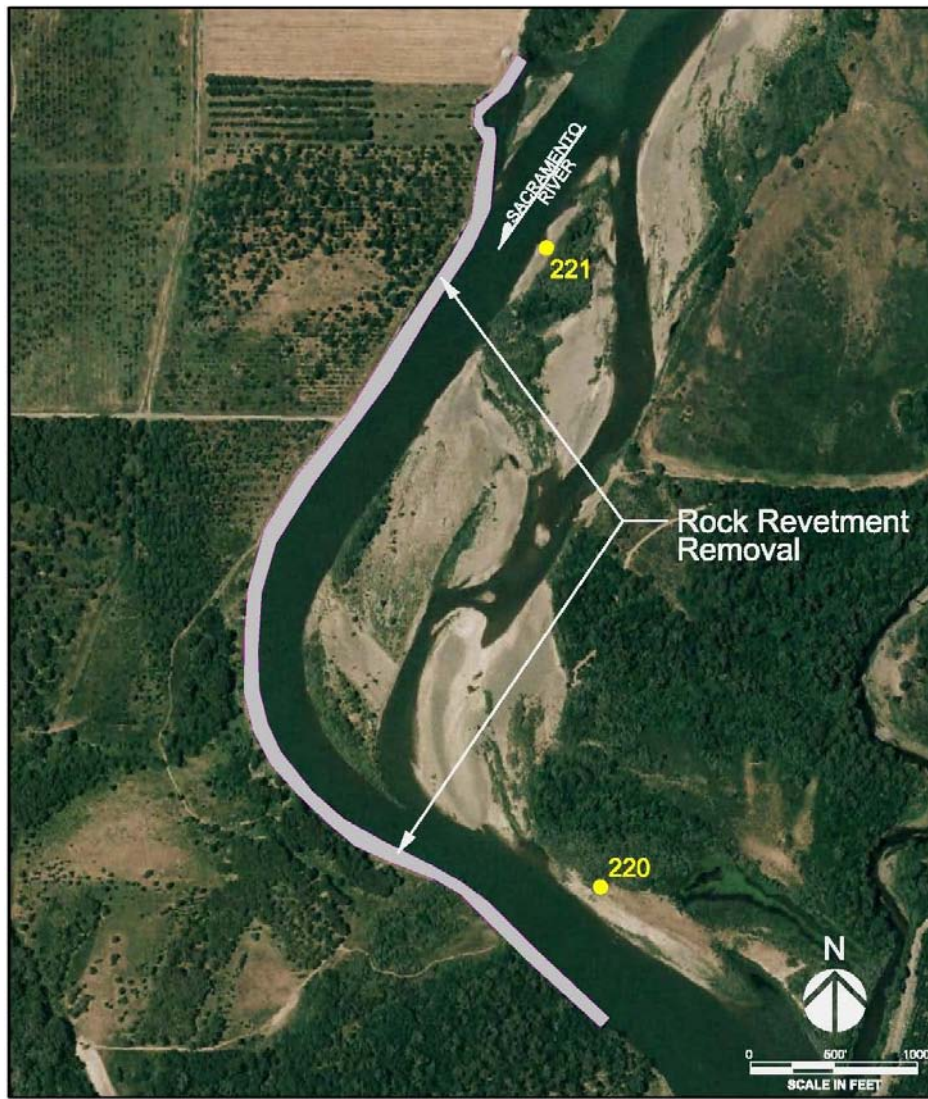
Figure 28. Location of Rock Revetment Removal

Scenario 2 simulates a 10-year flow in combination with habitat restoration on Kopta Slough property, removal of existing rock bank protection, and bank protection at Woodson Bridge and the City of Corning sewer outfall. The restoration habitat is the same as described in Scenario 1. The rock revetment removal will be from the right channel bank from RM 220 to 221, roughly one and a half miles of rock, as shown in **Figure 28**. The cross section view of the rock removal is shown in **Figure 29**. The rock will be removed as shown in the figure, the high berm along the bank will be lowered to floodplain elevation, and the land use will be changed to shrubs. The land use category of shrubs best represents the post-revetment removal condition in that they are likely to grow on the site (given their presence in the surrounding areas). The modeled roughness represents the eventual full growth condition for the greatest potential hydraulic effects. The bank protection will consist of rock armor for the protection of Woodson Bridge, and a low berm for the protection of the City of Corning sewer outfall, as shown in **Figure 30**. Cross sections showing the rock armor and low berm protection are shown in **Figures 31 and 32**, respectively. The ground elevation will be changed to match the rock design and the land use will be changed to revetment. The rock will extend up the bank to the elevation where the velocity is greater than 5 ft/s.

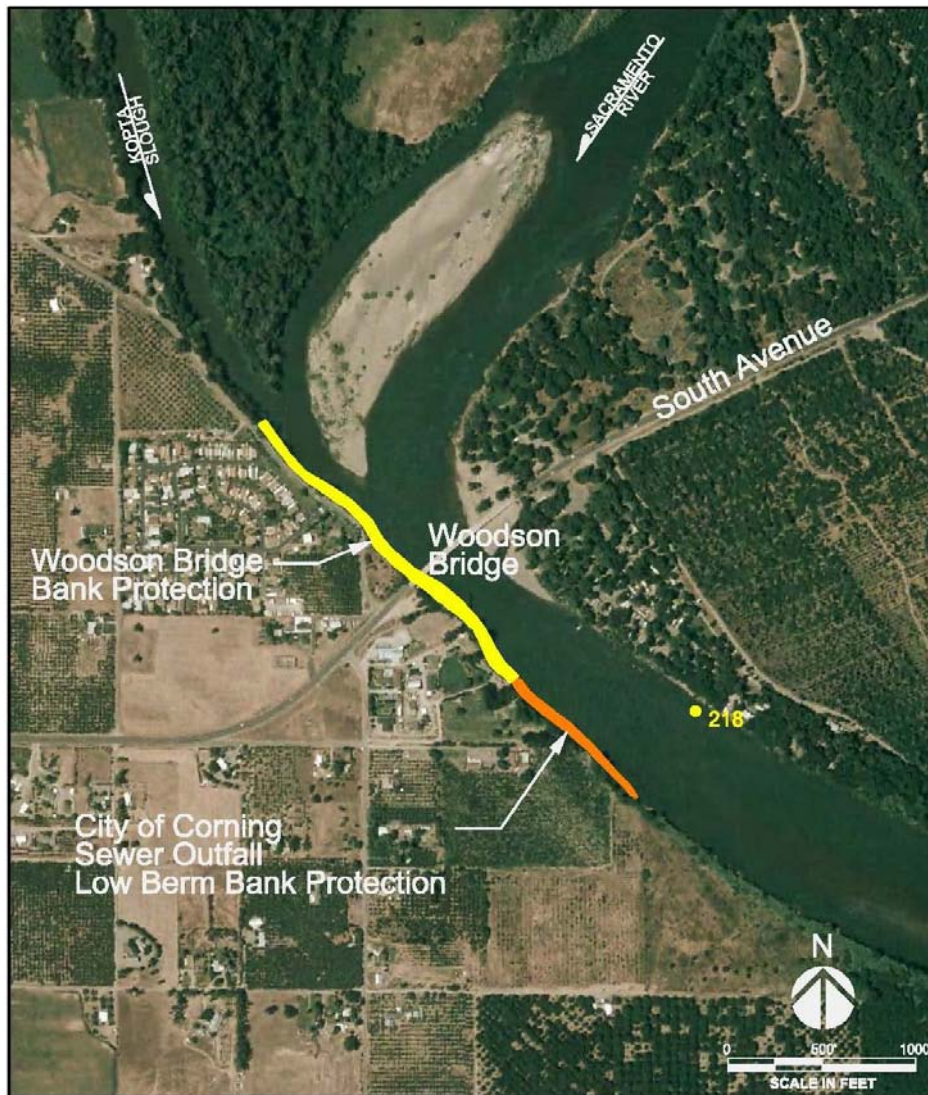
Figure 30. Location of Bank Protection at Woodson Bridge and the City of Corning Sewer Outfall

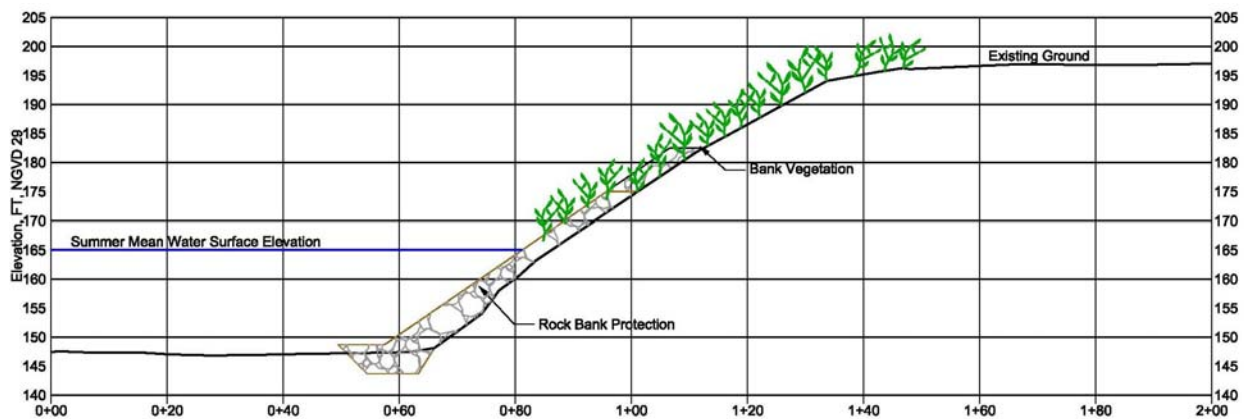
Figure 31. Cross Section showing Rock Armor Protection at Woodson Bridge
