*Bank Swallow (Riparia riparia)
Conservation Strategy for the
Sacramento River Watershed, California*

Bank Swallow Technical Advisory Committee

June 2013

Version 1.0
June 2013

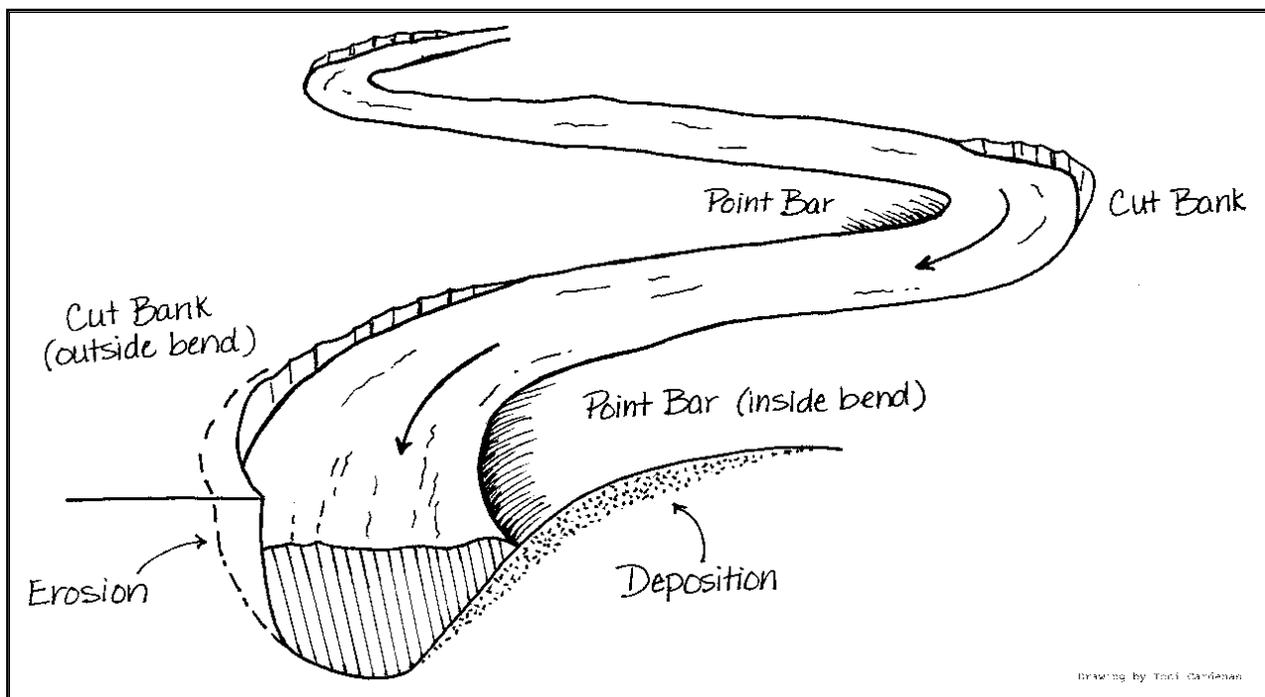
Figure 2: Typical bend on a meandering river (Toni Cardenas, SRCAF Handbook, 2003)

Alluvial rivers naturally move, or migrate, due to erosion on the outside banks of channel bends and sediment deposition on the inside of the bends creating point bars (Fig. 2). As a result of these dynamic river processes, meander bends move through time, both downstream and cross-stream. The lateral extent of the river's migration is

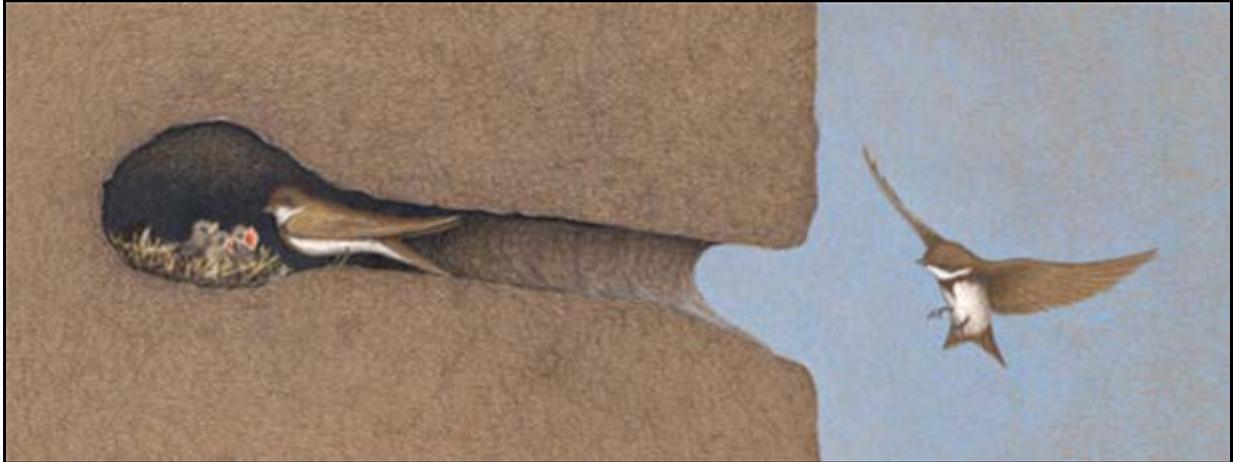
Figure 5: Artist rendition of Bank Swallow burrow and nest structure. Typical burrows can be as much as 3 feet deep. Figure by permission from Tim Gunther, www.gunthergraphics.biz.

Bank Swallows arrive in California each spring as early as March to nest; they seek suitable colony locations, excavate burrows, and form pairs. Males excavate burrows prior to pairing, and nests are built in the burrows using materials gathered from the ground, and pieces of roots from exposed banks (Fig. 5).

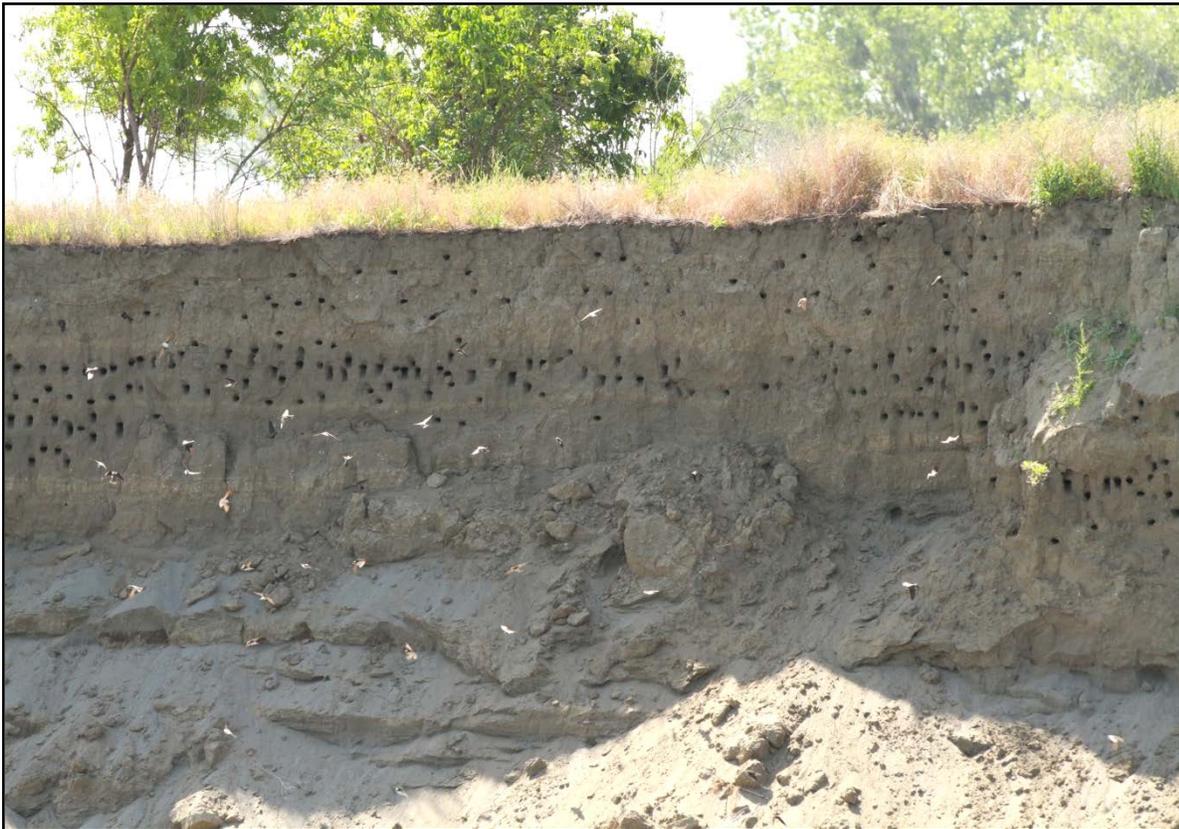
Figure 7. Active Bank Swallow Colony on the middle Sacramento River. Photo by Scott McReynolds (CDWR), 2012.

Bank Swallows establish colonies along eroded, vertical banks within river systems with friable alluvial soils (Fig. 7) (Garrison et al., 1987). Dynamic river processes create these conditions as rivers meander and expose fresh soil. In coastal areas and lakes, wave action erodes banks or bluffs to create vertical faces.

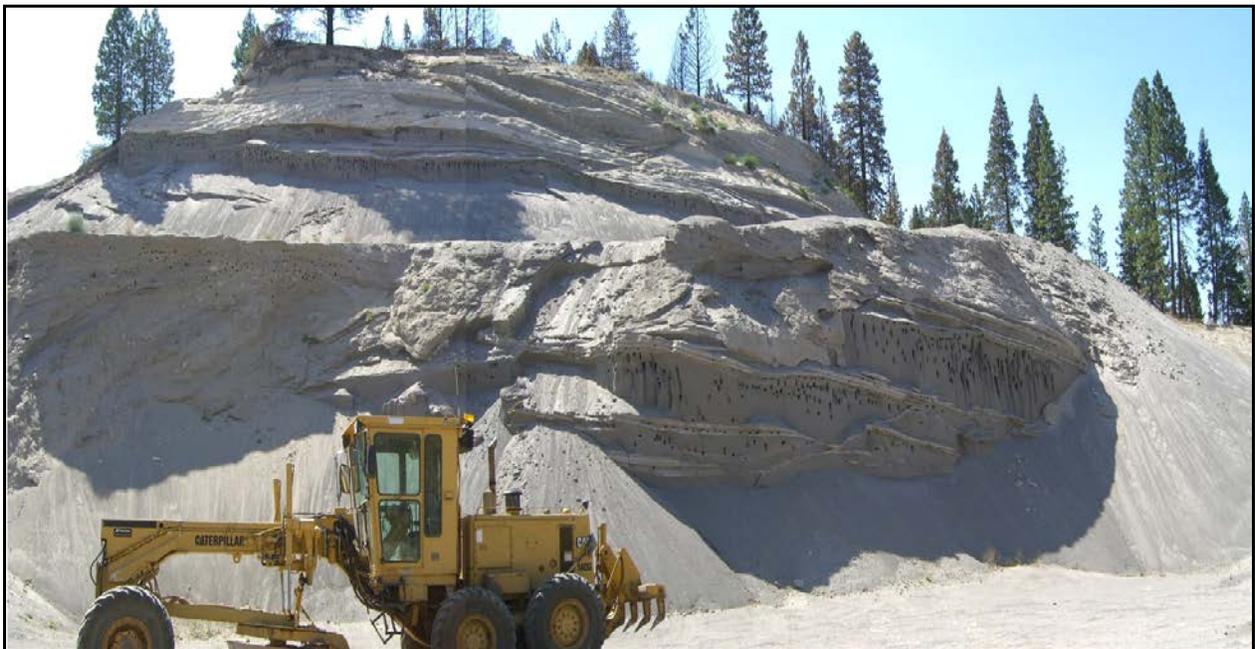
Figure 8. Bank Swallow burrows in sand mine (in shadow, right-center), Shasta County. Photo by Tricia Bratcher (CDFW), 2011.

Bank Swallow nesting colonies are also found in artificial sites, including sand quarries (Fig. 8) and road cuts, where resurfacing occurs during mechanical removal of materials, but these are uncommon (Garrison, 1999). These off-river sites are not well documented although there are California records from Siskiyou, Shasta, Lassen, Plumas, San Joaquin, and Inyo counties (pers. comm. D Garcia, 2008).

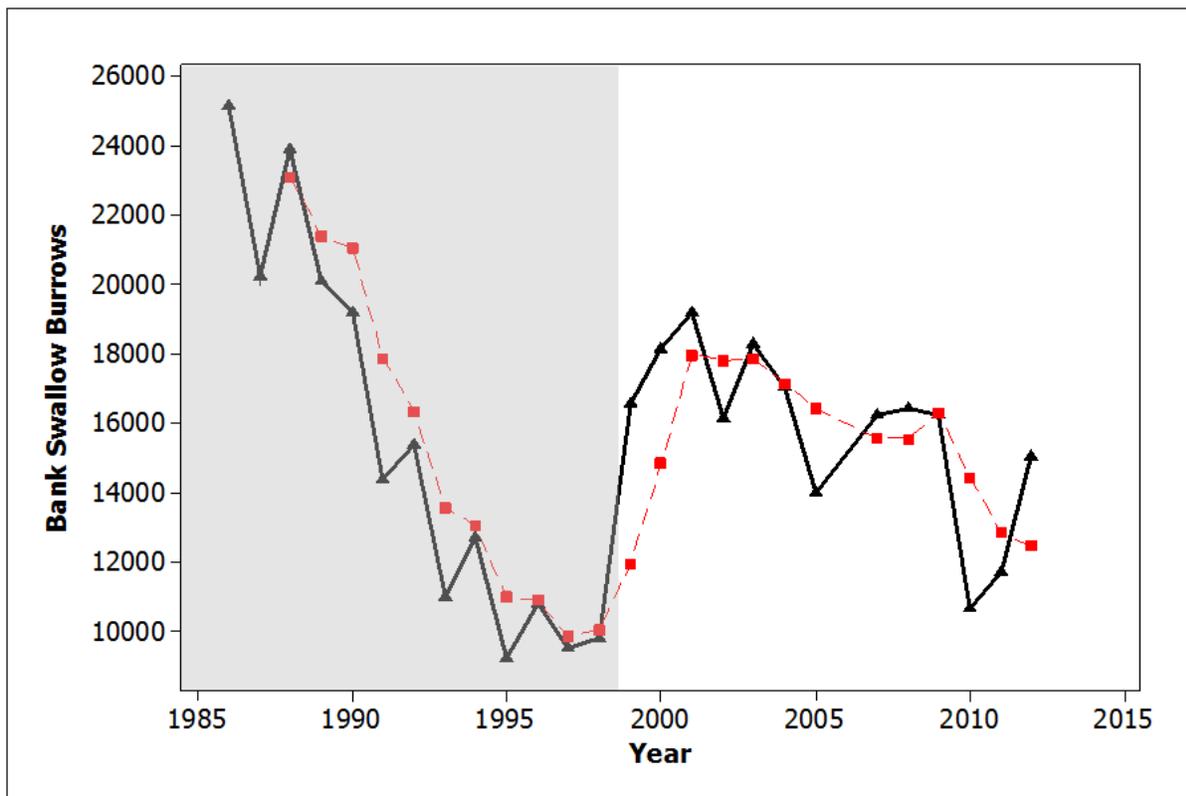
Figure 9. Bank Swallow burrow counts reported for the Sacramento River between Red Bluff and Colusa (100 river miles), from interagency survey efforts (1986-2012). Annual counts are shown in black, 3 year moving average in red. Data within the gray shaded area (1986-1998) were compiled from Hight (2000).

Since 1986 the CDFW (in partnership with the USFWS since 1999) has conducted annual surveys along the Sacramento River between Red Bluff and Colusa (middle Sacramento River) (Fig. 9) (Laymon et al., 1988; Schlorff, 1997; Hight, 2000; Garcia et al., 2008; Wright et al., 2011). At the time of CESA listing in 1989, the burrow count based on the 1986 survey was approximately 25,000. Through most of the 1990s burrow counts, and the corresponding estimate of Bank Swallow pairs, consistently declined, reaching a low of 9250 burrows in 1995. Since 1998, the number of burrows has fluctuated between 10,000 and 19,000 (Schlorff, 2000). The most recent estimate (2012) was of 15,000 burrows.

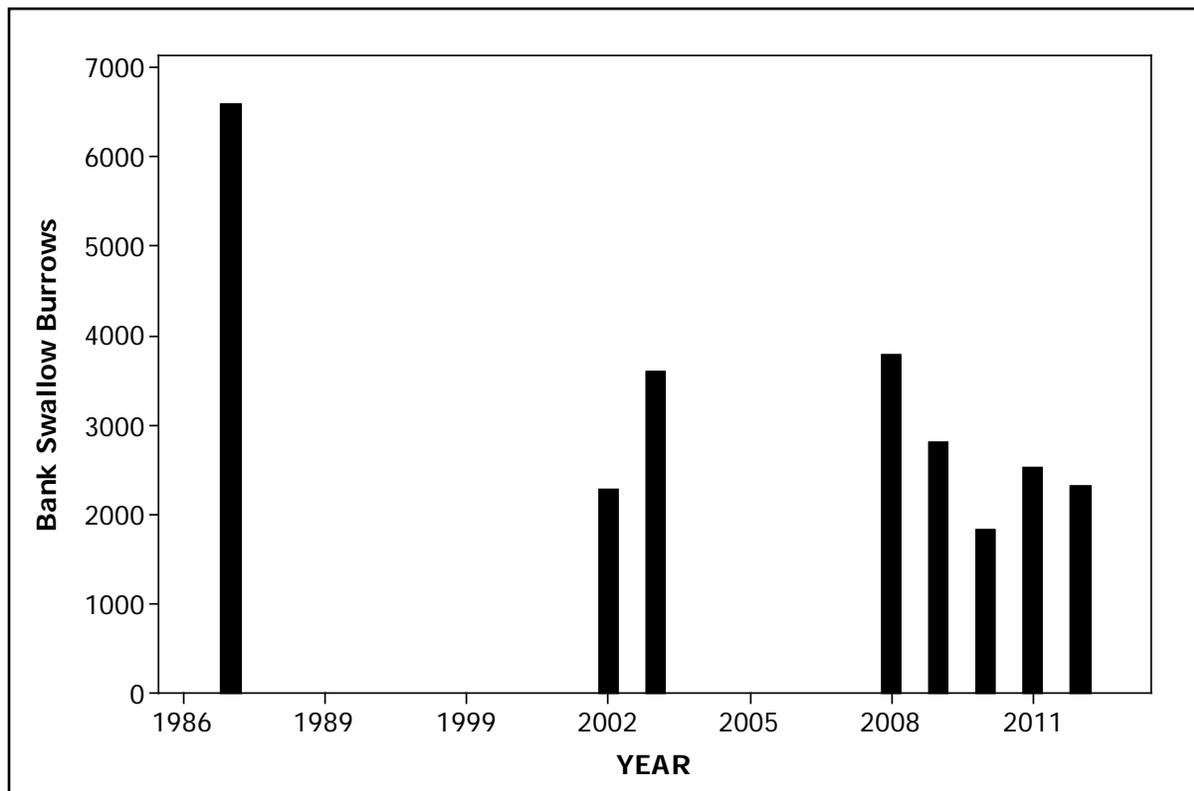
Figure 10. Bank Swallow burrow counts reported for the Feather River between the mouth and Thermolito Afterbay Outlet (59 river miles). DWR Annual surveys began in 2008. Surveys were not conducted in years without bars.

In 1987, CDFW conducted a survey of the Feather River and obtained an estimate of 6,590 burrows (Laymon et al., 1988). In 2002 and 2003, the Department of Water Resources (DWR) surveyed the Feather River and obtained burrow estimates of 2,270 and 3,590, respectively. Since 2008, DWR has conducted annual surveys of the Feather River, counting a low of 1,830 burrows in 2010. The most recent estimate (2012) was 2,320 burrows (Fig. 10).

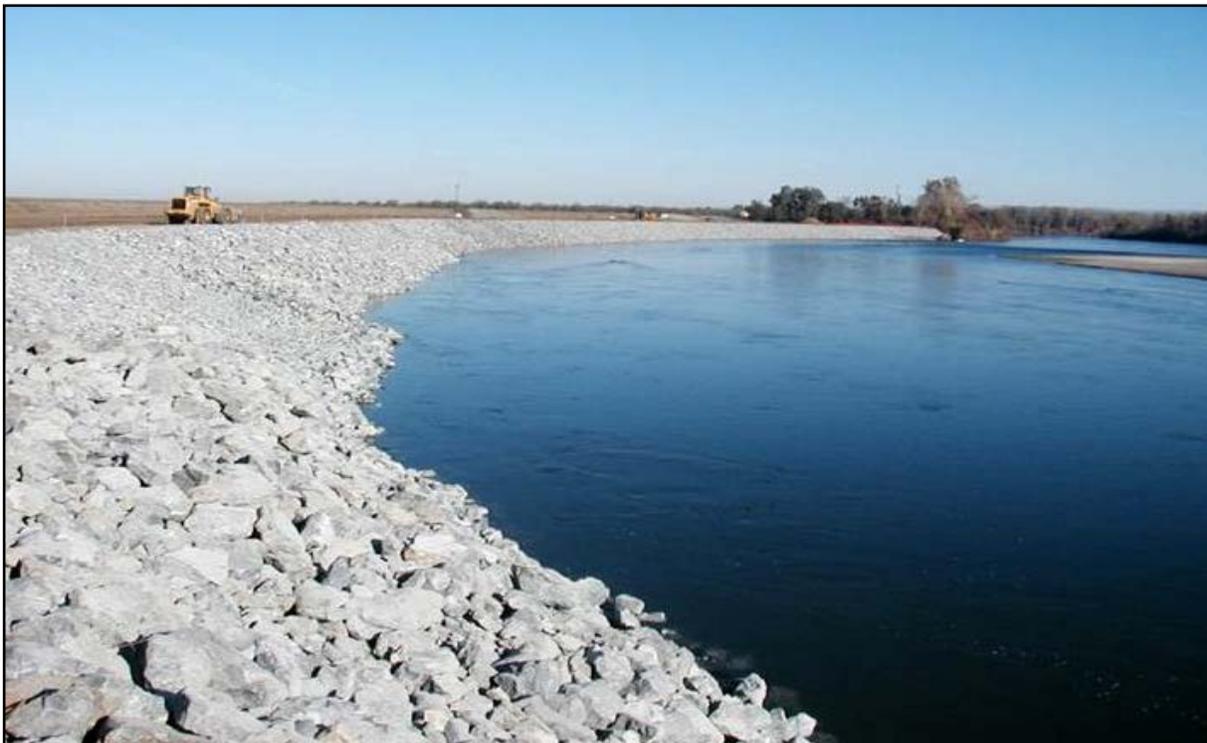
Figure 11. Agency revetment placed on an eroding bank on the middle Sacramento River under Executive Order S-01-06. Photo by Joe Silveira (USFWS), 2007.

Projects that prevent lateral migration of the river channel through placement of rock revetment have significantly reduced the amount of available nesting habitat and altered the river processes that renew these habitat features (Garrison et al., 1987; Humphrey and Garrison, 1987; CDFG, 1992; Stillwater Sciences, 2007) (Fig. 11). In addition, erosion control projects constructed at active nesting sites during the breeding season have caused direct mortality to adult and nestling birds (Garrison, 1991; Schlorff, 1995; Garcia et. al., 2008).

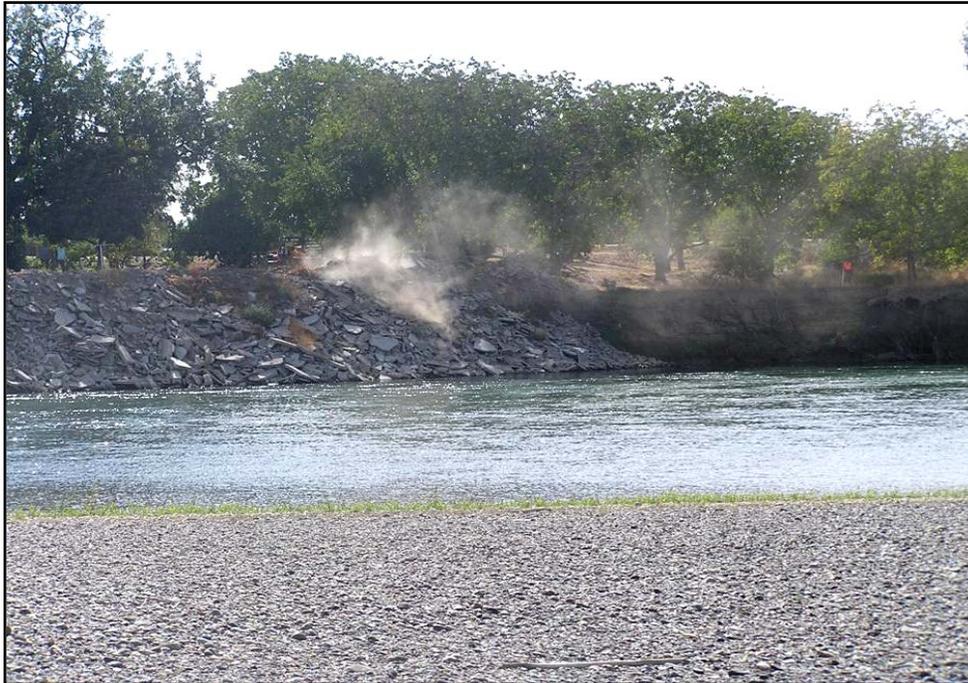
Figure 12. Private revetment being placed on an eroding bank on the middle Sacramento River. Photo by Dave Forwalter (DWR, Northern Region Office), 2007.

Installation of non-federal or State revetment by local maintaining agencies and private landowners proves difficult to quantify, but to date, an additional 264,000 linear feet (50 miles) of banks are known to have been impacted along the Sacramento River from Verona to Red Bluff (DWR unpublished data, 2012) (Table 1, Fig. 12).

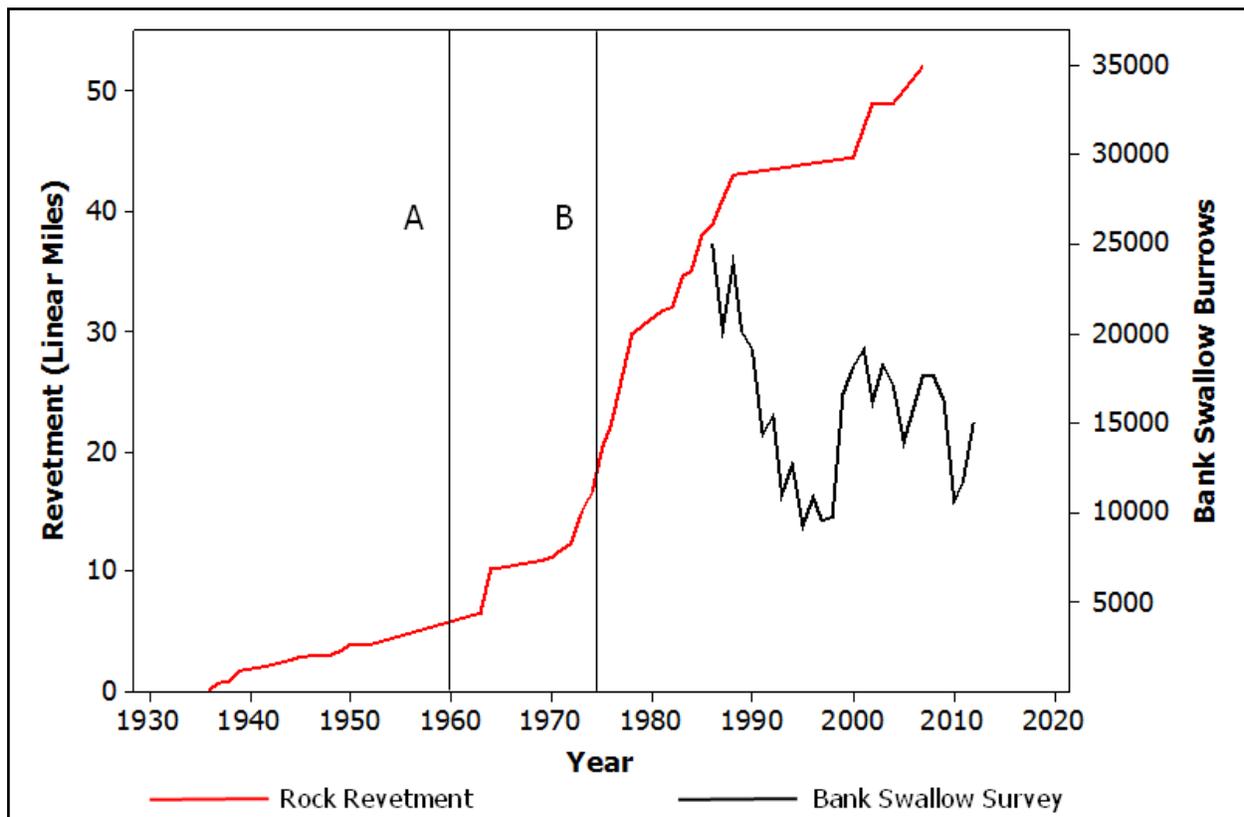
Figure 13. Cumulative length of rock revetment placed on the middle Sacramento River between Red Bluff and Colusa (approximately 100 miles of river) from 1935-present and Bank Swallow burrow counts, beginning in 1986. Vertical line A - Initial authorization of SRBPP, Phase 1, 1960, Vertical line B – Authorization of SRBPP, Phase 2, 1974.

These actions not only reduce the amount of Bank Swallow nesting habitat (Fig. 13), they also alter sediment transport and deposition, vegetation regeneration, and other natural river processes to the detriment of the entire riparian ecosystem, including special status species such as salmonids (USFWS, 2000; Stillwater Sciences, 2007).

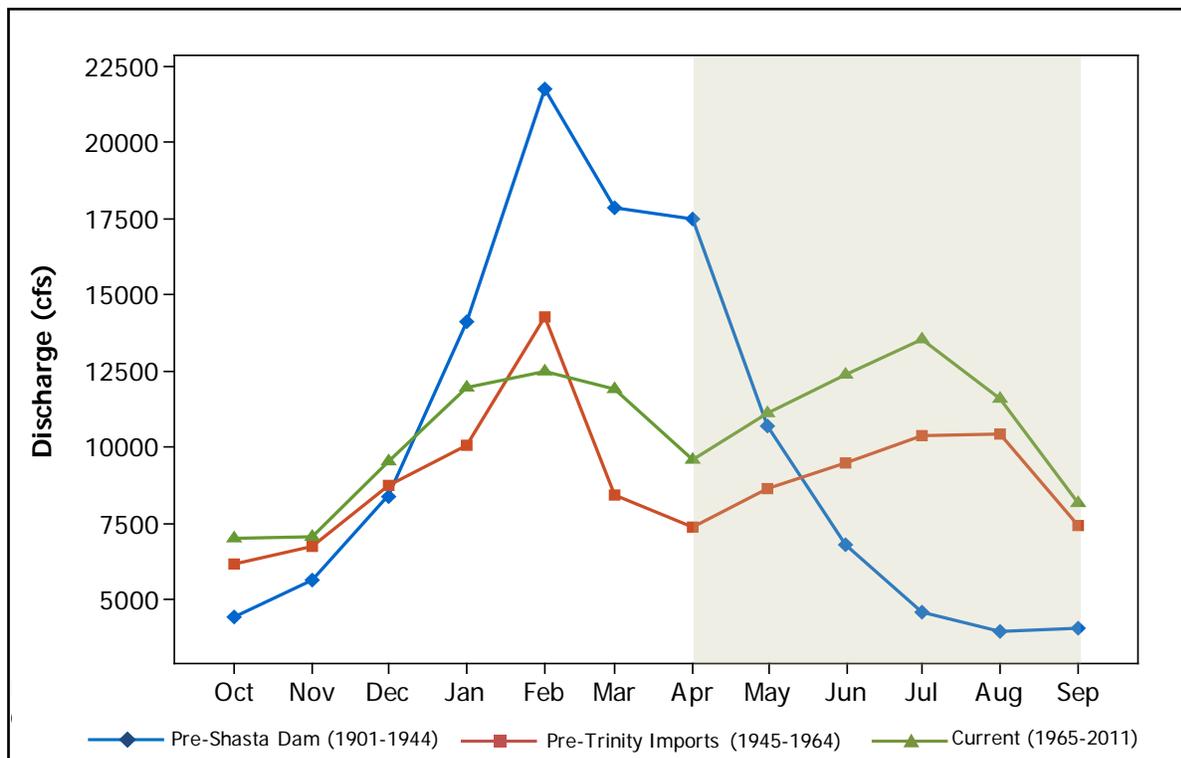
Figure 14. Monthly median flows in the Sacramento River at Bend Bridge, River Mile 258 (USGS Gage 11377100). Shaded bar indicates period of Bank Swallow nesting on the river.

Dam operations have greatly altered the timing, magnitude, duration, and frequency of winter high flow events on the Sacramento River (Fig. 14), and the Feather River. Since

the construction of Shasta and Oroville dams, winter and spring flows have been reduced while summer and fall flows have been increased above natural levels to accommodate water delivery schedules and agricultural and environmental water needs.
